AIRCRAFT ACCIDENT REPORT (Ref. N0 1/2016)

**Report on the Accident (collision) between
Aircraft (Reg No. G-SLYN)
And an ENEMED Fuel Bowser.
(5th of July 2016)**

Accident (Collision) between Aircraft G-SLYN and an ENEMED fuel Bowser.

Report Number 1/2016.

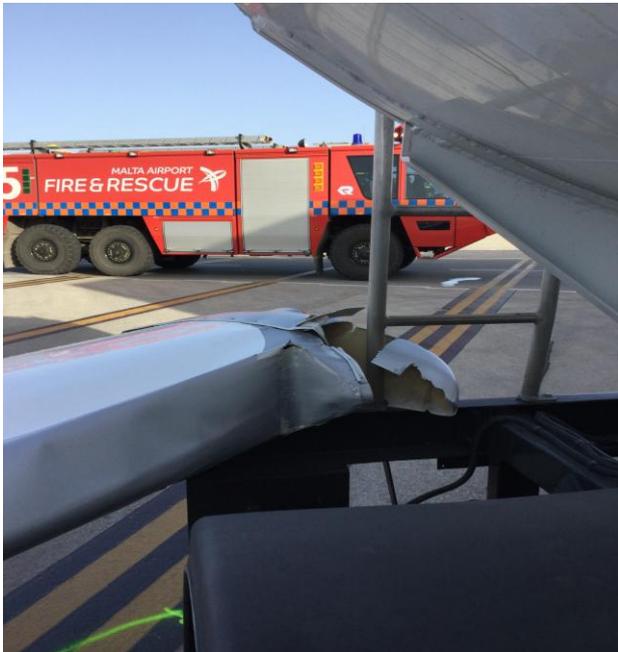
- (1.0) I began the investigation with an inspection of the accident site where I noted evidence such as the point of impact, the vehicles final resting positions, skid marks, scrub marks, and gouge marks (or the lack thereof). The Weather conditions and visibility at the time of the accident were excellent and although the Pilot was following the correct taxi procedure he miscalculated the space needed to safely make it past the obstacle (the fuel bowser). This resulted in the aircraft's left wing striking the Fuel Bowser, causing damage to the outer part of the left wing's leading edge and superficial damage to the Fuel Bowser.

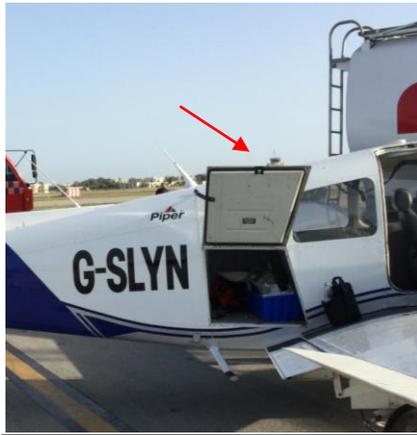
have advised the pilot to “taxi with caution”, or “stop taxiing” until the bowser was moved, however, when I viewed the area from the control tower a different reality emerged. Because of the geographical location of the control tower (specifically, its distance from apron 1) it would have been difficult for the controller to see the fuel bowser unless s/he knew exactly what to look for or had a valid reason to look in that direction. The ENEMED fuel bowzers are painted white and have a medium sized red stripe along both sides such that, from a distance, they are difficult to spot because they can easily blend with the surrounding structures.

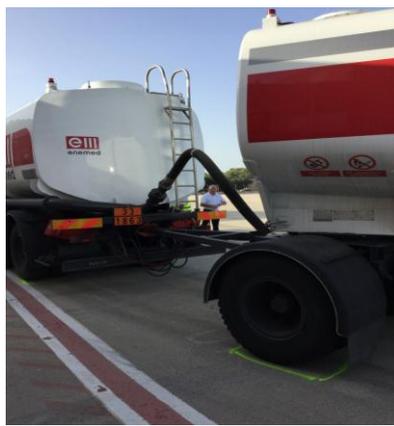
- 1.2 I noted that there were no skid marks and that the aircraft was pointed to its left in the direction of the fuel Bowser. This could indicate that the pilot never found it necessary to apply brakes until his port-side wing collided with the Bowser. The CCTV footage of the collision confirms this.
- 1.3 The position of the fuel bowser clearly indicated that neither the “Red limit lines” on the Apron nor the bowser’s position (*blocking the entrance to Park 1.*) were taken into consideration when the bowser was parked.
- 1.4 During the on-site interview, the PIC (*who was visibly still in shock*), assumed that he would clear the fuel Bowser because he was taxiing on the centreline. CCTV footage confirms that the Bowser was clearly and in plain view obstructing his taxi-way; therefore a collision was inevitable.
