SAFETY INVESTIGATION REPORT

REPORT NO.: 17/2012

September 2012

MT TRANS SCANDIC **Loss of Pygas cargo** **Whilst on passage** **Between 29 and 30 December 2011**

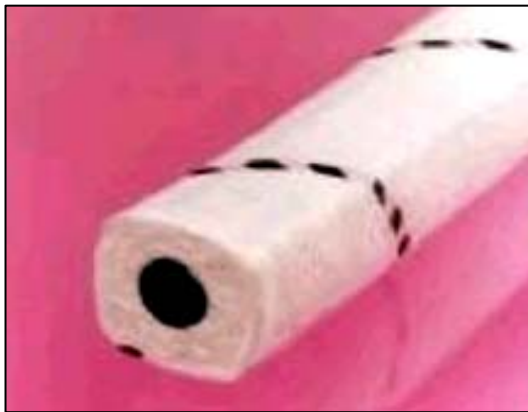
It was routine practice on board *Trans Scandic* to change gaskets when loading different cargoes, since different cargoes require specific gasket material (Figure 3).

Figure 3: Cross-section of the gasket used on the Butterworth covers. The gaskets are of the endless type, necessitating a custom made gasket, which fits the dimensions of the hatch coaming.

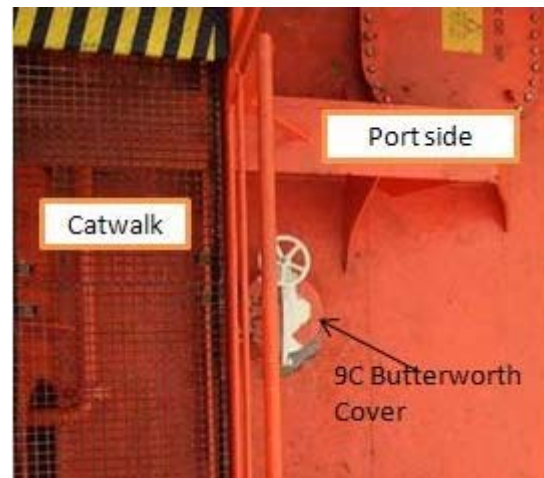
Figure 4: View of no. 9 centre tank Butterworth cover from the catwalk

Taking into consideration the very strong and distinct odour of Pygas, it was concluded that any opening left unsecured would have been easily noticed either at the port of Berre or Fos-sur-Mer.

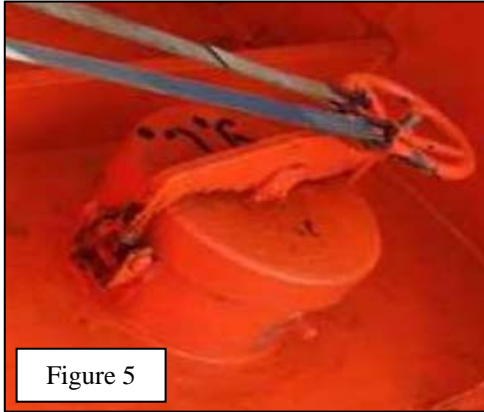
As a result of the above factors, the master was only informed at 0800 when the Butterworth cover was found open. It was only at this stage that the Butterworth was closed and re-secured with additional fastenings as a safety precaution (Figure 5).

Moreover, as a permanent corrective action, additional tierces were fitted where necessary on the Butterworth openings on board *Trans Scandic* and her sister ship. Notifications were also issued to the sister vessel and all crew members were briefed and encouraged to improve communication procedures.

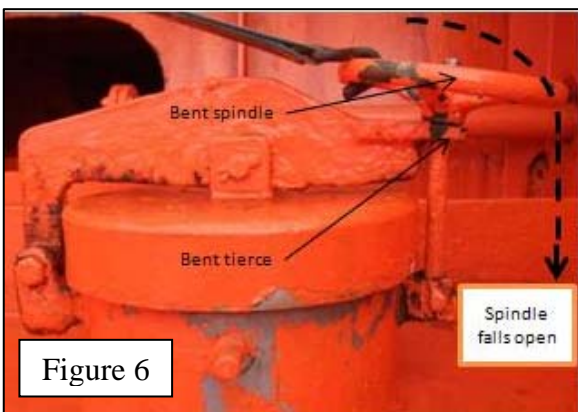
It was reported that the securing mechanism of the no. 9 centre cargo tank Butterworth cover had been bent for some time. However, there were no indications as to when this could have happened. Taking into consideration the cargo which the vessel loaded, and since there was only one locking device on the cover, it was of utmost importance that these devices were fully maintained.

During any particular deck inspection, it was not particularly difficult to notice that the extent, to which the spindle and tierce were bent, would have facilitated the falling of the spindle off the tierce with the least minimum effort (Figure 6).

Considering that the gasket on no. 9 centre Butterworth cover was renewed, there was also the possibility that this was not fully compressed when initially fitted. By time, the

gasket gradually compressed itself enabling the cover locking spindle to become free.

During the heavy rolling, the sloshing effect of the cargo imposed forceful pressure, facilitating the process of the spindle easing off the tierce. Once the spindle fell off, there was nothing else preventing the cover from opening.

Since the bent spindle and tierce were not considered critical, no formal risk analysis was ever carried out to determine the possibility of a Butterworth cover to open.
