SAFETY INVESTIGATION REPORT

REPORT NO.: 11/2012

MV AGGELOS B

Fatality on board

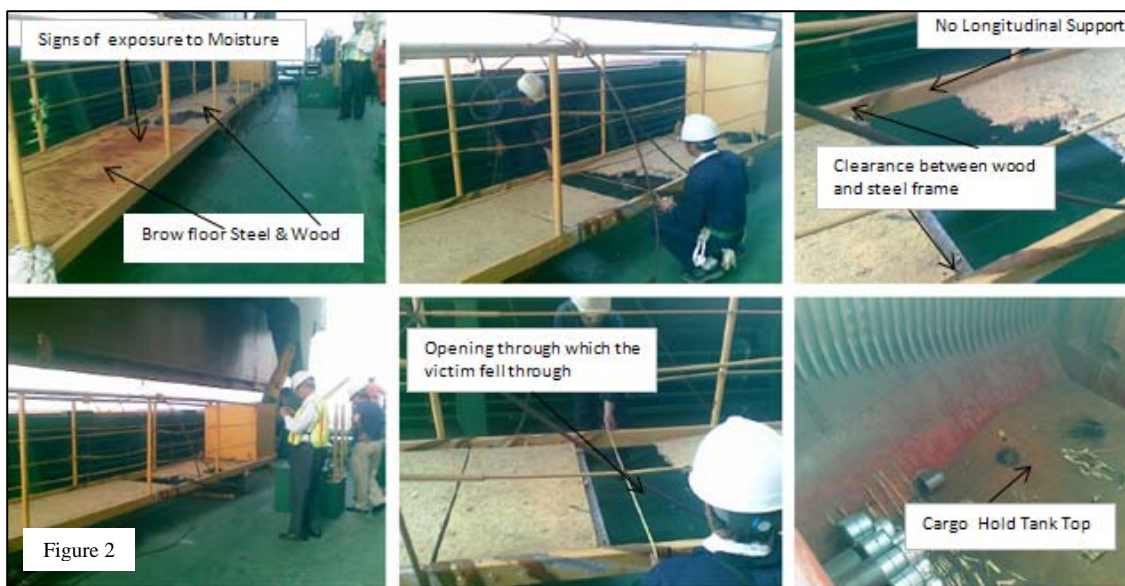
The AB climbed on to the top of the cargo hold hatch coaming and grabbed hold of the harness sling to which the safety belt was fastened at that end. This was secured to the crane's hook (Figure 3). Without wearing the safety harness, he jumped into the brow whilst still holding on to the harness sling. He landed on the wooden part of the floor of the brow, which gave way and broke under the sudden impact (Figure 2).

tanktop (Figure 2). The accident happened at around 1305 hours (LT).

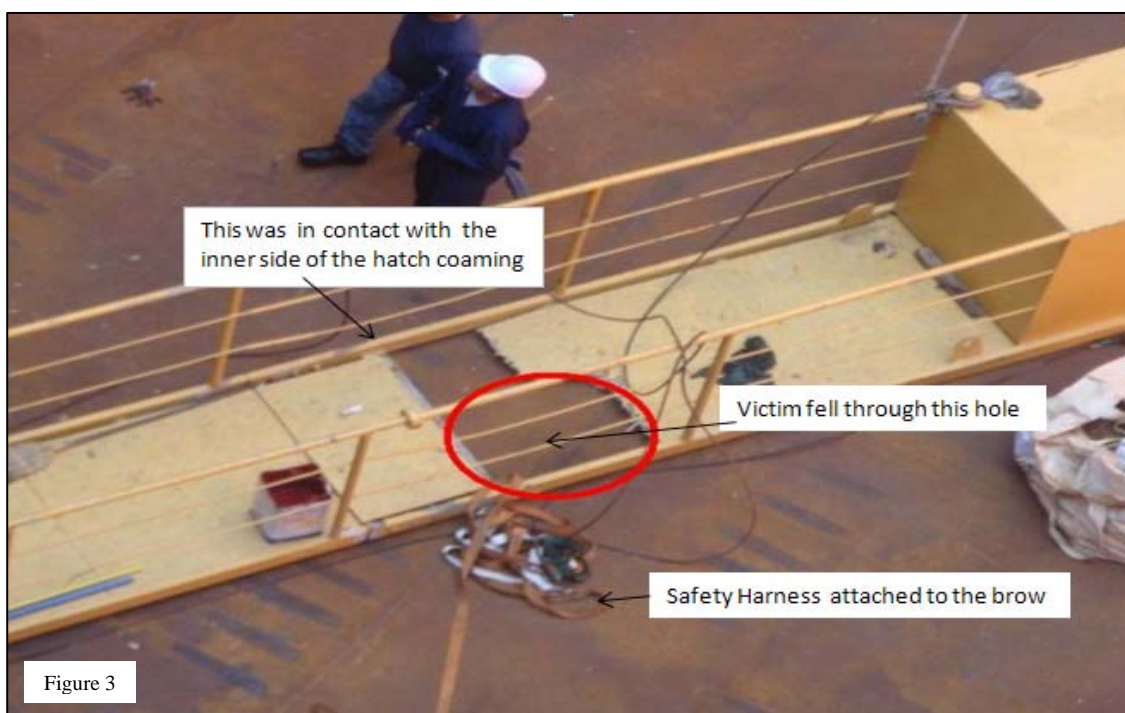
Using the crane, the chief mate lifted the brow from the deck and positioned it against the inner side of the hatch coaming of hold no. 5 (Figure 3). The first crew member to board the brow was the OS. It was reported that once in the brow, he adjusted the harness attached to his vest. The second crew member to board the brow was the AB.

The chief mate then returned to the crane and lowered the brow onto the cargo hold tanktop (Figure 3) in the hope that the brow will be used to lift the AB for medical assistance ashore.

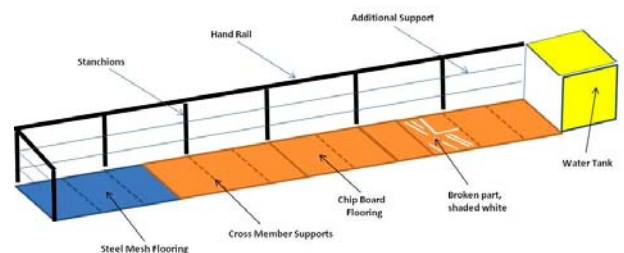
Figure 4: The brow

The brow (Figure 4) was manufactured in Piraeus, Greece by a workshop known to the managers¹. It was noted that no certification of integrity of the brow and the slings was available, possibly indicating the absence of testing prior to use. The brow was normally used by the crew in order to reach high levels when attached to a crane. The brow was secured to the crane by four slings and was lifted by means of the crane's hook during hoisting.

The overall dimensions of the brow were nine metres by one metre and had railings around its perimeter, one metre high. On one end, a water tank was fitted to the structure, serving as a counter balance of the brow.

The base frame consisted of a steel hollow section material 100 mm by 40 mm by 5 mm material thickness. It had cross supports at 750 mm intervals, which served as a support for the floor boards.

Six vertical stanchions of a diameter of about 38 mm were welded along the structure's length, serving as a support for the horizontal railings. The top horizontal railing was a 38 mm pipe, while the other two horizontal railings further below, were made of a 14 mm solid steel bar. The one metre end, which was opposite the water tank, also had fitted steel railings of the same material and size.

The floor of the brow was partly made of steel mesh and partly of chipboard material having a thickness of 20 mm. The steel mesh

covered approximately 25% of the brow length, while the remaining 75% was covered with the chipboard material. The flooring had no longitudinal support, its only support were the cross members spaced at 750 mm intervals. The cross member supports were made of 48 mm pipes and in some places of a hollow section of 100 mm by 38 mm; the 100 mm being the face supporting the flooring. The chipboard panels were being retained in position by six millimetre diameter bolts.

Soon after the accident, A.B. Maritime Inc. instructed the crew members not to use the brow until the wooden flooring was replaced with steel bleaching plates.

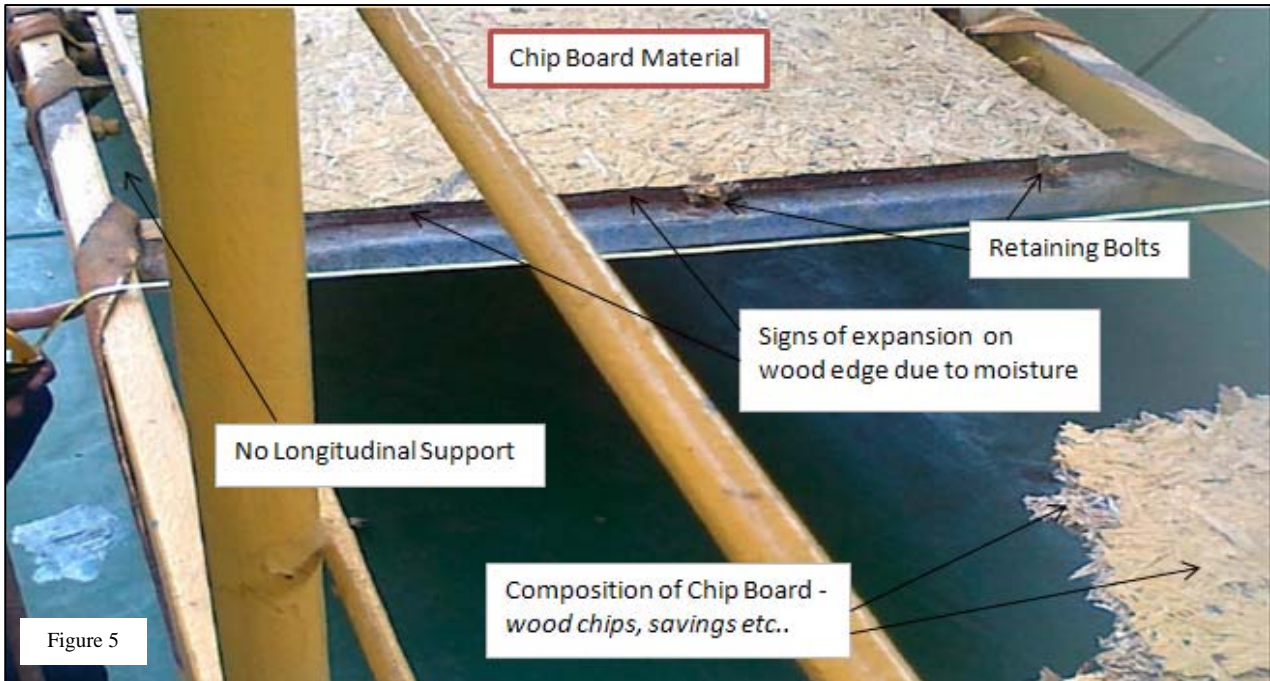
The brow steel structure was of galvanized steel. Available photos did not indicate that the entire exposed surface area of the wood was treated (Figure 5). The brow had been used on various occasions prior to the accident by the crew members, including the victim himself.

A major disadvantage of chipboard, however, is that moisture makes it very prone to expansion (Figure 5) and discoloration, particularly when it is not covered with paint or some other sealer². Chipboard is rarely used for outdoor purposes or places that have high levels of moisture. Moisture was therefore problematic for the flooring's integrity given that the brow was normally stored on the main deck aft of cargo hatch no. 5 and close to the accommodation block.

The structural integrity of the brow and the flooring was also another critical safety aspect. There were no records of periodical close up inspections of the brow. Moreover, the damages inflicted onto the chipboard by marine elements were not questioned and the integrity of the brow's flooring was never a concern (Figure 5).

This was noted whilst taking into consideration that apart from this hazard, the flooring also had no longitudinal support (Figure 5) - a latent factor which even though it was not deemed as a risk in the first place, it is one which contributed towards its weakening.

In addition, it has to be pointed out that the width of the wooden part was about 100 mm less than the width of the brow's base (Figure 5). The wooden part of the flooring was bolted at its transverse edge but this was not enough to support the weight of the sudden impact, thus causing the chipboard to collapse when the AB jumped from the top of the hatch coaming onto the brow.

The vessel was eventually supplied with stores and equipment and the wooden flooring replaced.
