SAFETY INVESTIGATION REPORT

REPORT NO.: 04/2012

MV ALGARVE **Fatality of shipyard worker** **In Rijeka** **21 July 2011**

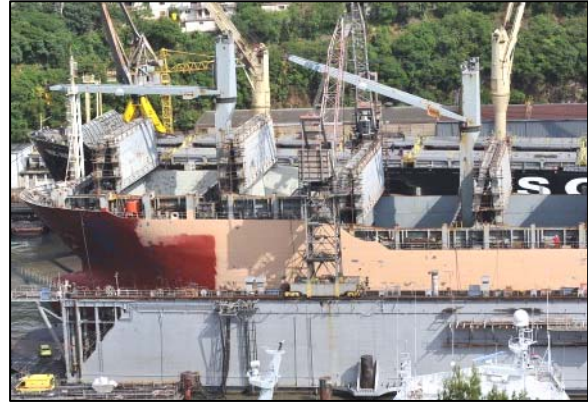
Figure 1: MV *Algarve* in Dock no. 5

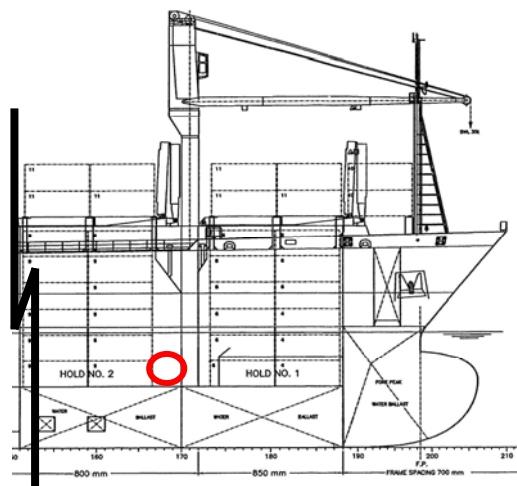
Figure 2: The Emergency fire pump space where the accident happened

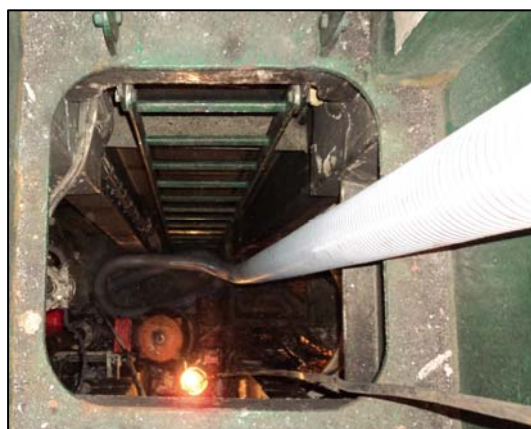
The emergency fire pump space was a very tight space, located between frames 166.5 and 170. The frame spacing was 850 mm and measured 1.52 m by 1.37 m and was 2.44 m high (Figure 3).

Figure 3: The restricted space where the accident happened

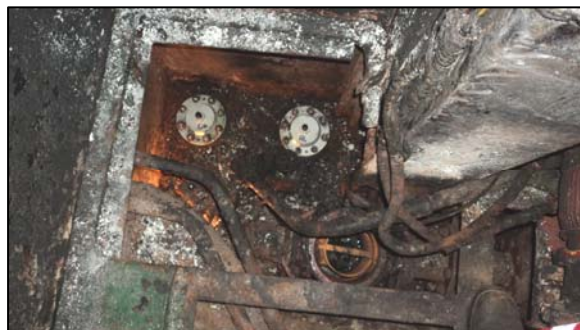
There were no structural damages reported as a result of the fire inside the emergency fire pump space. However, smoke damage was visible, with scorched paint and ashes in the space bilges (Figure 4). Most of the scorched paint was localised in the lower areas of the emergency fire pump space.

Figure 4: Fire damage inside the emergency fire pump space

Several units of the ship's equipment, such as the fire pump and pressure gauges, were also affected by the fire. An oxy-acetylene cutting

torch had also sustained fire damage. A melted red hard hat was found in the space together with a partially damaged yellow hard hat, a pair of burned protective gloves, and several burned rags.

Following the accident, the ship managers have taken the necessary steps to start their internal review process of the safety management system manuals for dry-docks and external repair supervision. It is envisaged that new procedures will be in place in the short term and communicated to all the ships.
