## SAFETY INVESTIGATION REPORT

REPORT NO.: 16/2012

### ***MV ARIANA***

**Fatality of one crew member  
In position 01° 56'N 091° 01'E  
06 October 2011**

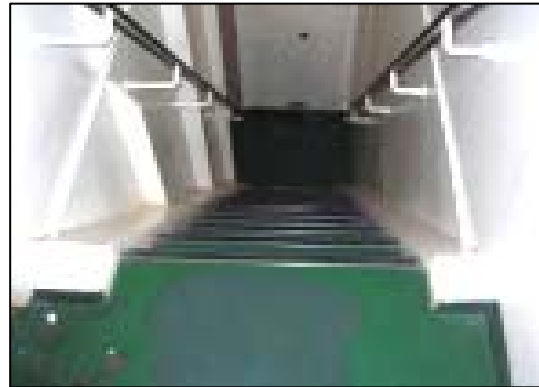
**Figure 1:** The stairway leading from the bridge deck to the boat deck

There were at least twelve steps on the stairway leading from the bridge deck to the boat deck, within the superstructure. The steps were quite narrow and steep. Hand rails were fitted on either side of the stairway.

Each stair had rubber non-slip edging fitted at the edge. However, the steepness of the steps with their limited surface foot space would have necessitated extra caution under normal conditions. The steps would have been even more dangerous if the vessel was rolling or pitching. The same would apply if someone not lucid or intoxicated attempted to descend the stairs.

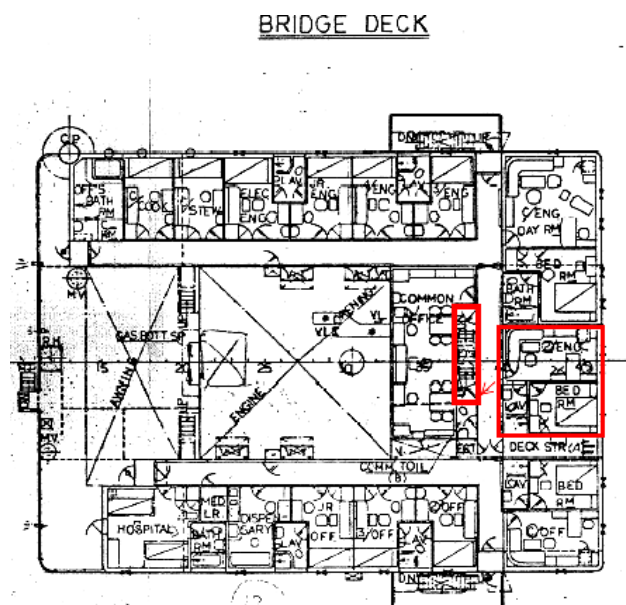
The second engineer's cabin, which was the last place the deceased had been prior to the accident, was located on the bridge deck, forward of the stairway (Figure 2).

**Figure 2:** Location of the second engineer's cabin in relation with the stairway

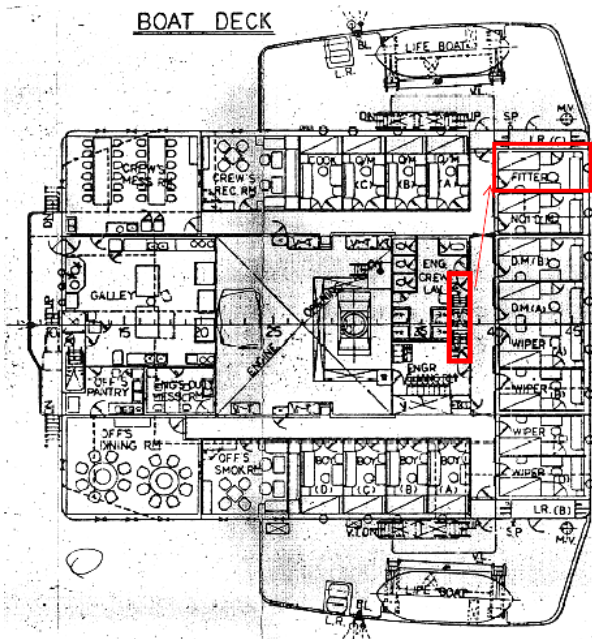
The fitter's cabin was located on the boat deck's port side at the end of the corridor and forward of the stairway referred to above (Figure 3). The fitter was returning to his cabin from the

**Figure 3:** The fitter was returning to his cabin, located on port side of the boat deck transverse alleyway

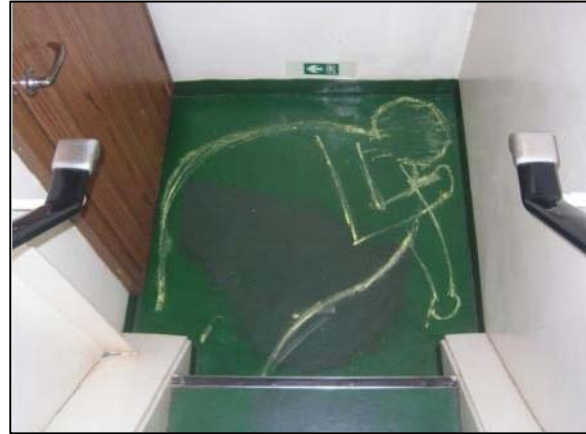
At around 2305, the fitter left the second engineer's cabin, and proceeded to his cabin on the boat deck below. He was wearing a pair of slippers. At the time of the accident, one of the oilers heard the fall and upon investigating the matter, he found the fitter unconscious at the bottom of the stairway with a serious head injury on the left forehead (Figure 4).

**Figure 4:** The bottom end of the stairway where the injured crew member was found

Based on the position in which the fitter was found, *i.e.* face down and at the bottom of the narrow stairway (Figure 4), it was very likely that the fitter did actually make contact with the side walls when falling down.

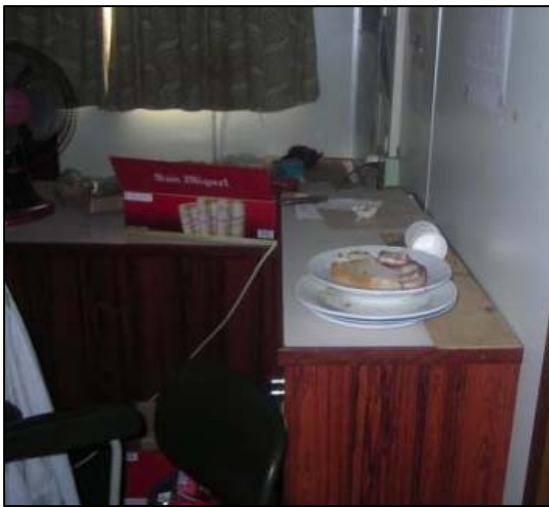
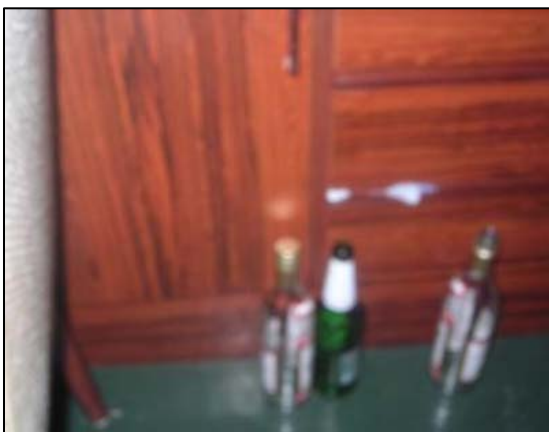
The Company's Safety Management Manual, section 7.10.4.2.2.3 stipulated that no alcohol should be consumed on board. However, from the gathered evidence, it was clear that some crew members, including the deceased, consumed a quantity of alcohol during the second engineer's birthday party. It was highly

**Figure 5:** Party leftovers and bottles of alcohol found inside the cabin where the party had been organised

Notwithstanding the company's Drug & Alcohol policy, a birthday party was organised on board and alcohol consumed. Based on the observations that there were empty bottles in the cabin, it would appear that the company's alcohol and drug abuse policy was not being effectively implemented on board.

- 16/2012\_R1** Establish measures to implement and enforce its Alcohol and Drug Policy on board its managed ships.

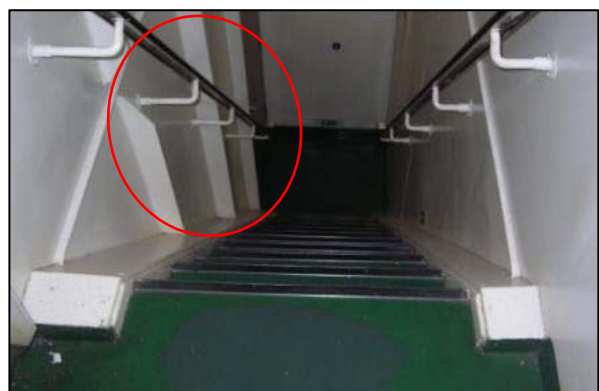
**Figure 6:** Aft section stiffeners protrude towards the stairway

It was also noticed that on the aft side of the stairway, there were a number of stiffeners. The frames protruded by several centimetres into the stairway (Figure 6).

This was considered to be a potential hazard if somebody suddenly lost footing whilst (or) before descending. It was not excluded that when the fitter fell down the stairway, he may have made physical contact with one or more of these frames, which could have caused eye and head injuries, and eventual death.

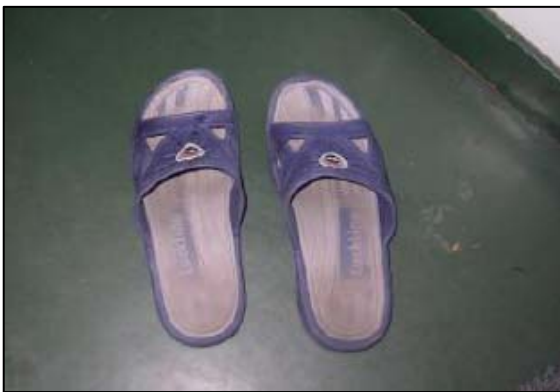
It was also stated that the fitter had left the second engineer's cabin, unaccompanied and wearing a pair of bedroom slippers, which may not have been suitable for use outside cabin spaces.

Moreover, the footwear worn by the fitter at the time of the accident (Figure 7) may have contributed to the fall as well.

**Figure 7:** Footwear worn by the fitter at the time of the accident
