SAFETY INVESTIGATION REPORT

REPORT NO.: 15/2012

MV BALKAN **Fire in engine-room** **In the port of Salerno** **04 October 2011**

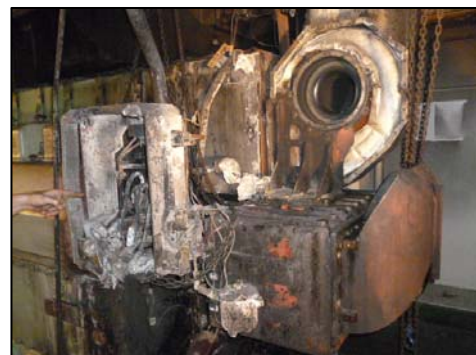
A detailed inspection of the generator room revealed that the fire was localised, on and around no. 3 generator prime mover. It could not be established when the fire had commenced or for how long it had been burning before it was discovered. However, the inspection of the fire scene indicated that the fire duration was short. This was so because by the time it was extinguished, the damage sustained to the generator and equipment was not extensive (Figures 1 and 2).

Figure 1: Localised damage restricted to turbocharger and intercooler area

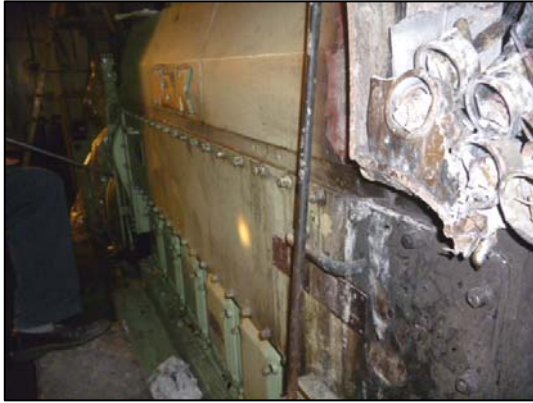
Figure 2: Extent of fire damage did not reach the prime mover units

When the engine-room alarm sounded, followed by the black out at 0044, the fire in the generator compartment had already started. The fire was eventually suppressed in approximately 20 minutes, reducing the severity of the damage to the generator and the generator room.

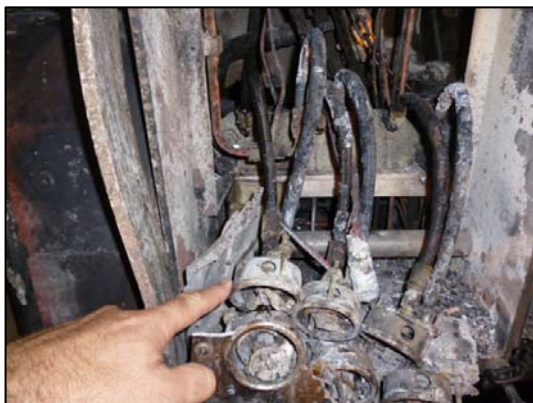
The investigation came to the conclusion that the cause of the fire was the ruptured flexible armoured rubber hose connected to the fuel gauge fitted on no. 3 generator instrumentation panel (Figure 3). After the fire, the chief engineer was requested to open the fuel delivery valve to no. 3 generator and oil could be seen leaking from the damaged flexible hose attached to the fuel gauge of no. 3 generator (Figure 4).

Figure 3: Close up of the burnt instrumentation panel showing finger pointing at the fuel gauge

- The fire was initiated by the rupture of the flexible armoured hose pipe on the fuel gauge of no. 3 generator instrumentation panel.
- The un-lagged turbocharger support brackets served as a hot spot to ignite the leaking fuel.
- The inspection and maintenance of the pressurised fuel oil system was hindered by the way the flexible hose was hidden behind the instrumentation panel.
- The timely intervention by the crew reduced the severity of the fire and equipment damage.

15/2012_01 revise the SMS, in order to take into consideration not only the manufacturer's periodical inspections and maintenance, but also incorporate guidelines from other recognised maritime bodies or institutes such as IMO circulars and Classification Societies technical papers on fires similar to the one on board *Balkan*.

15/2012_02 ensure that crew members, especially officers, are provided with enhanced risk assessment training and skills to identify critical equipment / fittings, the failure of which may have the potential to cause a hazardous situation or accident.

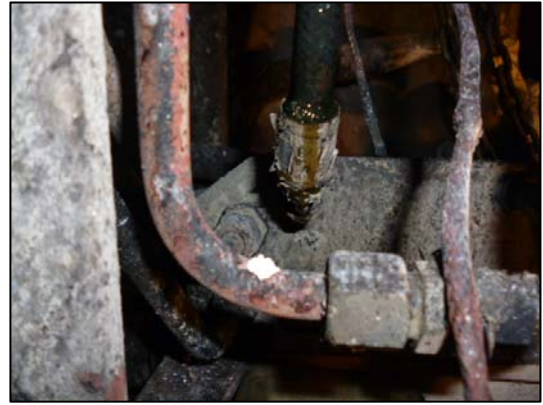
Figure 4: Leaking armoured flexible rubber hose fitted to the fuel gauge of no. 3 generator

No. 3 generator, which was the only generator working at the time of the fire, operated at a fuel oil pressure of between 4 and 5 bar. The flexible hose was directly connected from the main fuel supply line to the fuel gauge, although there was an isolation shut-off cock in between. The arrangement was also the same for nos. 1 and 2 generators.

The failure of the armoured flexible hose caused a continuous fuel spray to be pumped onto the hot surfaces of the turbo charger casing support brackets, which eventually gave rise to the fire. The fire, which spread to the immediate surrounding area, was assisted by the forced air from the ventilation fan situated aft and above no. 3 generator.

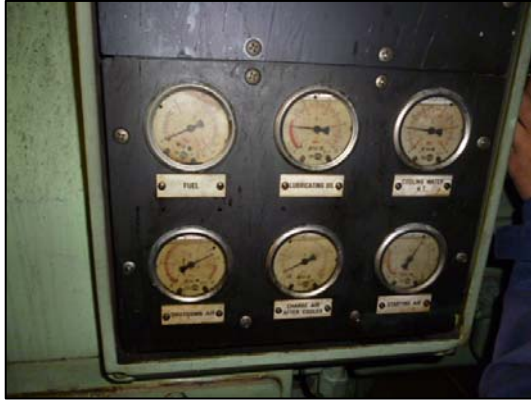
The flexible hose fitted to the gauge was not physically visible (Figure 5). It was enclosed inside the instrumentation panel and only accessible if the panel front face is unscrewed and removed. Frequent visual inspections of the flexible hoses' condition were not possible². The instrumentation panel was adjacent to the turbocharger air filter (Figure 6).

Figure 5: Instrumentation panel on one of the other intact generators

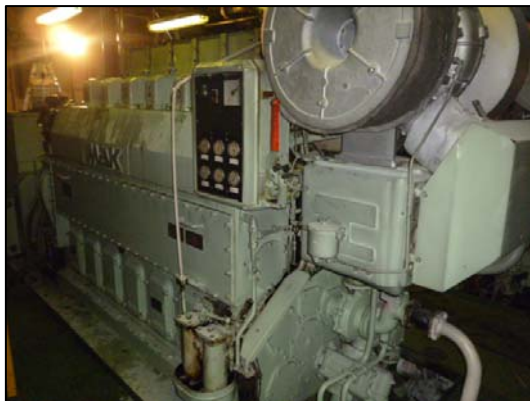
The support brackets of the turbocharger turbine side were not insulated and the temperature of the brackets exceeded 220°C when the generator was in operation. This was identified during the safety investigation, when the temperature readings of nos. 1 and 2 turbochargers' support brackets were taken³.

Moreover, whilst the brackets were not insulated as prescribed in SOLAS regulation II-2/4.2.2.6.1, the unshielded brackets temperature readings were in excess of 220°C, bordering on the auto-ignition temperature of the gas oil.

Figure 6: Location of generator instrumentation panel

15/2012_03 ensure that thermal surfaces exceeding 220°C and which may be impinged as a result of a fuel system failure are properly insulated.
