SAFETY INVESTIGATION REPORT

REPORT NO.: 05/2012

MV BALTIA
Lifeboat accident
In position 46° 12.2'N 123° 48.86'W
01 August 2011

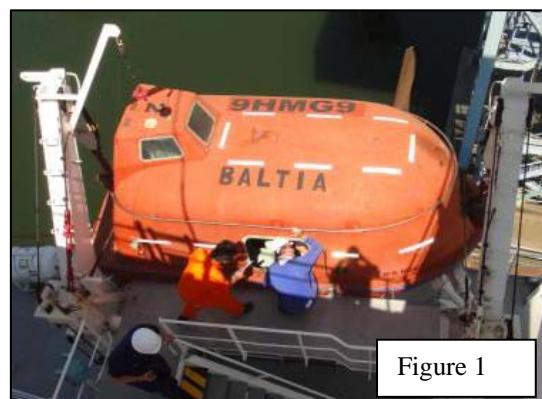
Baltia was fitted with two totally enclosed lifeboats each with a capacity of 25 persons (figure 1). They were built by Shigi Shipbuilding Co. Ltd., in 2004.

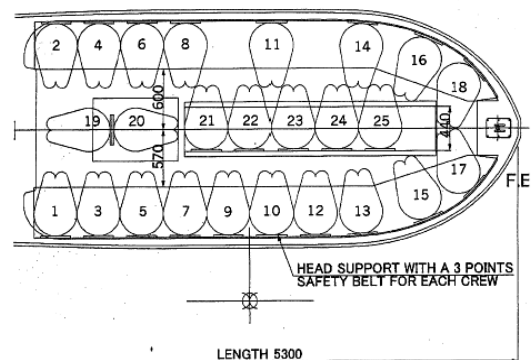
Figure 2

Both hooks were designed to open simultaneously and the lifeboat is released from its falls. If the lifeboat was not waterborne, the crew member had to pull the safety pin and lift the safety interlock. The interlock had to be kept in the upward position whilst the release handle is pulled to release the boat. Being enclosed, the lifeboats were also fitted with a remote control wire operation. The seating arrangement is shown in figure 2.

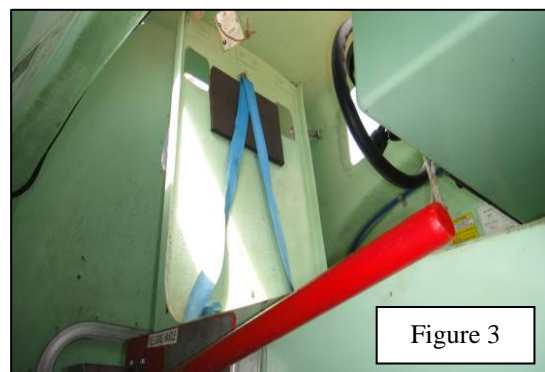
The seats in both lifeboats (figure 3) were fitted with rubber pads (10 cm by 110 cm) which served as head rests. These seemed to have been part of the original design since the managers had no documents which indicated that these were fitted or replaced at some later stage.

It is not excluded that in view of the restricted leg and head spaces available in the lifeboat's wheelhouse, the master had to sit in such a position that the fall contributed to a longitudinal compression, which severely damaged a section of his thoracic vertebrae with subsequent paralysis of his lower extremities.

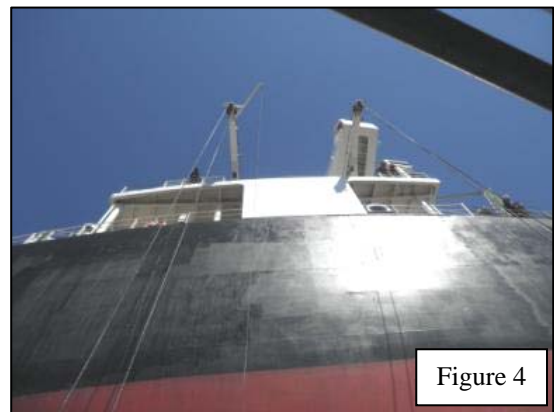
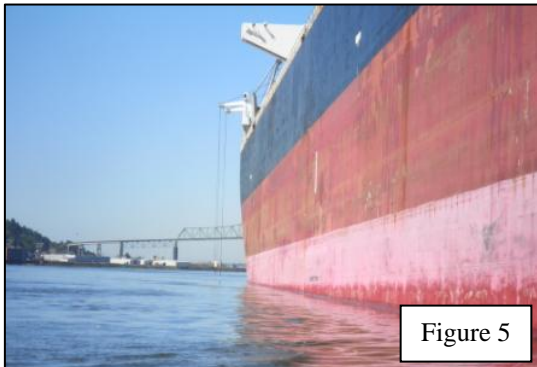
The height of the boat deck from the keel was 23.00 m. Taking into consideration the height

of the chief mate (1.75 m) and the aft draft (7.35 m), the chief mate was about 17.40 m above sea level.

Considering this height (figures 4 and 5), it would have been very difficult for the chief mate standing on the boat deck, to determine with a significant degree of accuracy that the lifeboat was actually only one metre above the sea level⁴.

⁴ Figures 4 and 5 are pictures of the starboard side but the height on the port side is exactly the same. The pictures were taken by the crew members inside the starboard lifeboat.
