SAFETY INVESTIGATION REPORT

REPORT NO.: 02/2012

MV CSL TRIMNES

Grounding

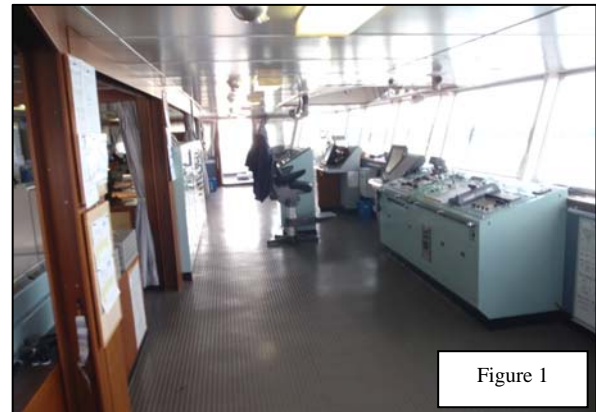
Figure 1

CSL Trimnes was equipped with the necessary navigation system and equipment as listed in the vessel's Record of Equipment for the Cargo Ship Safety Equipment Certificate (Form E). The navigation bridge was spacious, fitted with a central chair next to the vessel's helm (Figures 1 and 2).

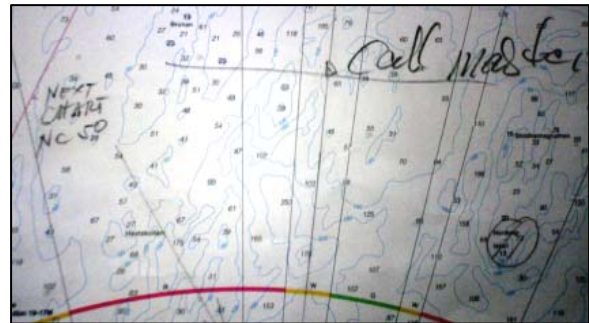
Figure 4

The navigational officer took over the watch on 17 July 2011 at midnight. The watch was handed over without any particular remarks and both officers signed the deck logbook. In addition to the usual instructions to the bridge, the master had inserted a remark in the night order book that the navigational officer had to call/wake him up when the vessel reached position 65° 18.9'N 011° 01.70'E. A note and a line were also made on the chart, to indicate clearly this position (figure 4).

The master was not called when the vessel reached the indicated position (see also navigational sectors in figure 4) and the

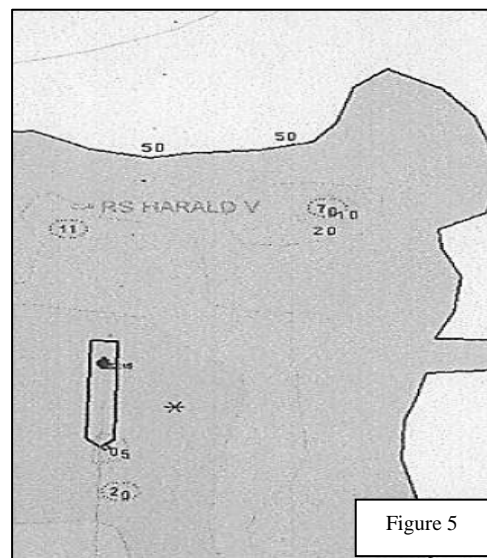
navigational officer only woke up when the ship ran aground at about 0215 (figure 5).

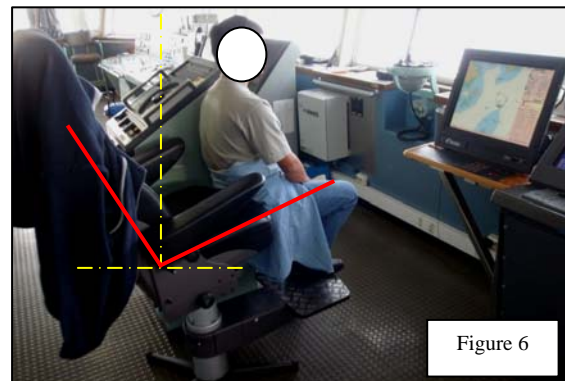
Figure 6

Combined with this matter is the reclined chair in the bridge (figure 6). It is understood that the seating position is adjusted by each and every officer according to his own personal preferences. It was not established whether the chair was reclined (as shown in Figure 6) just before the grounding.

If the chair was reclined before the grounding, it would have affected the officer’s view of the sea surface forward of the ship’s bow (as seen from the reclined chair). Moreover, it would have also helped create a comfortable

sitting position, making it easier for the officer of the watch to fall asleep⁷.
