## SAFETY INVESTIGATION REPORT

REPORT NO.: 07/2012

### *MV KADMOS* Contact with submerged wreck In the Malacca Strait 05 August 2011

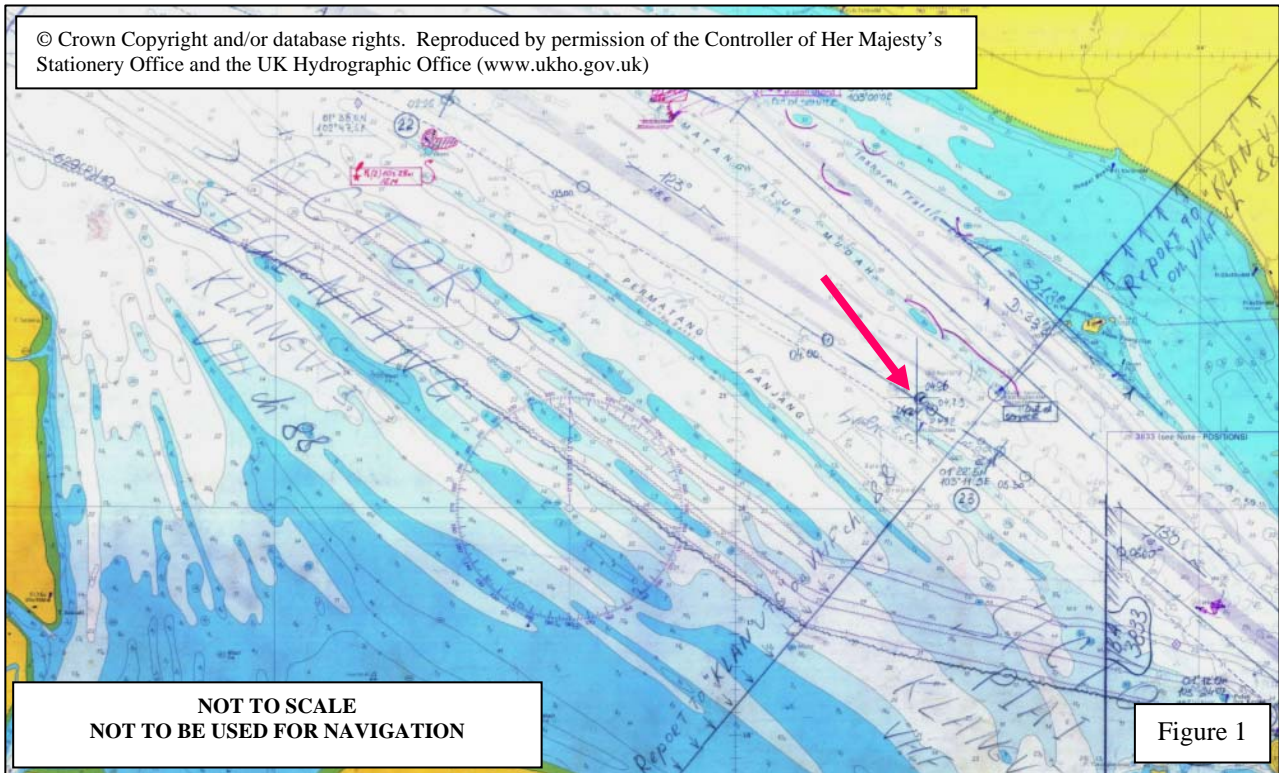
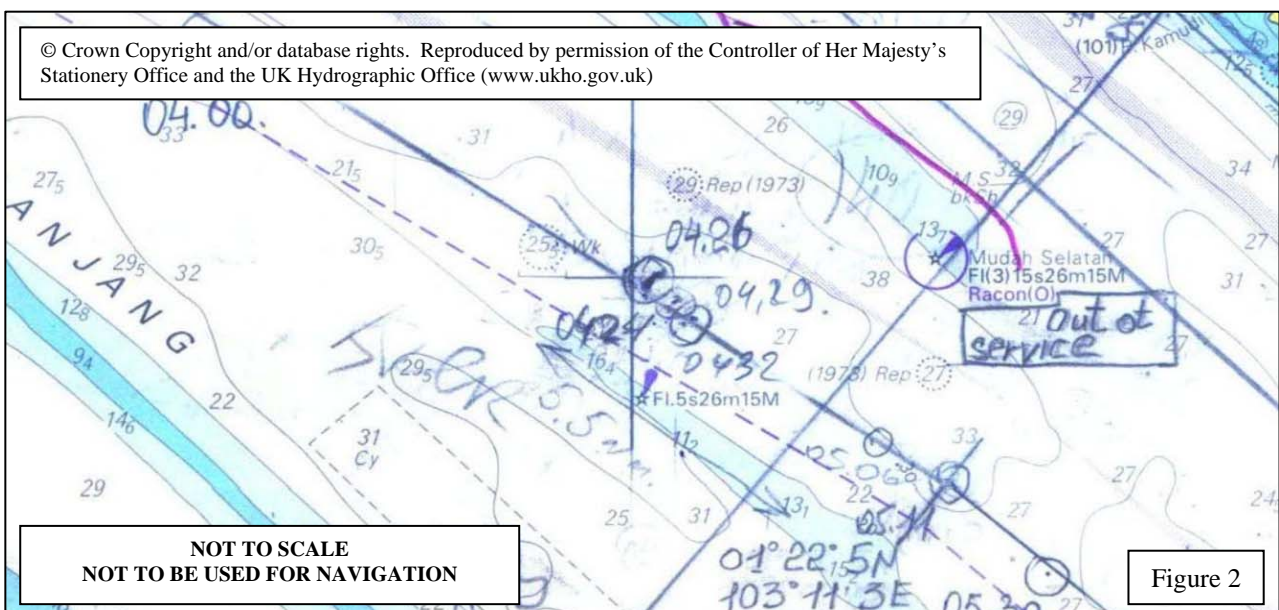
At about 0426, whilst the OOW was looking out of the front window, a sudden impact was felt throughout the vessel. It seemed that *Kadmos* had almost stopped. The vessel's position was 01° 24.8'N 103° 8.1'E (Figures 1 and 2).

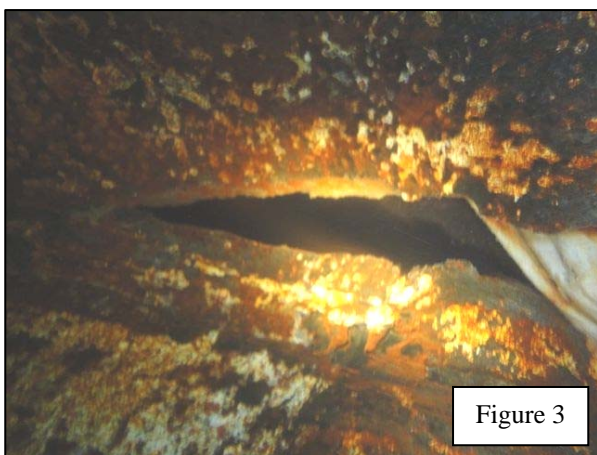
Although the flooding in the double bottoms was an immediate indication that the tanks were open to sea, the underwater survey carried out whilst the ship was on anchor, later revealed the actual extent of the damage. Two holes were found on starboard side measuring about 2.4 m in length by 0.8 m in height and 0.4 m in length by 0.3 m in height.

Three other holes were found on port side measuring approximately 2.5 m by 0.6 m, 3.2 m by 1.2 m, and 0.2 m by 0.2 m. Moreover, both port and starboard bilge keels were damaged. Figure 3 shows some of the sustained damages to one of the double bottom tanks.

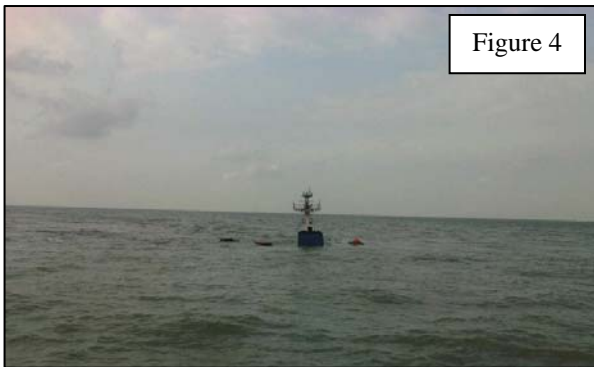
warning ships passing Malacca Strait to keep a short look-out due to a sinking ship<sup>4</sup>. On 01 August 2011 at 0150LT, NAVTEX message UA 61 was promulgated. It advised mariners that the wreck of MV *B Oceania* (least depth unknown) was reported within one nautical mile radius of isolated danger buoy (FL(2) W 10s) in position latitude 01° 24' 895" N, longitude 103° 07' 736" E. Mariners were also advised to navigate with caution in the area<sup>5</sup> (figure 4).
