SAFETY INVESTIGATION REPORT

REPORT NO.: 08/2012

MV KAIE
Fatality of crew member
In position 57° 48' 40"N 009° 50' 40"E
05 August 2011

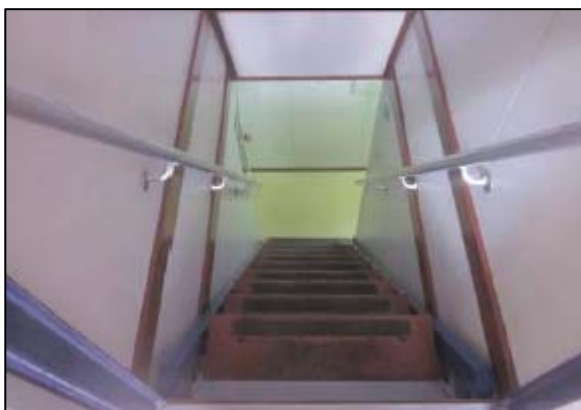
Seeing this, the engineer walked the length of the alleyway and approached the bosun and one other crew member and requested the bosun to follow him. The engineer led the way through the alleyway to where the AB was lying on the deck on his right side (figure 1). It was evident that the crew member was seriously injured. He was immediately assisted by two of the crew members while the other called the chief officer. They were later joined by the master who left the bridge after he was relieved by the chief officer.

Figure 1: The AB was found lying down at the bottom of this staircase

The fall of the crew member was not witnessed by any of the crew members. However, the way he was found at the bottom of the staircase and the noise which

was heard by one of the crew members just outside his cabin, left no doubt that the crew member had fallen down the staircase. It is probable that the crew member had just returned from the open deck where he had been smoking.

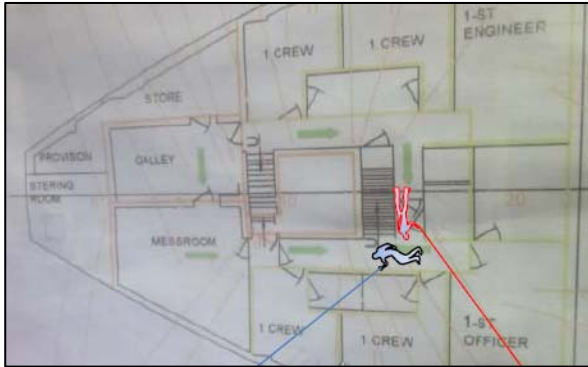
The injured crew member was carefully transferred to another part of the alleyway (figure 2).

Figure 2: The blue figure indicates the position in which the AB was found lying down at the bottom of this staircase. The red figure shows the area where he was initially transferred

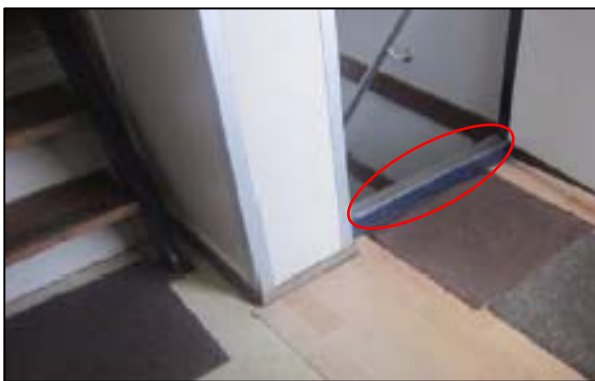
An inspection of the staircase where the accident happened did not reveal any structural defects that could have contributed to the fall in a direct or indirect way.

Figure 3: The lower horizontal part of the door frame

It was not excluded, however, that the crew member could have tripped in the lower horizontal part of the door frame (figure 3). It was also considered possible that the rolling of the ship in the swell may have also contributed to the fall.

1. The crew member may have tripped in the lower horizontal part of the door frame, falling down the staircase after returning from the open deck where he had been smoking;
2. It is probable that the rolling of the ship in moderate swell could have contributed to the fall of the crew member;
3. The master did not effectively enforce the company's 'no alcohol' policy;
