## SIMPLIFIED SAFETY INVESTIGATION REPORT

REPORT NO.: 09/2012

### ***MV OCEAN RANGER*** **Scavenge fire** **In position 15°31.6'S 38°7.1'W** **23 August 2011**

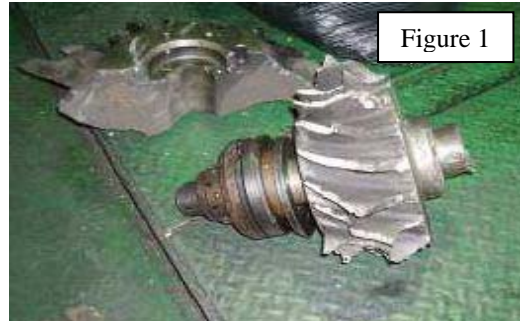
The most severe damage was contained within the main engine and the turbocharger rotor was completely destroyed by the fire (Figure 1) as a result of overspeeding. Minor damages were identified to one of the main generators tachometer and a bilge high level alarm. The magnetrons of both radar sets were damaged as a result of the blackout. No injuries were reported.

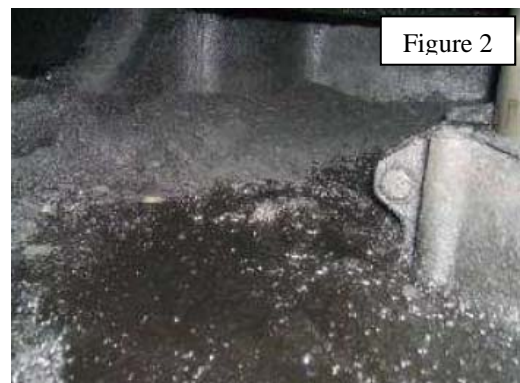
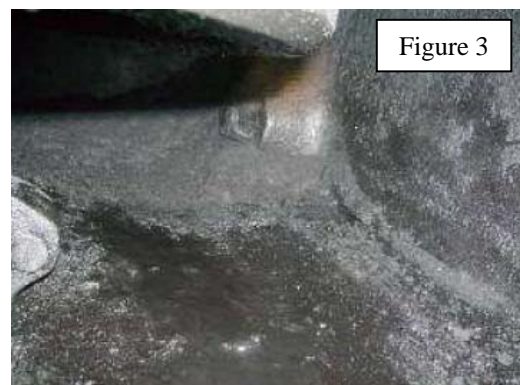
The probable causes of the scavenge fire were fouled scavenge spaces (Figures 2 and 3) and two defective fuel injectors. It was stated that the last scavenge space cleaning had been carried out on 08 August 2011, *i.e.* about a fortnight before the fire. However, an inspection of the scavenge space revealed approximately a 10 cm build-up of carbon deposit.

Moreover, the dirty and heavy gummy residues present in the scavenge space seemed to suggest that the 1,000 – 2,000 hour cleaning interval recommended by the engine maker had not been adhered to. The defective fuel injectors had not been detected. Analysis of the main engine cylinder calibration reports did not indicate excessive wear in the main engine cylinder liners and piston rings, except for a piston ring on one of the main engine units.

The ship's managers have taken several actions in order to prevent similar accidents. A message has been sent to all Company's managed vessels highlighting the importance of inspecting and cleaning scavenge spaces, and inspecting pistons, cylinder liners and the fuel injection system. The relevant ISM Form has been transmitted to all the Company's
