SAFETY INVESTIGATION REPORT

REPORT NO.: 01/2012

MY LADY LUCK
Flooding of lazarette
In position Lat. 44° 10.9'N Long. 009° 27'E
17 July 2011

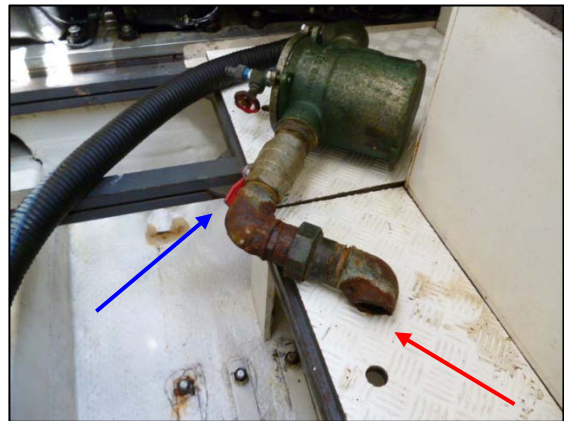
The flooding in the lazarette was the result of a failed elbow fitting, which was part of the cooling water system of the air conditioning unit, as indicated below. The failure was the result of galvanic corrosion, accelerated by the use of dissimilar materials.

In actual fact, the elbow fitting (which is normally made of cast iron with a thin layer of zinc coating) acted as a sacrificial metal. Erosion also played a contributing part as a result of the change in water flow direction.

The failure (red arrow) occurred just after the sea suction valve and before the quarter turn valve (blue arrow) as shown in the picture. Therefore, closing the sea suction valve would have limited the extent of flooding inside the lazarette⁴. Both valves could only be operated manually and locally. An inspection of the two valves *i.e.* the sea suction valve and the quarter turn showed that the crew would have found it extremely difficult to close the valves (if not impossible) as they were seized in the open position.

The extent of corrosion on the elbow fitting and other areas of the pipe was not a short term issue. It indicated that the corrosion problem, whilst expected, was missed over a number of months. So were the two seized valves.

01/2012_R1 Ensure that a maintenance management plan identifies and addresses all the critical components, their condition, and hence the system's function.
