SIMPLIFIED SAFETY INVESTIGATION REPORT

REPORT NO.: 23/2016

MV *Hagland Borg* Serious injury involving a moveable bulkhead At Karlshamn, Sweden 28 December 2015

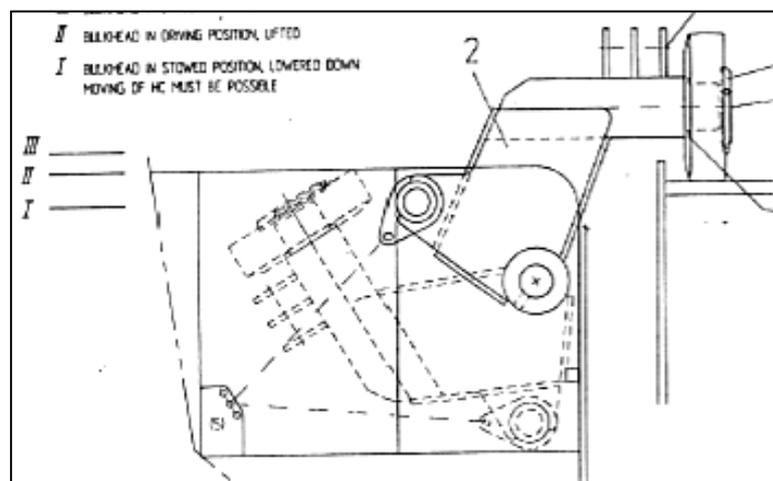
The bulkhead was fitted with a wheel arrangement on port side and another one on starboard side at the top edges (Figure 1). Two recesses were fitted to the portable bulkhead, which provided access to hydraulic jacks to be fitted (Figure 2).

Figure 1: Bulkhead wheel arrangement (in the open position)

A closer inspection of the system revealed that the wheel on the port side of the portable bulkhead had slipped of its shaft. As a result of this, the bulkhead dropped by about 3.5 cm. It was also observed that the bulkhead was not at right angles to the tank top but was slightly tilted towards the direction of movement.

The inspection carried out by the crew members soon after the wheel failed, revealed that the bolt securing the wheel to the shaft had failed. It was also not excluded that the wheel bearing was damaged. The Company confirmed that the maintenance of the wheel arrangement as part of the vessel's planned maintenance schedule was neither detailed nor specific. The failure of the bolt was also not detected during the crew members' routine inspections on board. It may be concluded that the exclusion of the wheel assembly from an effective preventive maintenance regime led to a missing critical process to ensure that reliability was not compromised over a period of time.

- Inspections routines on the portable bulkhead were implemented as part of the Company's electronic maintenance system;
- Prior to rectification of defects which would necessitate shifting the bulkhead, the crew members are being instructed to ensure that it was upright and that there were no external moments acting on it before the shifting operation was commenced;
- Routines for risk assessments on board Company vessels were enhanced;
- A new procedure has been introduced which requires that in cases of similar damages to the wheels and when it is not possible to prevent the bulkhead from moving, a shore crane is hired to lift the moveable bulkhead in a safe manner.

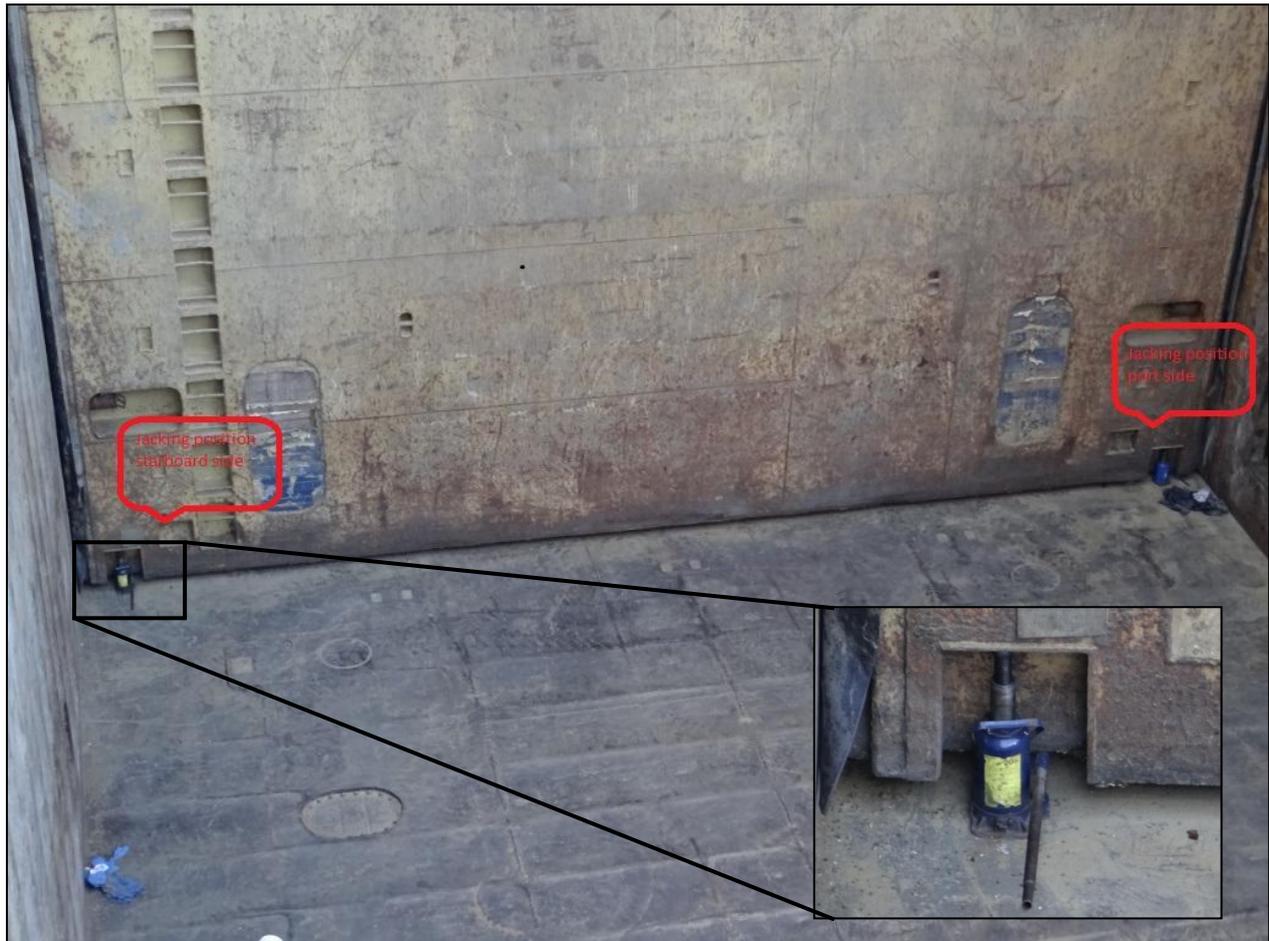
The jacks exerted hydraulic pressure against the bulkhead, creating a resultant upward force which lifted the bulkhead. With the bulkhead clear from the tank top, the wheels could be rotated outwards and locked in position on the hatch coaming (Figures 1 and 3).

Figure 2: Hydraulic jacks in position to lift the bulkhead

The bulkhead was eventually lifted to create enough clearance for the wheel to be reinserted. At this stage, without any warning, the bulkhead tilted backwards and fell from the hydraulic jack. The hydraulic jack was also displaced and the bulkhead landed on it and consequently it toppled on the AB's foot (Figure 5), although bearing partial weight of the bulkhead.

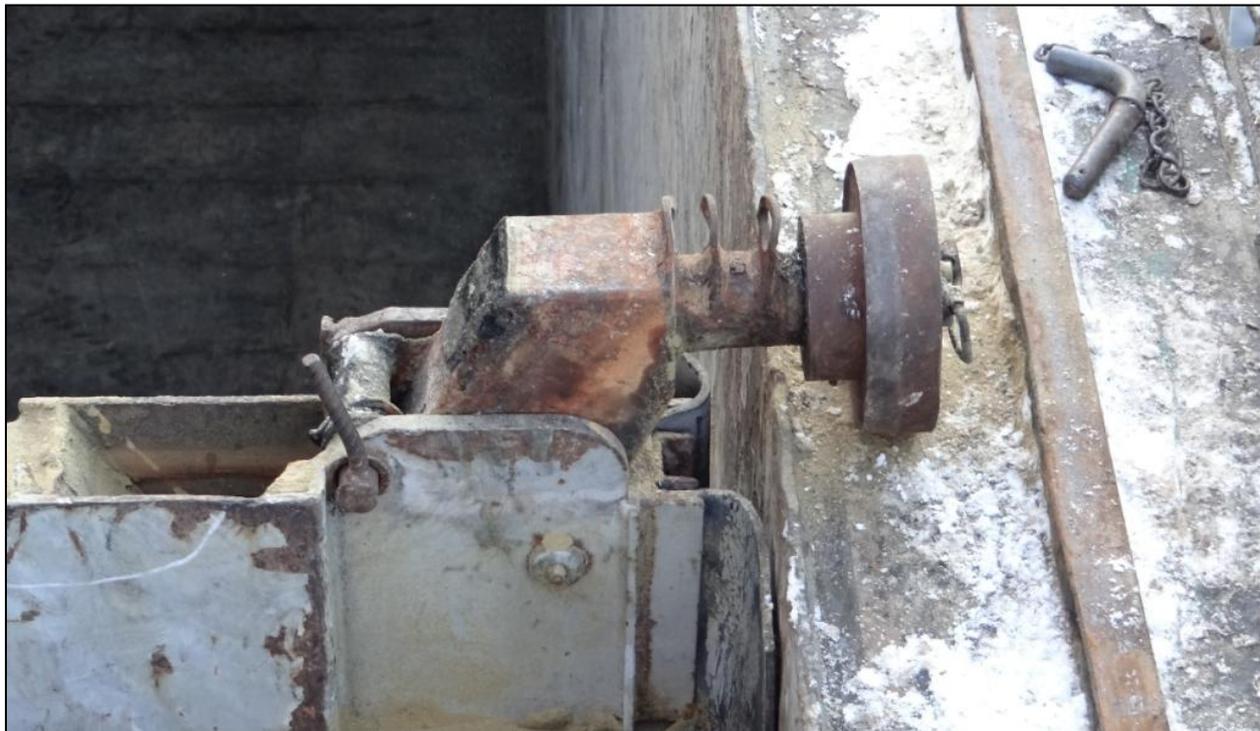
Figure 3: Wheels locked on the cargo hold coaming

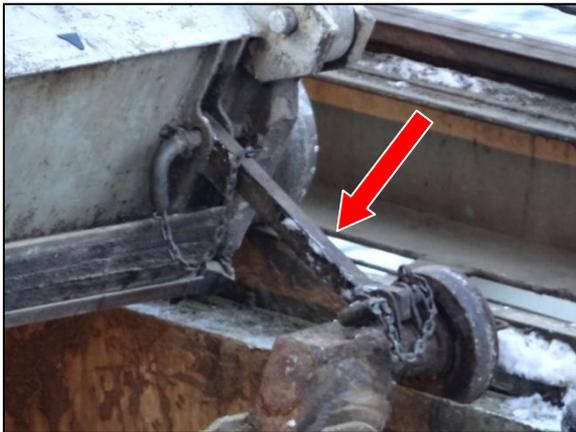
Figure 4: Link between the hatch cover and the portable bulkhead wheel arrangement

On this particular occasion, the bulkhead was raised as per normal procedure and the wheel arrangements extended on both sides. The hydraulic jacks were removed and the shifting operation initiated. Initially, after the wheel arrangements were linked to the cargo hold hatch cover, the system could not move and the crew members decided to use the on board compact loader (Bobcat), to move the hatch covers¹.

The intervention was successful and the cargo hatch covers were moved, hence shifting the portable bulkhead. However, the bulkhead was only shifted by a few metres, when the system came to a halt.

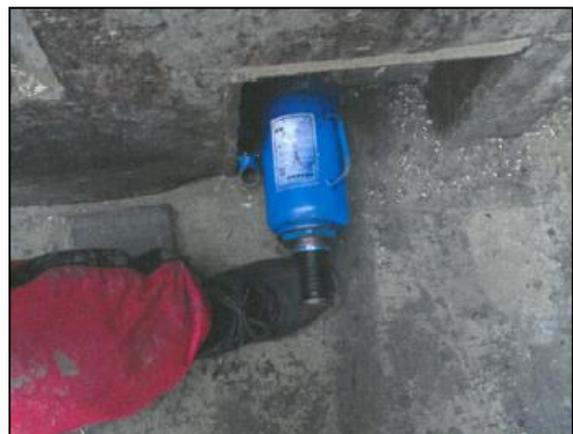
Figure 5: A crew member showing how the injury happened (during the accident, the portable bulkhead fell on the hydraulic jack)

The immediate cause of the accident was the tilting of the bulkhead at a vulnerable time when the structure was being supported by the hydraulic jacks and not secured by its securing bolts. The operation of the hydraulic jacks necessitated at least one crew member to be in close proximity of the hazard.

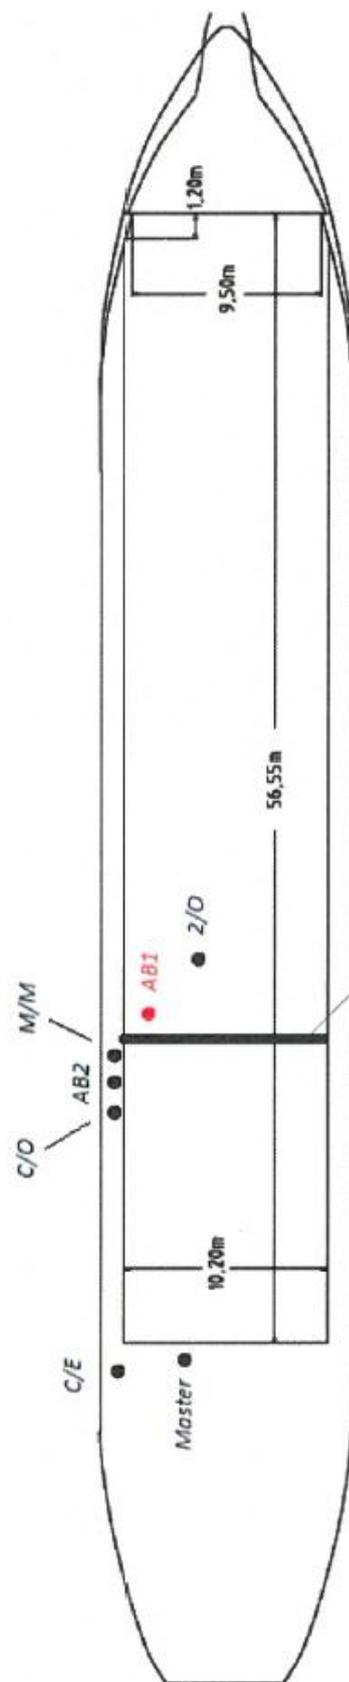
The MSIU did not come across any documents, which stipulated the manning required to shift the bulkhead. It would appear that the manning level was more based on the experience of the crew members. However, as indicated in Figure 6, at the time of the accident, there were seven crew members on the deck and inside the cargo hold².

Figure 6: Position of crew members during at the time of the accident

² The vessel was manned by nine crew members. The injured crew member is identified as 'AB 1' in Figure 6.
