# SIMPLIFIED SAFETY INVESTIGATION REPORT

REPORT NO.: 19/2016

## MV SOVEREIGN Serious injury to crew member during mooring operation 08 October 2015

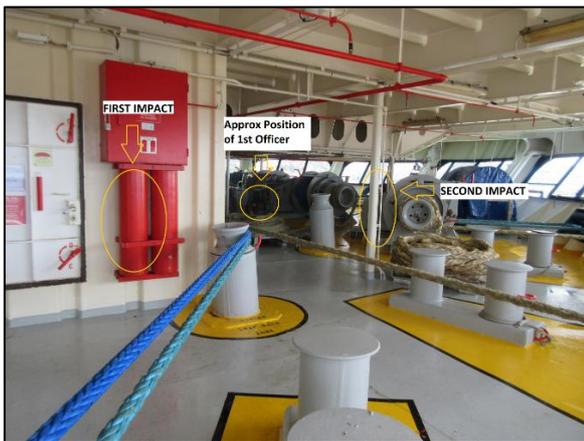
**Figure 3: Approximate position of the chief mate, the CO<sub>2</sub> bottle and steel stanchion**

Moments later, at 0727/51s, the back-spring parted. The whiplash of the broken line hit a CO<sub>2</sub> bottle on the port side bulkhead and a steel stanchion before striking the first mate behind winch WW3. The staff captain, who was on the bridge, observed the vessel moving astern at 0.1 knot. He instructed the forward mooring station to slacken the head ropes, and requested power on the stern thruster. The two gangways set out for passengers and guests were immediately removed.

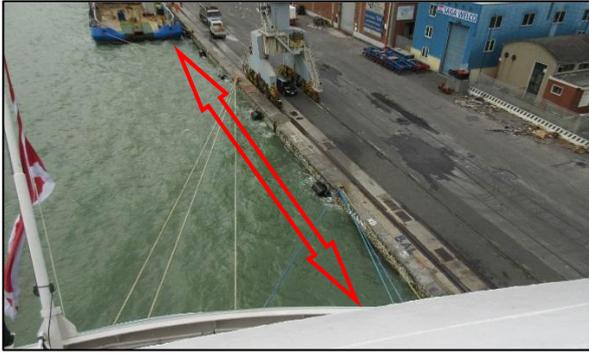
Figure 4: Unoccupied berth space behind *Sovereign*

During the course of the safety investigation, it was noticed that there was ample berthing space behind the vessel (Figure 4), which if used would have significantly improved the direction of the head ropes and probably altered the course of events. However, no explanation was found in the submitted evidence as to why this space was left unoccupied by *Sovereign*.

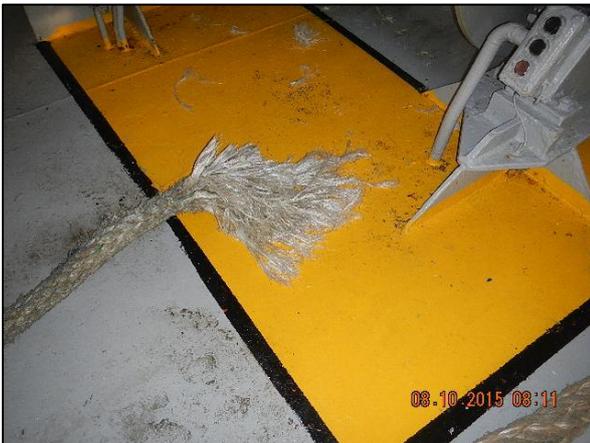
Figure 5: Section of parted mooring rope

The aft backspring had parted in the vicinity of universal roller fairleads in the port bulwark. Its tensile strength (when new) was not known to the MSIU as no documentary records on the type, size, inspections or when it was brought in service were maintained on board. The parted mooring was described as a 12 strand polypropylene rope, 88 mm diameter and appeared slightly worn. This information was based on photographs taken before the rope was removed<sup>3</sup> (Figure 5).

Therefore, the MSIU was unable to conduct destructive (and non-destructive) tests to establish the mooring rope characteristics and its residual breaking strength. It was also reported that the vessel had recently put in

**19/2016\_R1** Ensure regular maintenance of mooring equipment and fittings and keep records of mooring ropes in use and results of periodical inspections;

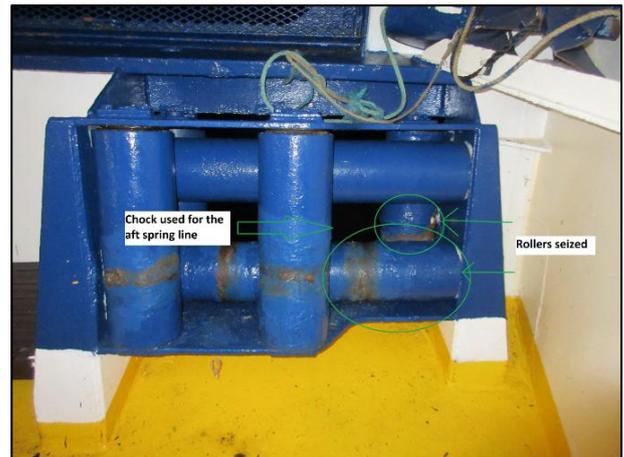
Figure 6: Seized universal roller fairlead

As part of the planned maintenance, mooring winches and fittings are checked and maintained in good working order. Documents submitted to the safety investigation showed that during the inspection in August 2015, six fairleads on the aft mooring deck were found practically seized and not turning freely (Figure 6). Two of the six fairleads mentioned were used with the backspring. It is probable that the seized fairleads may have increased friction and the likelihood of an eventual mooring rope breaking under load.

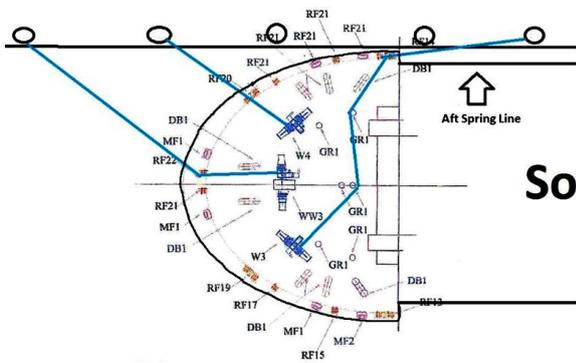
Figure 7: Lead of the aft-back spring

A lead chosen for backspring from the universal roller fairlead on the port side necessitated the passing of the line over two pedestal fairleads. With this layout, the backspring changed direction three times before reaching the winch on the starboard side (Figure 7). Thus, each change of direction increased the number and size of snapback zones.
