## SIMPLIFIED SAFETY INVESTIGATION REPORT

REPORT NO.: 17/2016

### **MY *Namaste 8*** **Serious injury to passenger** **while using a powered surfboard** **03 September 2015**

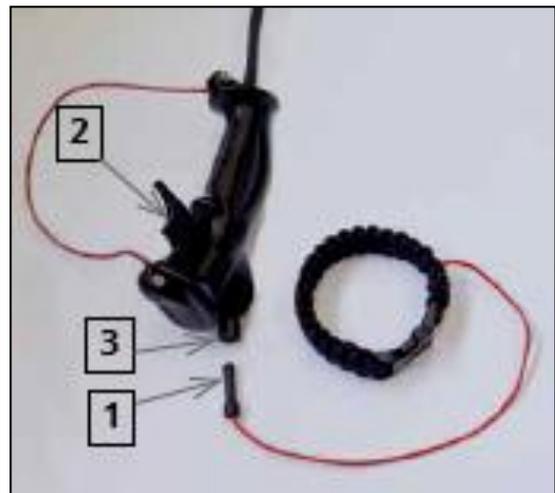
Figure 2: Surfboard's control handle – (1) starter key with kill cord, (2) trigger to control throttle cables, (3) ignition slot

The propulsion and speed of the surfboard is controlled by the rider using the throttle trigger in the control handle. In the event of the rider falling off the board and the control handle dropped, the ignition key is pulled out, quickly disengaging the engine.

The master recalled that when the passenger fell from the surfboard, the latter kept her grip on the control handle. With the trigger

depressed, the surfboard accelerated forward as it reached the end of the throttle cable. Before the control handle was released, the surfboard pivoted on the throttle cable, changed direction and eventually struck her on the head.

As the accident indicated, falling from the surfboard but not releasing the grip on the trigger had actually by-passed a rather effective safety barrier system embedded within the equipment.

**17/2016\_R2** issue a safety alert to highlight the importance of releasing the control handle as soon as the rider falls from the surfboard;

**17/2016\_R3** consider a failsafe design which ensures that the engine is shut down without relying on the operator's release of the control handle;

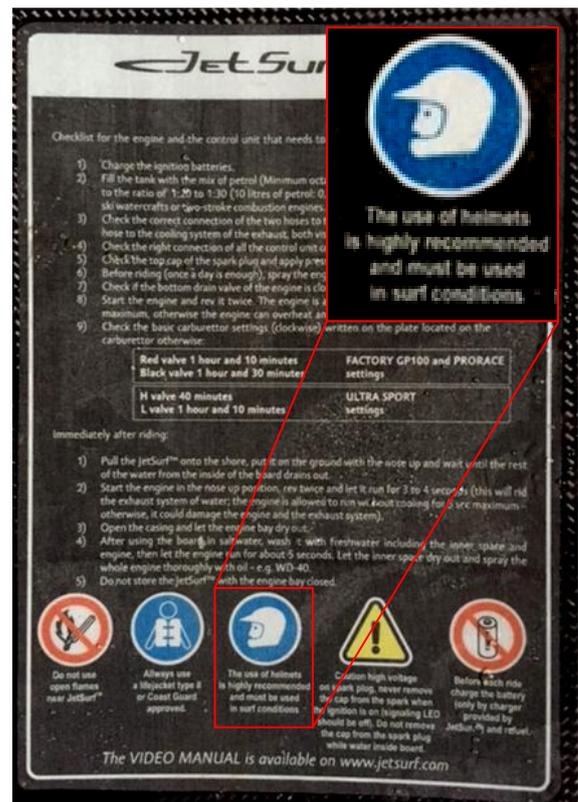
been successful. Nonetheless, the jet surfboards came with an illustration of five key symbols and a checklist for the engine and control unit. One of the symbols displayed a graphic image of a helmet with a caption ‘the use of helmets is highly recommended and must be used in surf conditions’ (Figure 4).

Figure 4: Safety symbols displayed on the surfboard

The same conflicting messages were also observed in the User Manual and the illustration on the surfboard (with respect to the wearing of the safety helmet). Whereas, the User Manual emphasised that it is *mandatory* to wear a safety helmet, the illustration on the surfboard made a *recommendation* to this effect.

**17/2016\_R5** amend all the safety instructions in order to ensure that there are no conflicting messages with respect to wearing of the safety helmets.
