SAFETY INVESTIGATION REPORT

REPORT NO.: 09/2021

MT FT STURLA **Serious injury to a crew member,** **during mooring operations** **in Westlius Lock, Terneuzen** **The Netherlands** **01 May 2020**

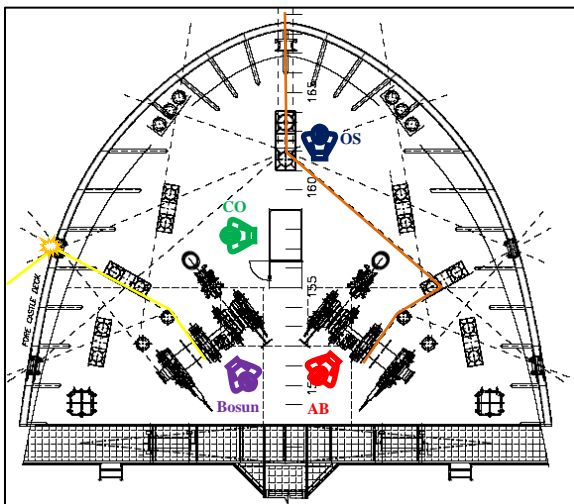
Figure 2: Mooring arrangement, spring line failure point and position of crew members

The chief mate hand-signalled the bosun to hold the spring and walked towards the starboard mooring drum. The engine was stopped, and the vessel was gradually slowing down. During the process, the back spring came under tension and a few seconds later, at 1621, it parted in the vicinity of the bulwark fairlead (Figure 2).

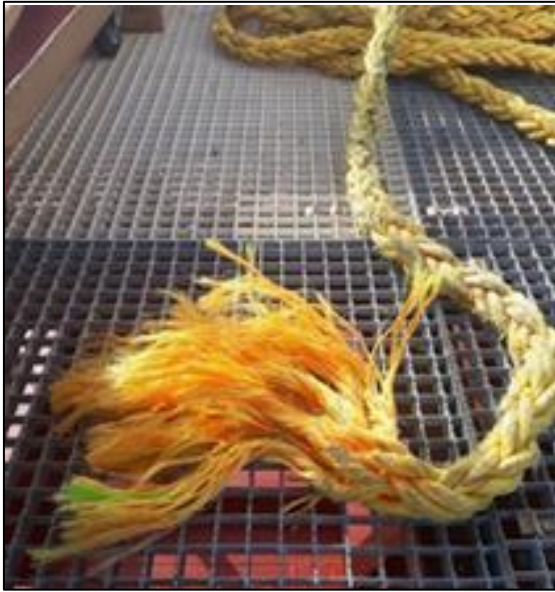
Figure 3: Parted spring line

The spring line that parted (Figure 3) was an eight-stranded orange colour mooring rope, 44 mm in diameter and made of polypropylene fibres. The rope was supplied with protective canvas sleeve covering the spliced eyes at both ends. The Inspection Certificate supplied with the rope certified a breaking strength of 38,492 Kgf². This test, attended by a DNV-GL surveyor, was performed on 24 December 2018 as per BS EN ISO 2307:2010³. The mooring rope was delivered to the vessel on 13 December 2019, and it was put into use on the same date as a forward back spring.

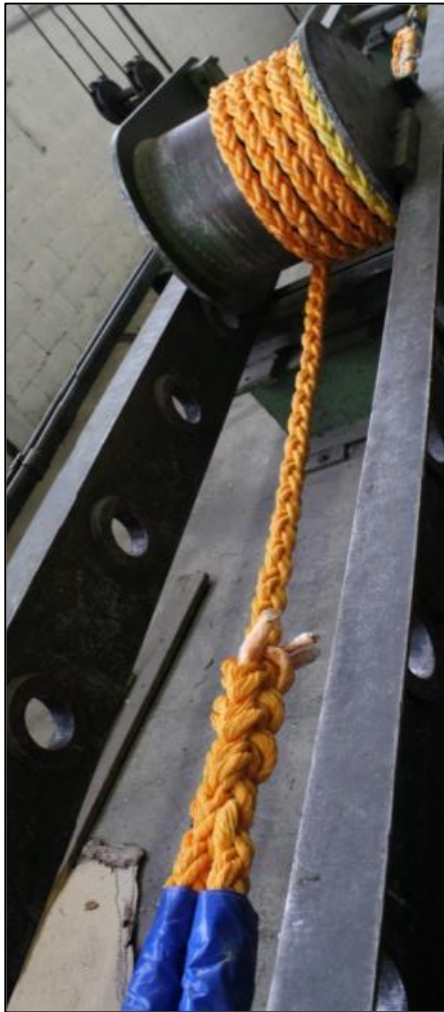
Figure 4: Outboard section of the mooring rope undergoing breaking load test

Subjected to a breaking load test, the rope parted two metres from the splice-end at 16,420 kgf. The results indicated that the percentage breaking strength of the mooring rope was about 42% of the certified breaking strength (38,492 kgf).

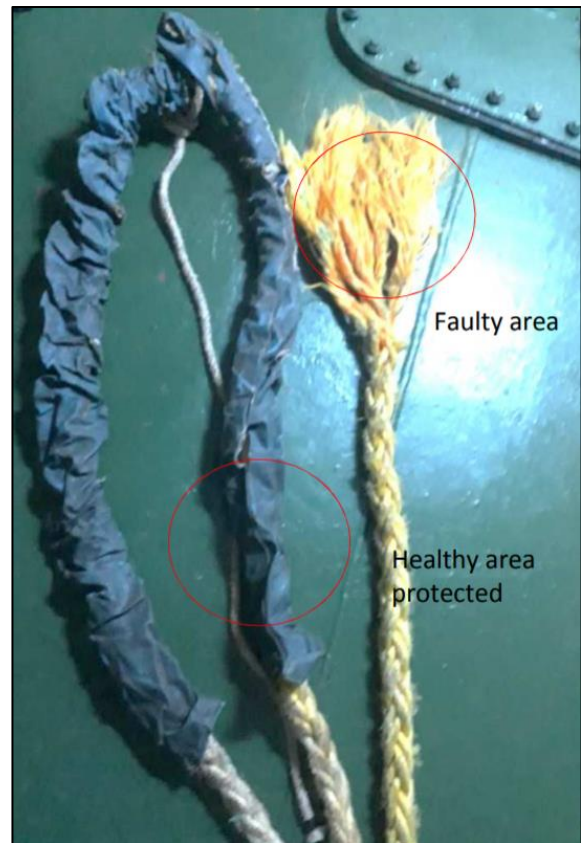
Figure 4: Area of the mooring rope under optical and SEM/EDX analysis

The optical microscopy examination of the protected healthy section highlighted an area where the strands and the braid were complete, and an area where the strands have been frayed by the operator. The strands and braid in the faulty area were similar to the healthy area but included a section where faces of rupture were identified. Under the SEM/EDX microscopic examination, the polymeric fibres of strands of healthy protected area had a variable diameter (350 μm and 550 μm).

The polymeric fibres of strands in the faulty area also had a variable diameter of between 170 μm and 450 μm . In both cases, however, the surface of the fibres appeared smooth, non-porous and identified no fracture or crack apart from some grooves

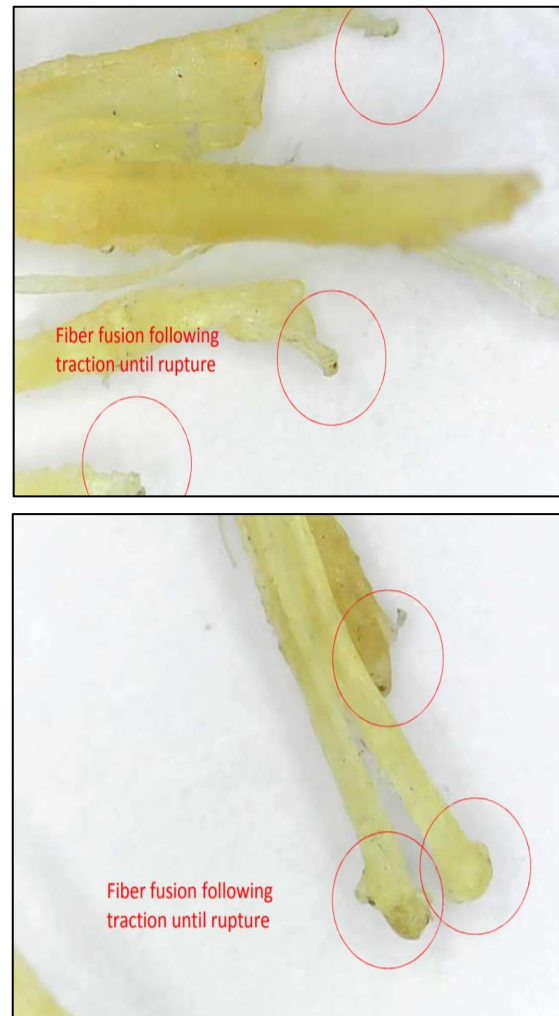
Figure 5a and 5b: Microscopic image showing rupture from fusion due to exothermic enthalpy

The optical and SEM/EDX microscopic examination concluded that the faces of rupture of the mooring rope (fault area) highlighted a phenomenon of fusion possibly due to the exothermic enthalpy (Figures 5a and 5b) resulting from excessive traction.

The safety investigation found it very unlikely that the mooring rope could have degraded to such an extent and in such a short period of time. Taking into consideration the above and the available information, including post-accident laboratory tests and microscopic analysis, the MSIU did not exclude the possibility of material defect in the mooring rope fibres, although this could not be confirmed.

mooring ropes deemed 'defective' have been replaced on all the fleet vessels.

The Company has also developed specific mooring procedures for lock operations and issued instructions to vessels on the saving and retrieving of VDR data in the event of an accident.
