## SAFETY INVESTIGATION REPORT

REPORT NO.: 03/2020

### **MT GIOVANNI DP** **Inadvertent release of the FFLB** **and subsequent injuries to a crew member** **in position 30° 27.7' N 040° 53.6' W** **09 March 2019**

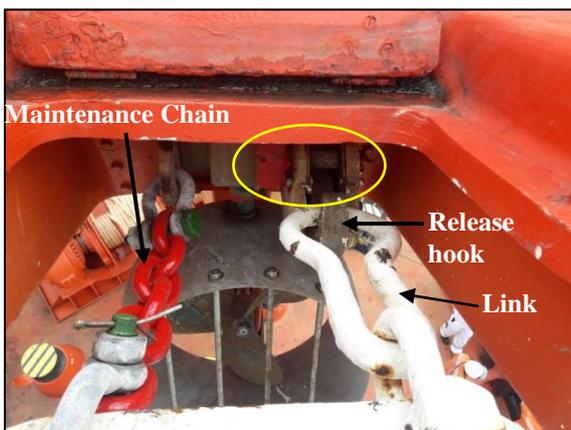
The FFLB's maintenance chain was installed and the hook's safety bolt was checked to be in place (Figure 1). All crew members entered inside the lifeboat, confirmed their seating positions, and instructions on the different methods of launching the FFLB were given by the chief officer. Thereafter, all persons left the FFLB except for the chief officer.

**Figure 1: Maintenance chain and Free-fall release hook (safety bolt circled in yellow)**

The immediate cause of the lifeboat's release into the water was the failure of the maintenance chain. A contributory cause to its release was the removal of the safety bolt from the maintenance position.

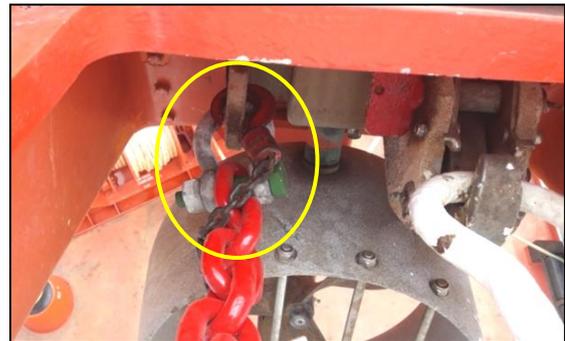
**Figure 2: Chain block assembly at the lifeboat's side. The other end of the chain block was attached to the stairs leading to the lifeboat's embarkation platform**

The installation of the chain block with a safe working load of two tons did not hold the lifeboat in position. The lifeboat weighed twice as much as the SWL of the chain block and the weight of the FFLB alone would have caused the chain block to exceed its tensile breaking strength.

Moreover, the chain block did not absorb the shock load applied, once the maintenance chain had failed. Chains do not absorb such loads and are not suitable to be used as fall preventer devices.<sup>6</sup>

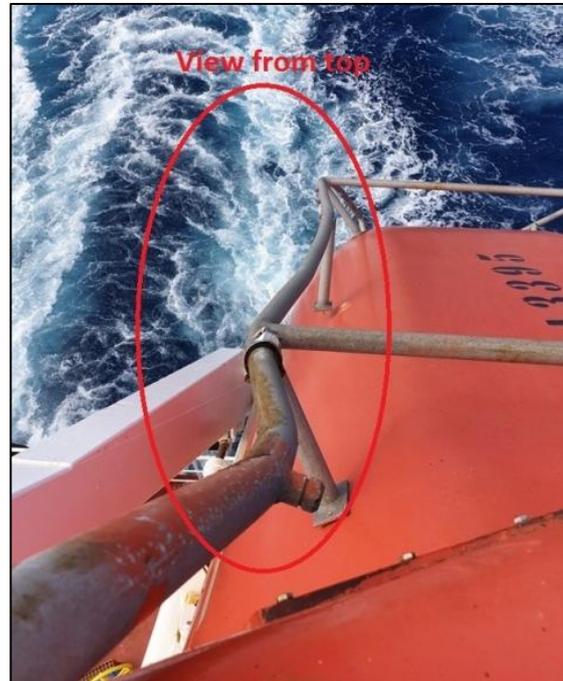
- bottom slider flat-bars;
- guard rails and;
- aluminium sprinkler pipes and supports (Figure 3).

Figure 3: Damage to lifeboat's sprinkler system

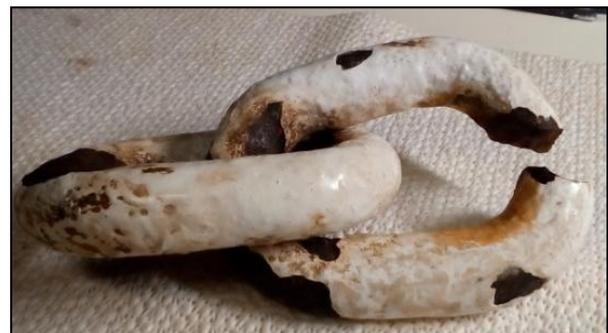
The immediate cause of the accident was the failure of the lifeboat maintenance chain.

Moreover, it was later confirmed that the maintenance chain, which was in position prior to the accident, had failed from the second link closest to the FFLB's stern (Figure 4).

Figure 4: Broken maintenance chain

During the course of the safety investigation, the Company identified several shortcomings, which had contributed to the accident. To prevent recurrence of this event, the Company updated its planned maintenance system, now requiring the maintenance chain to be replaced at five yearly intervals.

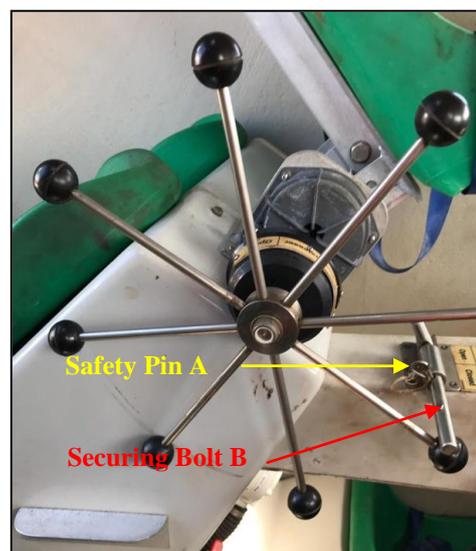
Figure 5: Hook release wheel with its securing in place

position during a ‘mock-training free-fall’. This would have prevented the free-fall release hook from releasing when operating the hook release wheel (Figure 5) from inside the boat.

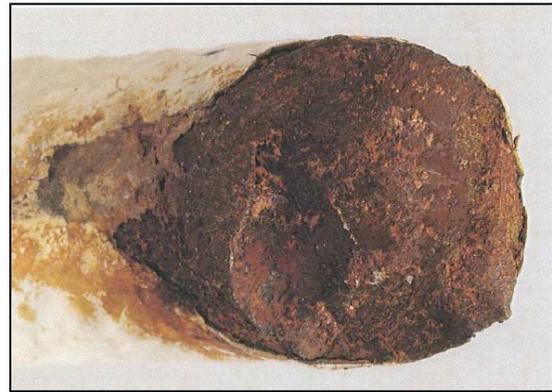
A portion of the maintenance chain (one broken link and one intact) was sent to a laboratory for metallurgical tests and to determine the possible cause of the fracture (Figures 8 and 9). As a basis, the test used a standard specification for grade 80 alloys; ASTM A391:2007.

The minimum tensile strength required from a grade 80 chain is  $800 \text{ Nmm}^{-2}$ . The tensile strength of a machined test piece taken from the broken chain link was measured to be  $1345 \text{ Nmm}^{-2}$ . The lab analysis showed that the tensile strength and hardness were very high for the grade of chain; which was probably the result of insufficient tempering after quenching<sup>8</sup>.

On a macroscopic scale, two cracks were found to have a brittle appearance, most probably originating from the inner radius of the chain. The causes of these cracks, although not completely confirmed, were deemed to be either from stress corrosion or a hydrogen assisted crack<sup>9</sup>.

Figure 8: Macrophoto of fracture side A, magnification approximately 3.3X

The metallurgical test therefore concluded that the high hardness of the chain was most probably the main cause of the fracture.

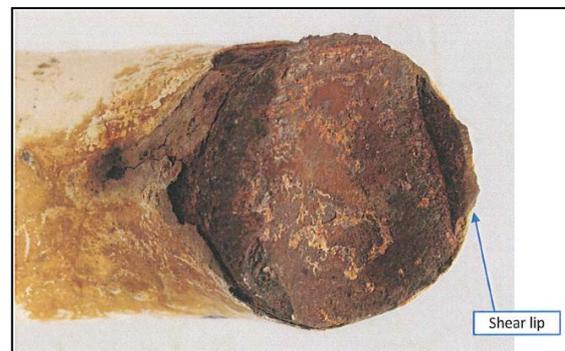
The corrosion on the chain was deemed to be a partial cause of the failure as poor coating was noticed to have been applied on top of corroded steel. However, it was also acknowledged that the complete prevention of corrosion on such chains in a maritime environment is difficult to achieve.

Figure 9: Macrophoto of fracture side B, magnification approximately 3.3X
