MARINE SAFETY INVESTIGATION REPORT

Safety investigation into the collision involving the
Maltese registered oil tanker

KANALA

LIAODANYU 23626

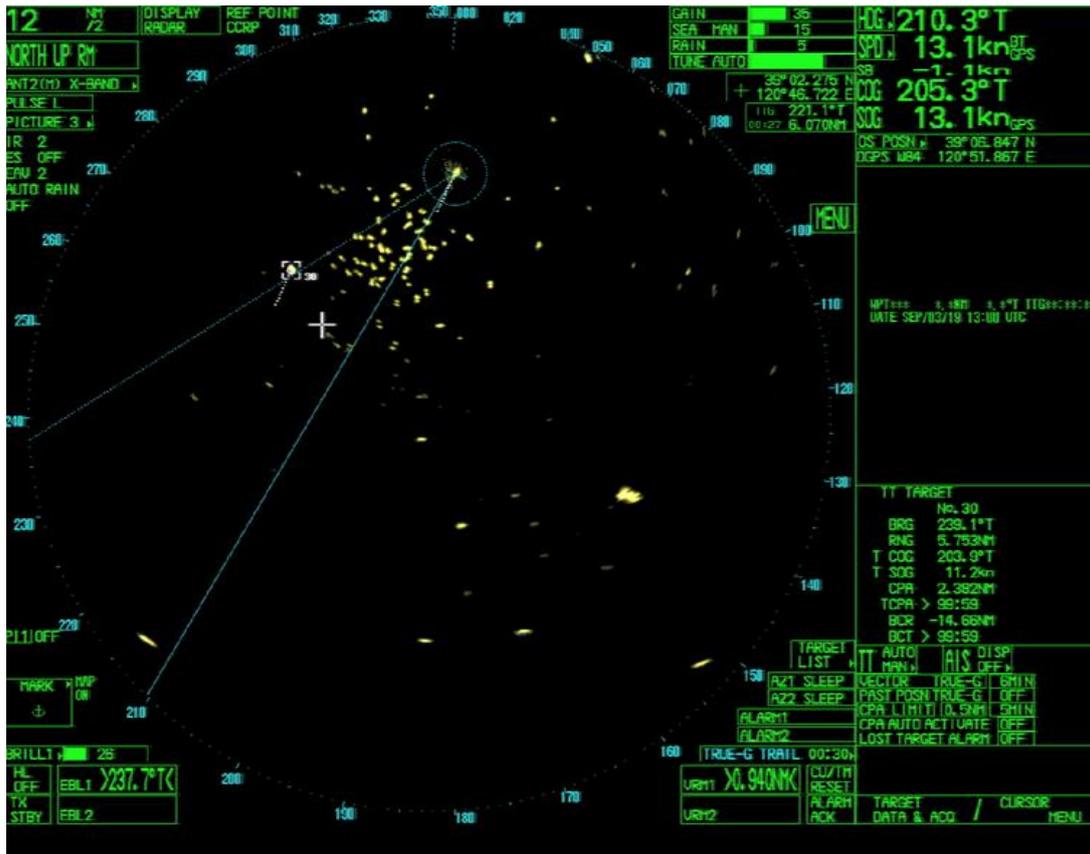
Figure 3: Radar image at 2100 showing concentration of fishing vessels ahead

At 2000, *Kanala*'s OOW and look-out observed a cluster of vessels, far off ahead on the port and starboard sides. It was also noticed that by 2030, the fishing vessels were increasingly getting closer to *Kanala*. 10 minutes later, the OOW started adjusting the autopilot heading gradually to starboard. By 2100 (**Figure 3**), *Kanala* passed the gyro heading of 210°. At the time, her speed was 13.10 knots.

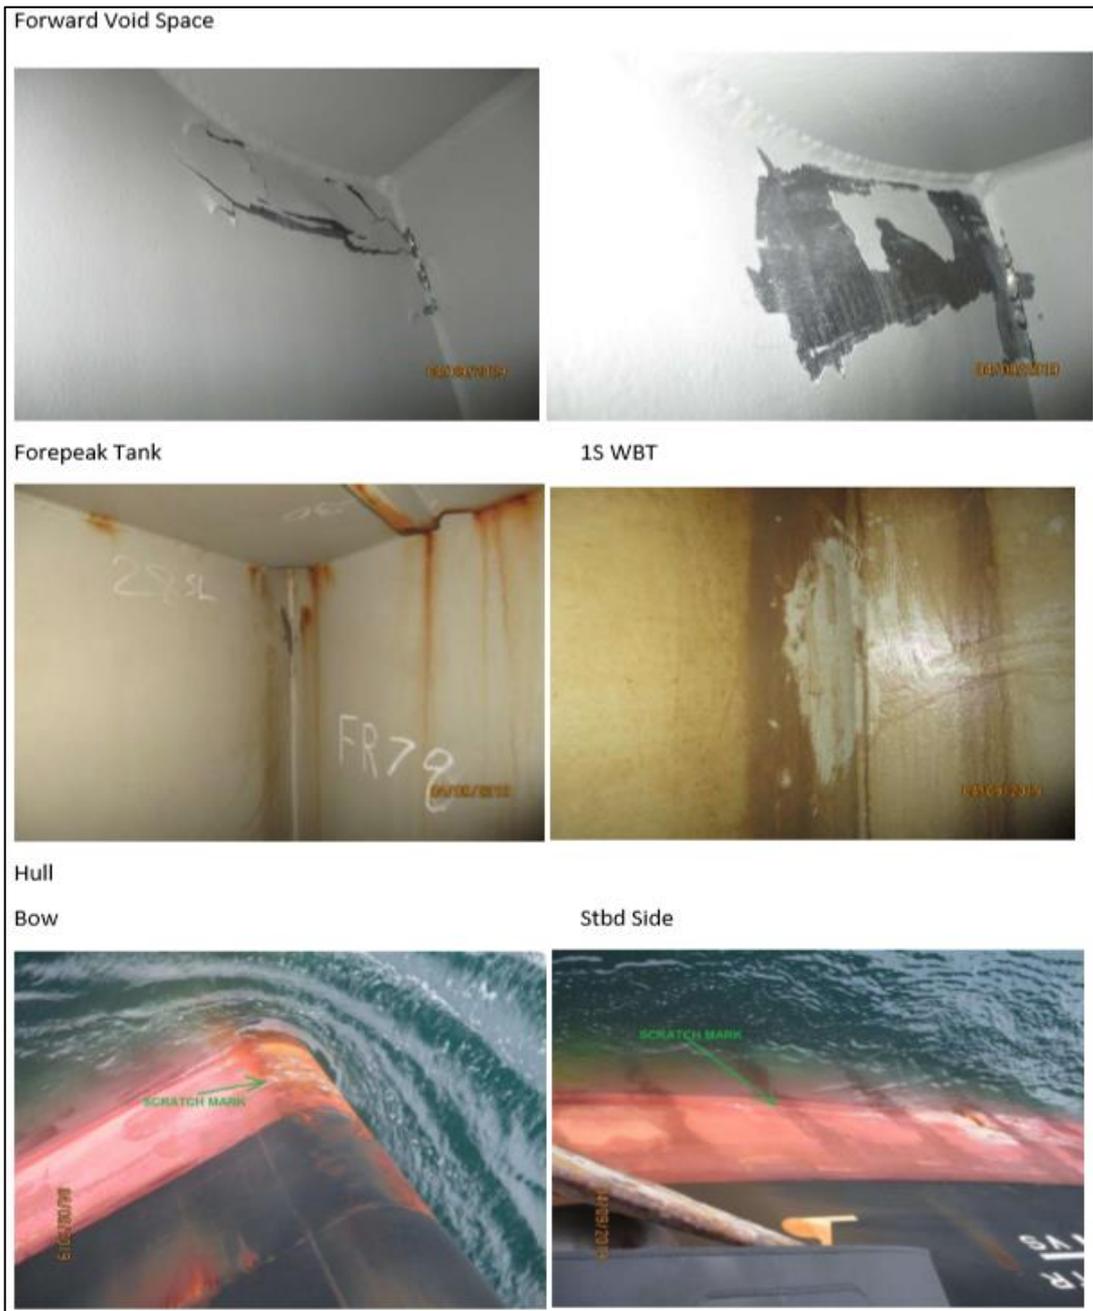
Figure 4: Structural damage sustained by Kanala
 Source: Executive Shipmanagement Pte Ltd.

- indentation on the stem below side stringer no. 32, measuring about 270 mm by 160 mm and approximately 15 mm deep;
- indentation on shell plating in way of frame 78 (collision bulkhead) and below side shell longitudinal no. 28 on starboard side. The indent forward of frame no. 78 was about 450 mm by 200 mm and about 15 mm in depth. The indent, aft of frame no. 78 was about 240 mm by 100 mm and about 5 mm deep; and
- indentation on the side shell plating, forward and aft of frame no. 79 below side shell longitudinal no. 28, measuring about 450 mm by 200 mm in size and about 10 mm in depth.

No cracks, leakage, indentation or damages were found on the internal structures of the void space, forepeak tank and water ballast tank no. 1 starboard. The structural damage identified by Classification Society surveyor was within the tolerance of the Class rules' requirements and no repairs were recommended to the vessel hull (**Figure 4**).

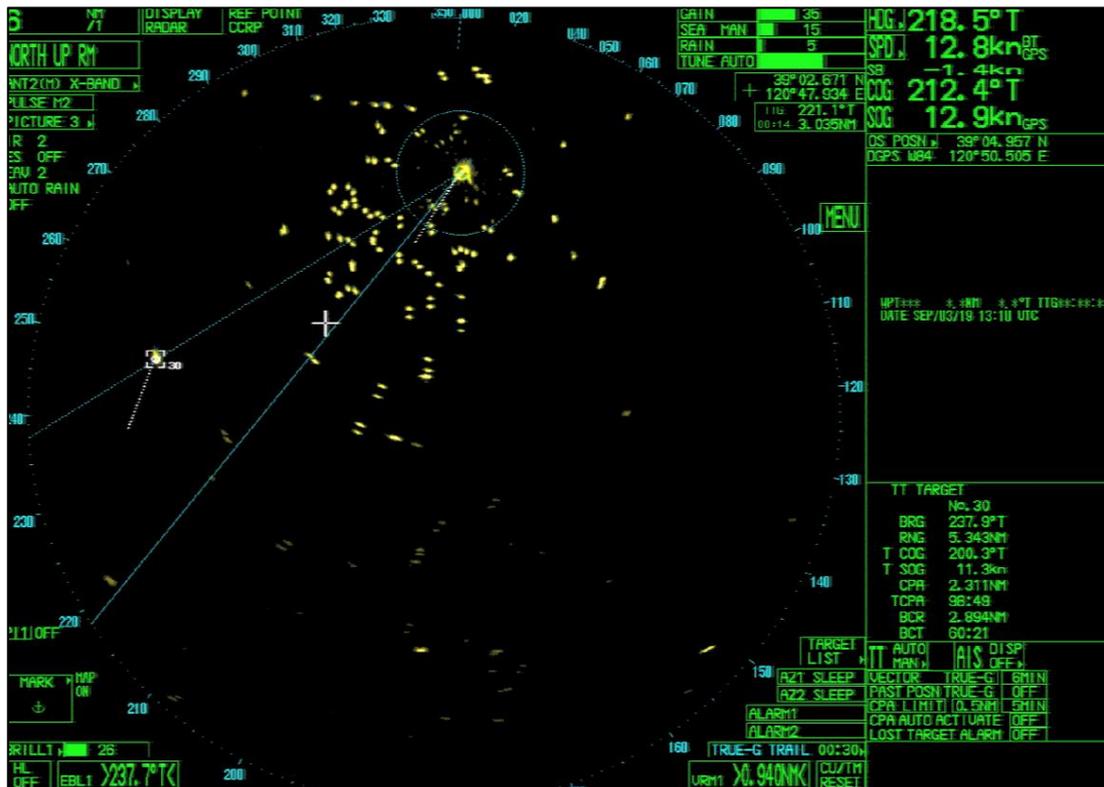
Figure 5: Radar image at 2110 showing fishing traffic in the close proximity of *Kanala*

The bridge was manned in accordance with the SMS for navigation in coastal waters. Upon departure from Jinzhou and up to Laotieshan TSS in Bohai Sea, the passage was uneventful. However, shortly after 2000, a cluster of fishing vessels was detected both visually and on the radar (**Figure 5**). Although applicable standing orders allowed wide course alterations⁴, the OOW proceeded along the planned course. As mentioned earlier in the safety investigation report, the OOW had previous navigation experience through fishing traffic in these waters. It was therefore considered possible that he perceived that on this occasion, like previous occasions, the situation was under control and manageable, whilst the circumstances did not warrant large course deviation, reduction of speed and / or the need to call the master.

As *Kanala* progressed along the planned route, the traffic became denser and the OOW was compelled to turn the vessel to keep clear. From the review of the VDR data and course recorder graph, it was evident that from 2040 onwards, the OOW had been making numerous incremental adjustments of *Kanala*'s course to starboard, apparently 'weaving' through fishing vessels. The audio records confirmed that at regular intervals, the AB was calling out the position and movement of the fishing vessels. It was evident from the radar image that the situation in the immediate vicinity of *Kanala* was demanding and dynamic, necessitating constant helm movements. Therefore, it would seem likely that under these conditions, the OOW was for most of the time stationed at the steering console, relying on look-out and his own assessment of the situation for evasive action.

Procedures for navigating in Bohai Sea and the East coast of China were revised. Additional control measures were introduced, addressing the risk of encountering dense fishing traffic and actions required by the officers on watch. The master was instructed to include in standing / night orders course deviation of up to 15 nm from planned track to avoid fishing traffic.

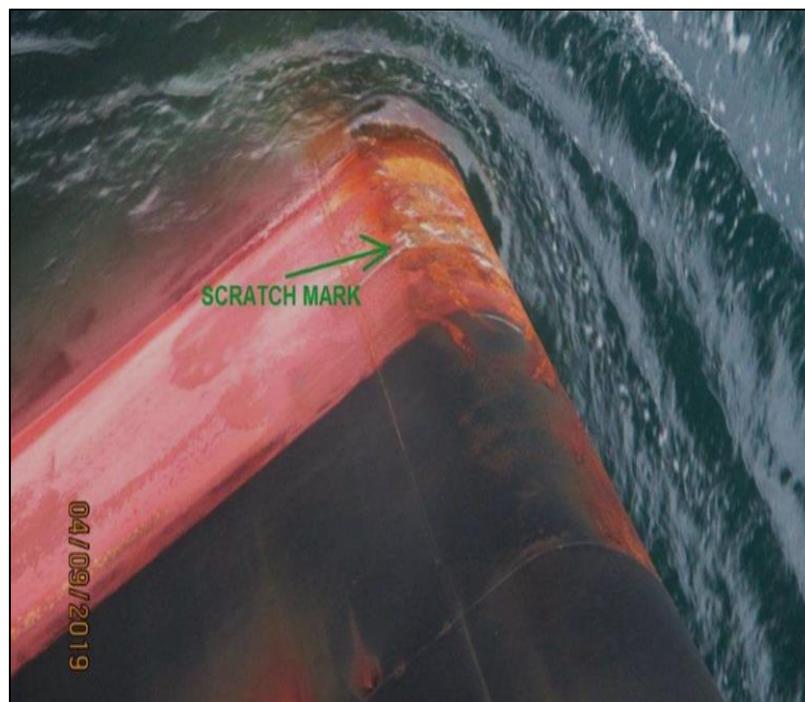
Figure 6: Superficial scratch marks on *Kanala*'s stem and starboard side hull
Source: Executive Shipmanagement Pte Ltd.

In the absence of compelling evidence, it is hypothesized that when *Liaodanyu 23626* was crossing the bow, the skipper of the *Liaodanyu 23625* cut the trawling warp, leaving the trawling gear trailing behind the sister fishing vessel. During crew interviews on board the vessel in Japan, both the OOW and look-out maintained that *Liaodanyu 23626* was momentarily out of view and was again sighted fine on the starboard bow. This indicated that *Liaodanyu 23626* had effectively crossed over within the shadow zone of the forecastle structure which briefly blocked the view of her lights. As soon as *Kanala*'s helm was turned to port to give the fishing vessel more sea room, very mild vibrations were reportedly felt by the OOW with no significant drop in speed. This suggested that the vessel's stem snagged the trailing end of the trawl warp (**Figure 6**), resulting in swamping and foundering of the fishing vessel.

- .1 Kanala's stem snagged the trailing end of the trawl warp and swamped FV *Liaodanyu 23626*;
- .2 The foundering of FV *Liaodanyu 23626* was attributed to the loss of reserve buoyancy.
