SAFETY INVESTIGATION REPORT

REPORT NO.: 23/2021

October 2021

MT MISS BENEDETTA **Fatal injury to a crew member,** **in position 16° 37.3' N 080° 01.0' W** **12 October 2020**

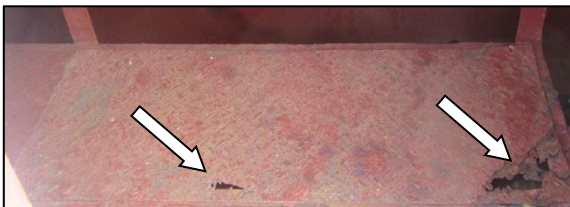
Figure 2: Corroded floor plate of the port side midship store

Information collected from the vessel indicated that there was concern that the corroded plate would give way should crew members walk over it and therefore, the intention was to replace it.

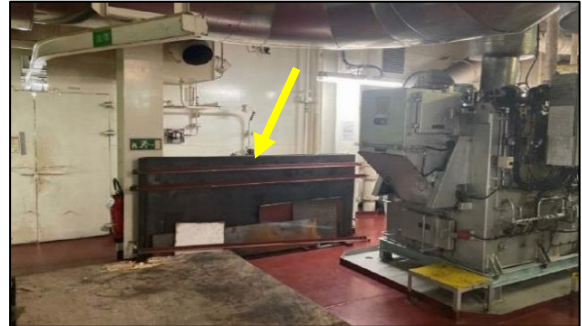
Figure 3: Location of the secured stack of spare steel plates in the engine-room

Almost all steel plates in the stack measured 2450 mm by 1230 mm, with different thicknesses. The weight of the steel plates in the stack ranged from 80 kg to 250 kg. The required steel plate, which weighed around 160 kg, was in the near middle of the stack (Figure 4), secured by three horizontal angle bars (Figure 5).

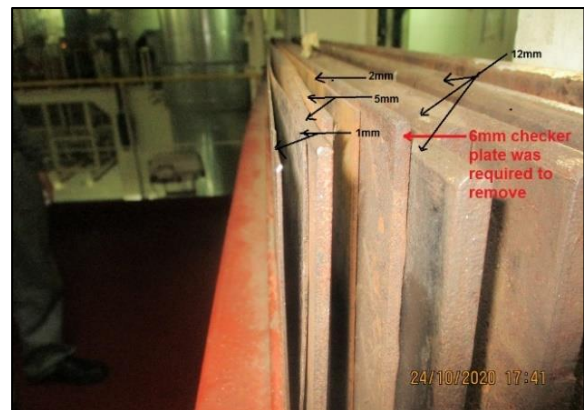
Figure 4: Position of the required steel plate (red arrow) amidst the stack

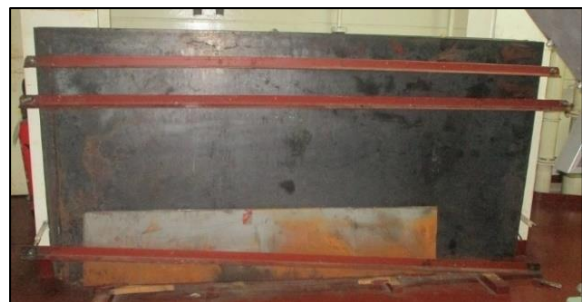
Figure 5: Securing arrangement of the stack

The storage location had been chosen following an agreement between the shipyard construction manager and the chief engineer on board the vessel at that time. The stack's securing arrangements were fabricated and fitted by the shipyard, with the assistance of the crew members.

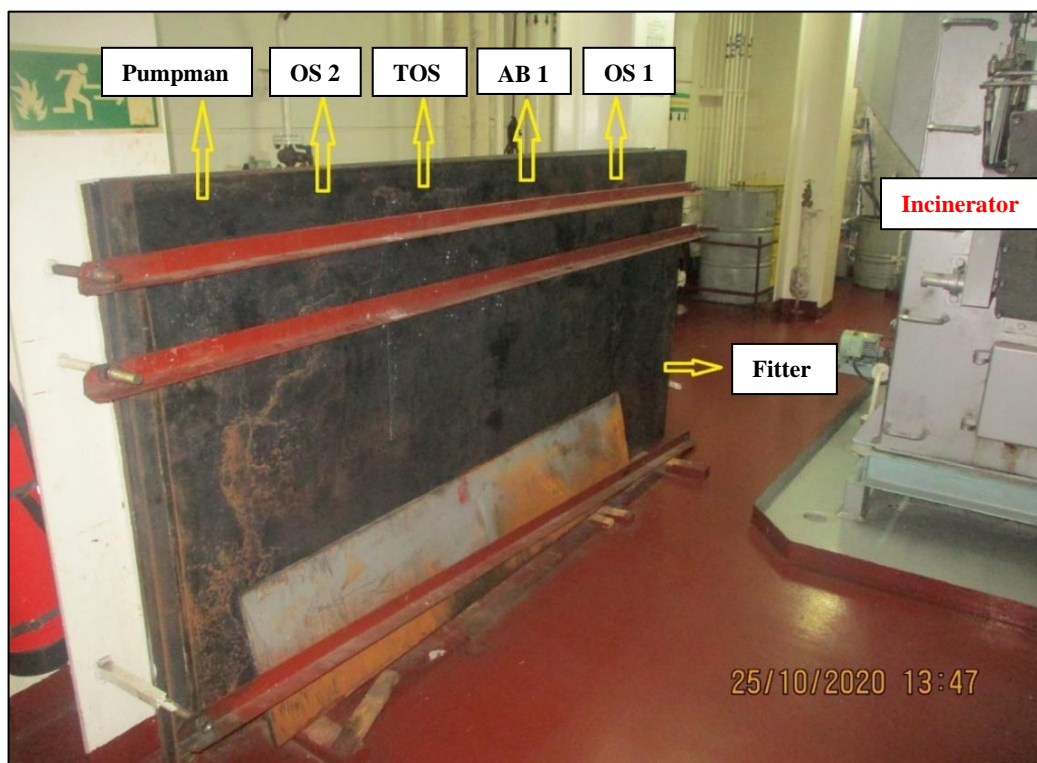
After the upper two angle bars were removed and the fitter commenced loosening the last nut of the lowermost angle bar, the crew members noticed that the stack was getting heavier to support.

Figure 6: Position of the crew members while the securing arrangement was being removed

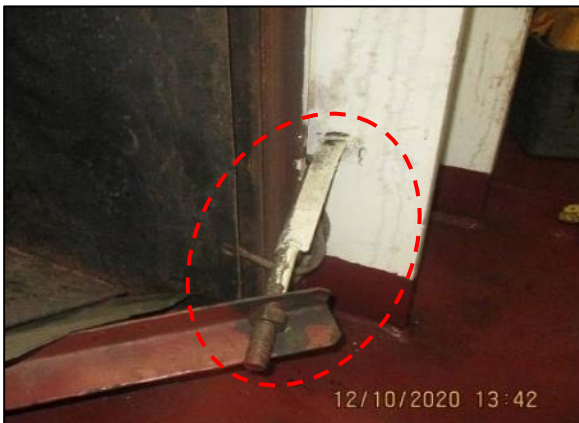
The fitter was still loosening the nut of the securing arrangement when the crew members became overwhelmed by the weight and, unable to support the stack any further, most of the steel plates tipped over. During this time, the securing arrangement buckled under the weight of the steel plates (circled in red, in Figure 7). While the other crew members managed to move clear of the falling plates, OS 1 did not manage to and was trapped between about eight steel plates and the incinerator (Figure 8).

Figure 7: Securing arrangement which gave way

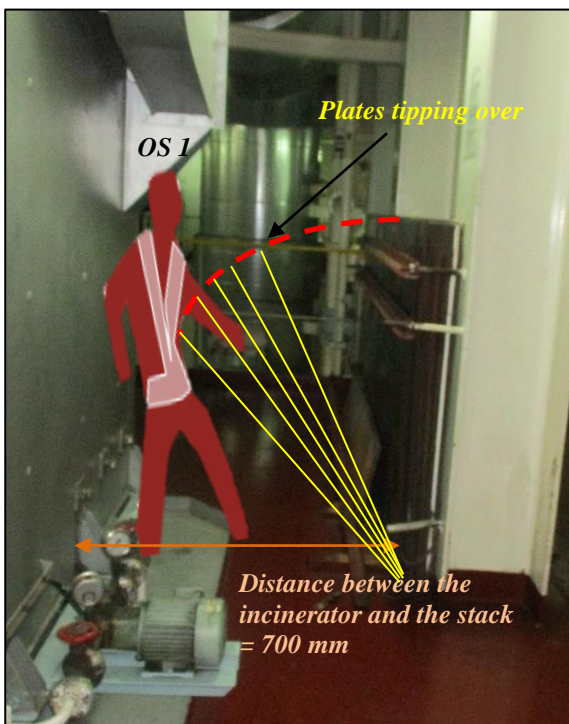
Figure 8: Simulation of the accident

OS 1 suffered fatal injuries after the stack of steel plates, each weighing between 80 kg to 250 kg, tipped over on him and trapped him against the incinerator.

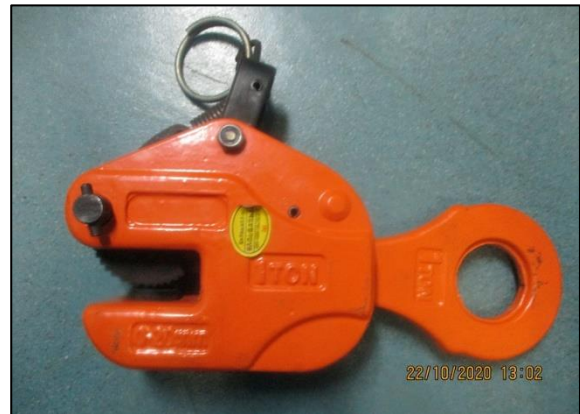
Lifting clamps for the transfer of heavy steel plates were available on board (Figure 9). The lifting clamps would allow for extraction of a required plate, without the removal of the securing arrangements (Figure 10).

Figure 9: A lifting clamp on board *Miss Benedetta*

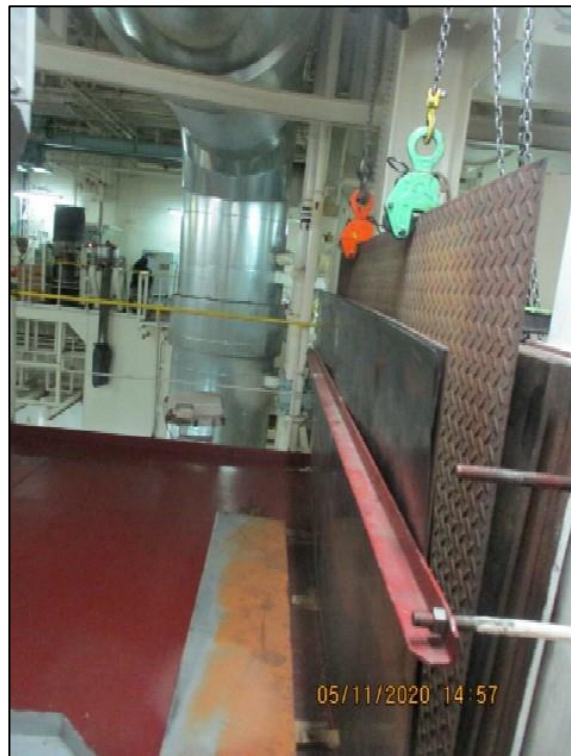
Figure 10: Extraction of a steel plate using the lifting clamps
