## SAFETY INVESTIGATION REPORT

REPORT NO.: 19/2020

### **MT RUBY-T** **Serious injury to crew member** **while alongside at the port of Nikolaev, Ukraine** **20 October 2019**

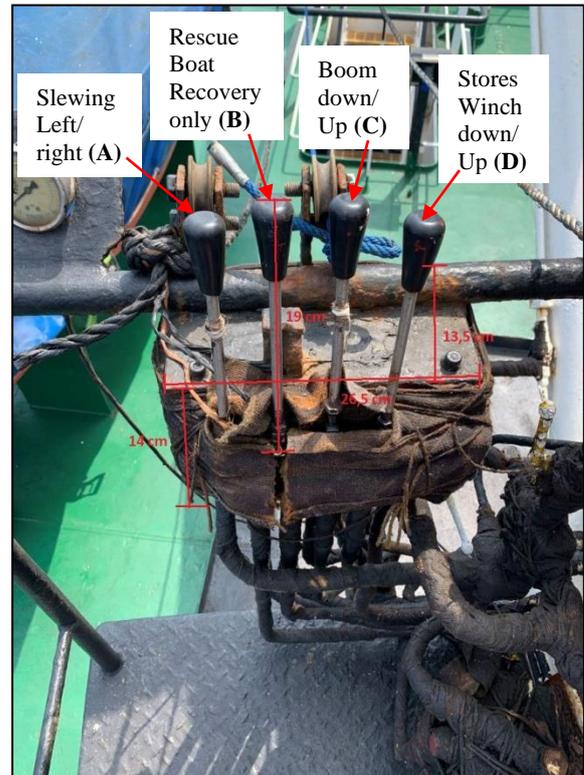
**Figure 3: The joysticks on the control box mounted on the platform**

The chief officer was initially handling the joysticks from the control box and, while testing the rescue boat limit switch, joystick (B) was damaged to the extent that it was displaced from the crane control box.

The MSIU could not establish the extent of damage caused to the crane control box's joystick (B). It was understood that joystick (B) was displaced from the control box, possibly during a jerking movement. Following the accident, the crew had fixed the joystick back onto the control box.

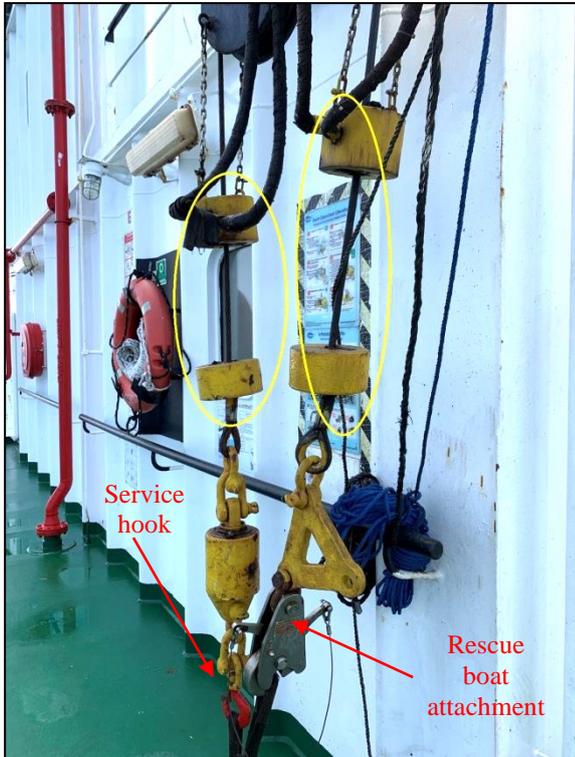
The hydraulic circuit of the crane incorporated two separate limit switches (Figure 4), which limited the travel-up movement of the service hook and rescue boat attachment. Once these limit switches

were activated<sup>2</sup>, the hydraulic circuit becomes isolated, thus stopping all movement before the extreme point of travel could be reached.

Figure 4: Limit switches for hook travel circled in yellow

**19/2020\_R1** Develop detailed written procedures for the testing of the crane's limit switches.

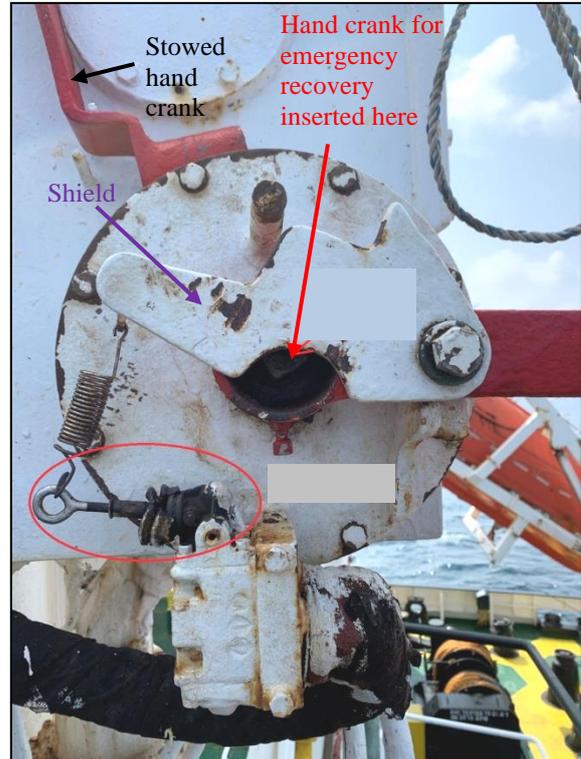
Figure 5: Mechanical safety device – shield for the squared spindle. Once the shield is lifted, the spring deactivates the electrical circuit and the R/B winch is isolated

The limit switch of the R/B winch was disengaged, allowing the winch to rotate even though the shield was lifted, due to the hand crank being inserted in the squared spindle.

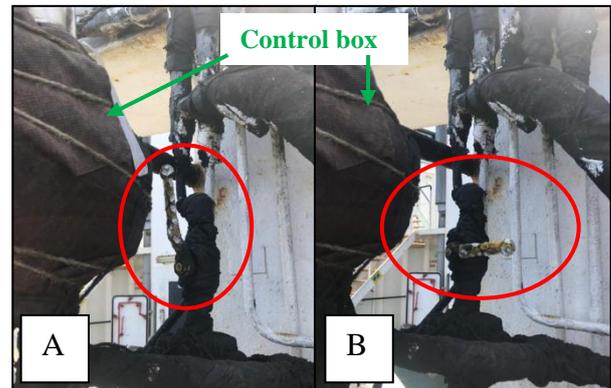
Thereafter, the chief engineer closed the switch disabling valve (Figure 6), to reset the limit switches. The wire of the service hook was successfully lowered and secured using joystick (D).

**Figure 6: (A) showing switch disabling valve in the open position and (B) showing switch disabling valve in the closed position**

Rightly so, the switch disabling valve had to be closed to allow resetting of the limit switches which were tested; therefore, in that moment, all limit switches ceased to function, hence eliminating the protection which they offered. Joystick (B) was damaged and dislodged. By improvising with the use of an adjustable wrench, the obstruction barrier was by-passed, as the wrench was not affected by it. In the opinion of the safety investigation, the use of the wrench was deemed necessary by the crew at that time, as this was the only means of operating the R/B winch until joystick (B) was repaired.

No symbolic barrier systems, in the form of warnings or posters, were posted next to the switch disabling valve to indicate its function. Neither were any warnings posted to inform operators that joystick (B) was only meant for hoisting the rescue boat attachment. Whilst considering that the bosun had forgotten that the hand crank was

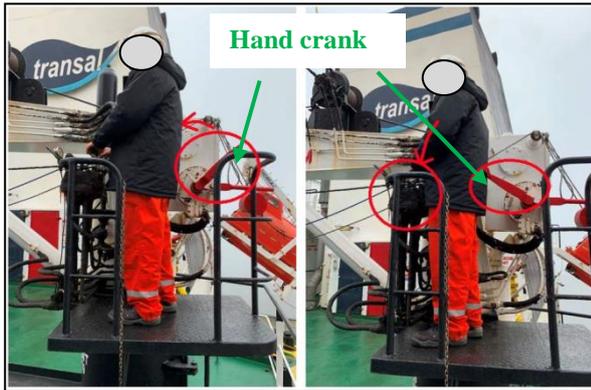
Several minutes later, he turned towards the control box and as soon as he used the adjustable wrench to engage the R/B winch, the hand crank struck him on his back (Figure 7). This action threw the bosun forward onto the control box from where he fell down. The crew members, who were close by, helped him onto the deck and provided assistance, as he seemed to have been in significant pain.

**Figure 7: A simulation of the bosun's position while handling the control box, with his back to the hand crank**

At the time of the accident, the bosun was standing in a relatively restricted space of the crane's platform, facing the control box. The switch disabling valve was closed and the hand crank was left mounted in the squared spindle. As soon as the bosun induced the R/B winch, the hand crank rotated and hit the bosun on his back.

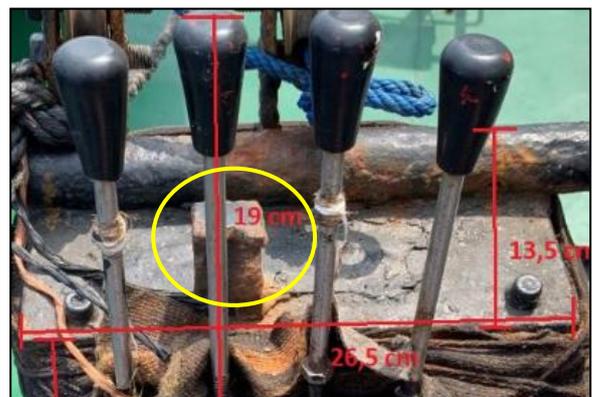
Joystick (B) was damaged and out of position, and in lieu, a wrench was used. As joystick (B) was barred from moving in the 'lowering' direction on the control box, due to a built-in physical barrier (Figure 8) and thus prevented lowering of the wire under power, the option to lower this wire by using the winch was not available before. However, with the use of an adjustable wrench, this physical barrier could be bypassed.

Figure 8: Built-in physical barrier circled in yellow

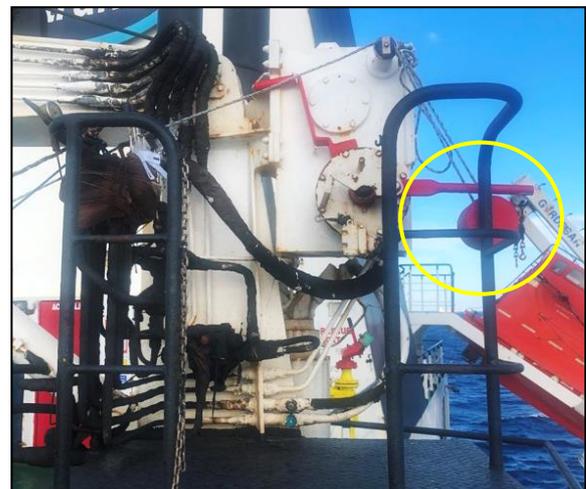
Figure 9: Governor brake circled in yellow

The manufacturer's manual indicated that in order to check the reliability of the governor brake functions, the hand crank should be engaged onto the squared spindle and turned in the opposite direction, as if to lower the rescue boat attachment. The manual specified that the hand crank should not turn in this direction, even under heavy effort. However, in the case of *Ruby-T*, the bosun was able to turn the hand crank in the opposite direction, and successfully lower the rescue boat attachment wire.

This would normally be an indication that the brake system's inner or outer race was badly indented and that the clutch required immediate replacement. However, after this accident, the Company had carried out an investigation on the brake system and found no wear-down. The Company, therefore, concluded that operation of the hand crank in opposite rotation could only have been possible if the brake was loosened.

Additionally, in accordance with the manufacturer's manual, the correct cranking direction was marked with an arrow. However, upon investigating, no arrow marking could be found. The absence of such an arrow, which in itself would have been a symbolic barrier, may have

**19/2020\_R2** Put in place a distinctive arrow marking to indicate the correct direction of rotation of the crank handle.
