SAFETY INVESTIGATION REPORT

REPORT NO.: 02/2020

MT SICHEM RUBY **Serious injury to crew member** **in position 41° 21.5' N 010° 11.0' W** **20 January 2019**

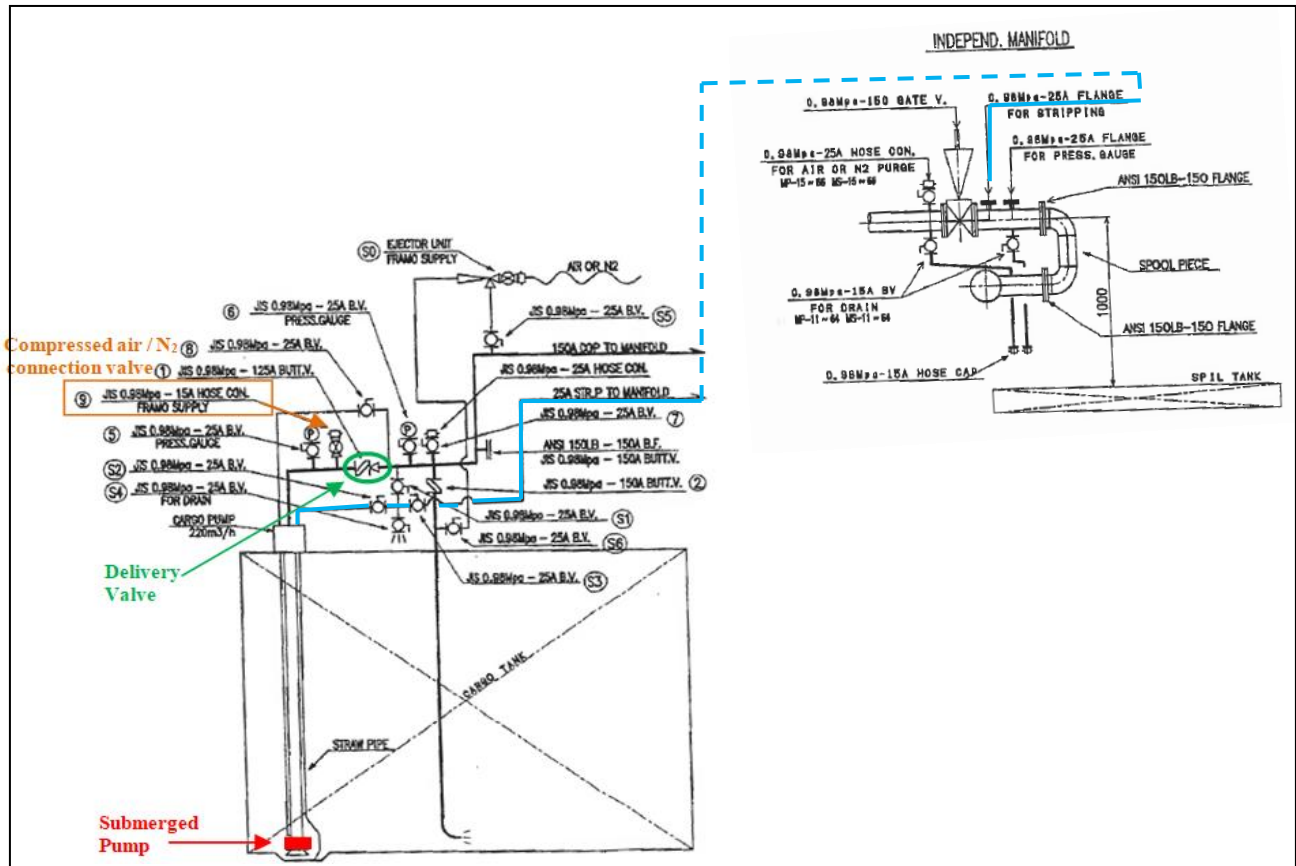
Figure 1: Piping arrangements for cargo tanks

According to the vessel's approved Procedures and Arrangements (P&A) Manual¹, the vessel had no special stripping line. A compressed air blowing system was provided on each cargo pump for stripping the cargo tank (Figure 1).

However, Figure 1 also shows pipelines of a 25 mm diameter, passing from the pump stack to the manifold, identified as '25A STR P TO MANFOLD' (highlighted in blue). Moreover, the P & A Manual also mentioned that a stripping system was available to strip the cargo tanks and lines, following unloading. Furthermore, the P & A Manual also indicated that the stripping system may also be used to drain the deck lines into the appropriate cargo tanks, upon completion of loading.

Although the P & A Manual initially indicated that there was no special stripping line on board, it later goes on to refer to a stripping system for cargo tanks and lines. During the course of this safety investigation, it was noticed that the vessel was, in fact, fitted with stripping lines of 25 mm diameter for each cargo tank.

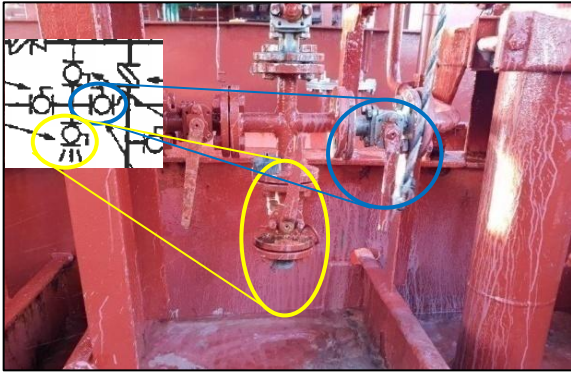
During the previous cargo operations, the pumpman had noticed that one of the stripping line valves of no. 2 port (2P) was leaking slightly and on 20 January, he decided to attend to it.

Figure 3: Position of the leaking valve (blue) & position of drain valve (yellow)

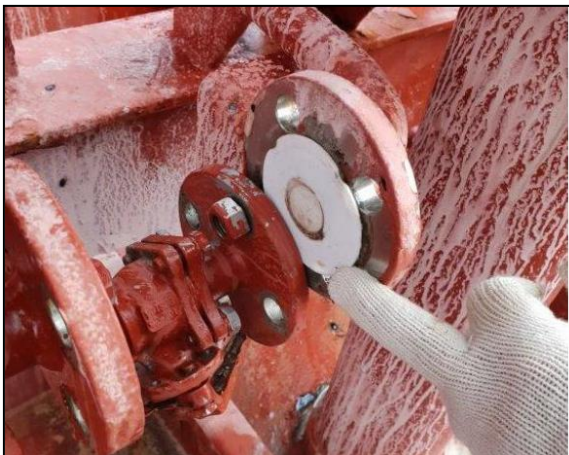
After removing the leaking valve, the pumpman noticed a Teflon blank installed on the right flange (Figure 4).

Figure 4: Teflon blank in way of the stripping line

1. Removal of all Teflon blanks from all pipelines and checks on sister vessel for any similar blanks;
2. Reinforcing of PPE campaign for routine maintenance jobs for the whole fleet;

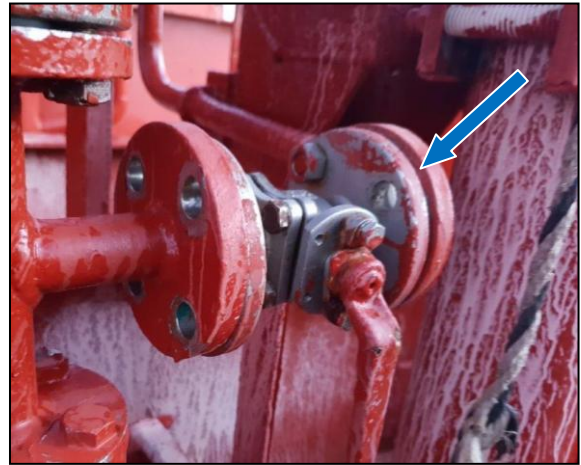
After removing the valve, the pumpman placed a reconditioned valve into position. Suddenly, sulphuric acid sprayed onto his face and body, as soon as he started tightening the first bolt on the right flange (Figure 5).

Figure 5: Right flange: location where sulphuric acid allegedly sprayed out from (blue arrow)

Sulphuric acid sprayed from between the Teflon blank and the pipeline flange which was to the pumpman's right side, while the pumpman was securing the first bolt on the reconditioned valve. It is the view of this safety investigation, that while tightening the bolt, the Teflon blank dislodged and gave way under the pressurised sulphuric acid, which remained trapped in the pipeline.

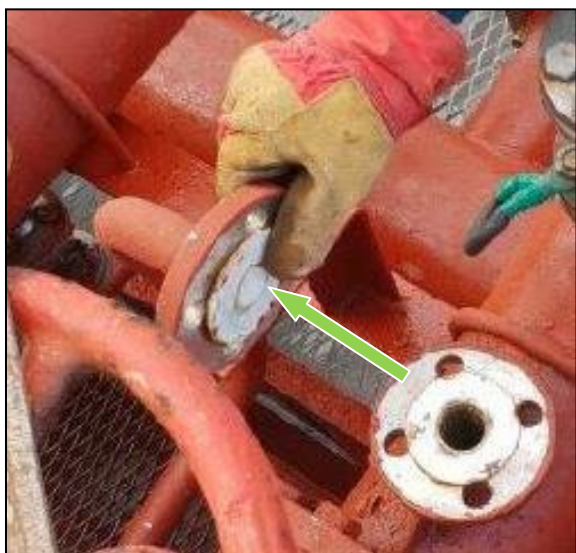
After the accident, the crew found that Teflon blanks had been placed on both ends of the stripping line on no. 2P. The blank that was nearest to the manifold was found cracked, allowing liquid to seep through (Figure 6).

The safety investigation could not establish the cause of the Teflon blank failure.

Figure 6: Cracked Teflon blank on the stripping line at the manifold's side

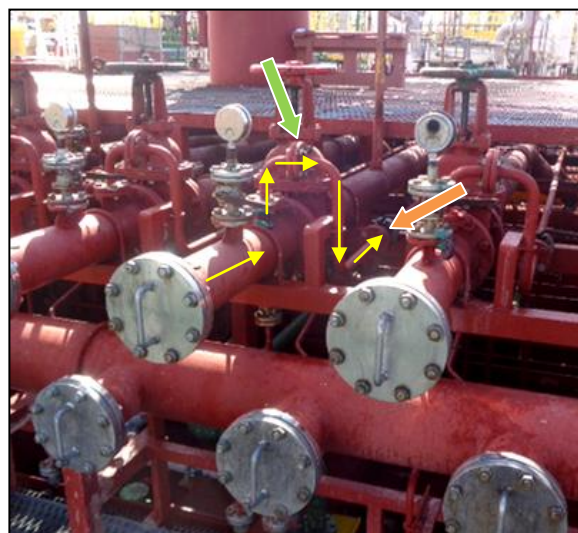
Following the stripping line piping, from the manifold side back to the cargo tank, it was observed that after the cracked Teflon blank, a ball valve was installed (Figure 7).

Figure 7: Location of the cracked Teflon blank, in between the flanges (green arrow) and location of the ball valve (orange arrow), on the stripping line

However, it was later reported that during deck line washing and draining, all the stripping line valves were kept open. This would have allowed sulphuric acid, which was accumulated in between the cracked Teflon blank and the ball valve, at the manifold, to pass through the rest of the stripping line unnoticed, until it reached the other Teflon blank.
