SAFETY INVESTIGATION REPORT

REPORT NO.: 07/2019

MV A NAVIGATION Fatality of a stevedore in the port of Kelang, Malaysia 01 April 2018

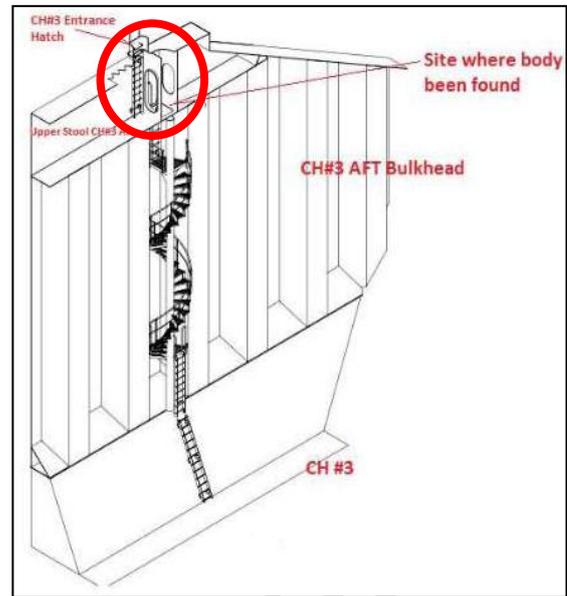
At approximately 1000 on 01 April, whilst the chief mate and the foreman were carrying out inspections of the cargo holds (from main deck level) to determine the balance of the remaining cargo, a burning smell was noticed to be emanating from the entrance hatch of cargo hold no. 3. They also observed a stevedore in the area on the main deck. Concerned, they approached the area and at that point, the foreman noticed the presence of an apparently unconscious person inside the entrance hatch of cargo hold no. 3 (Figure 1).

Figure 1: Location of body

The body of the stevedore was reported to have been discovered on the upper platform of the cargo hold access. The casualty's face and upper torso were noted to be severely burnt, with only his lower clothing remaining. The burnt safety shoes he was wearing were also found nearby.

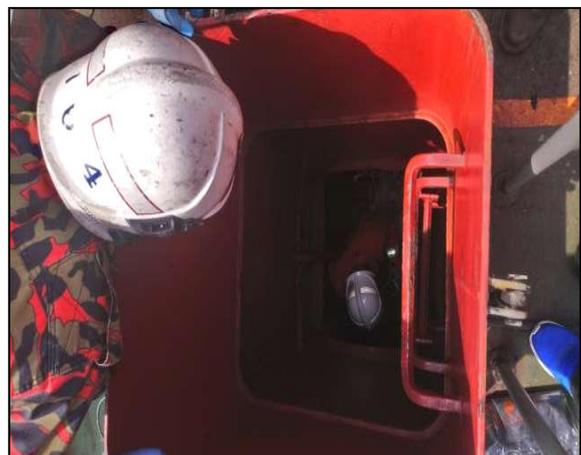
The rescues teams (Figure 2), consisting of the fire and police departments, boarded the vessel at 1445. The body was eventually retrieved from the entrance hatch of cargo hold no. 4 at 1555.

Figure 2: Rescue teams at the accident site

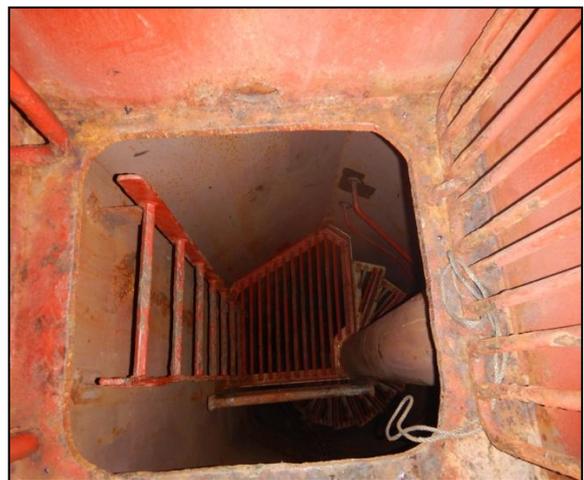
It was initially reported that the casualty was found located on the upper platform in way of the upper stool area. However, it was determined that this was factually incorrect; the body was located on the upper most platform of the Australian ladder (Figure 3).

Figure 3: Opening to ladder and first platform where the fatally injured stevedore was found

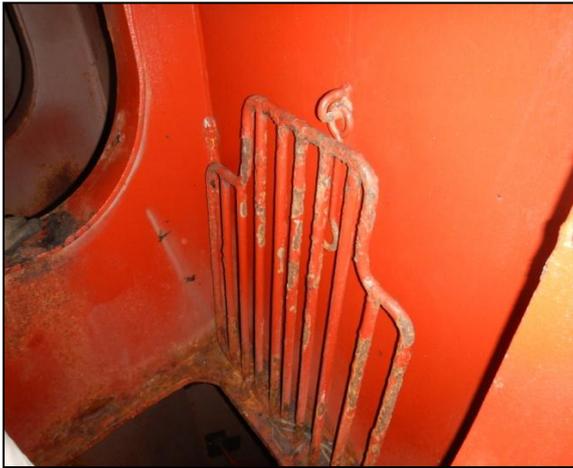
The Australian ladder on this vessel is enclosed by metal plating from the vertical ladder (close to lower hopper level) up to the upper stool area. The hatch grating at the upper stool deck area was found in the open and unlatched position. To open this, it was common to straddle the frames located on either side, above the grating (Figure 4).

Figure 4: Grating at entrance to Australian ladder

The deflagration may have then caused the stevedore to fall from the position where he lifted the grating to where his body was finally located on the upper platform of the ladder, following the tragic turn of events.

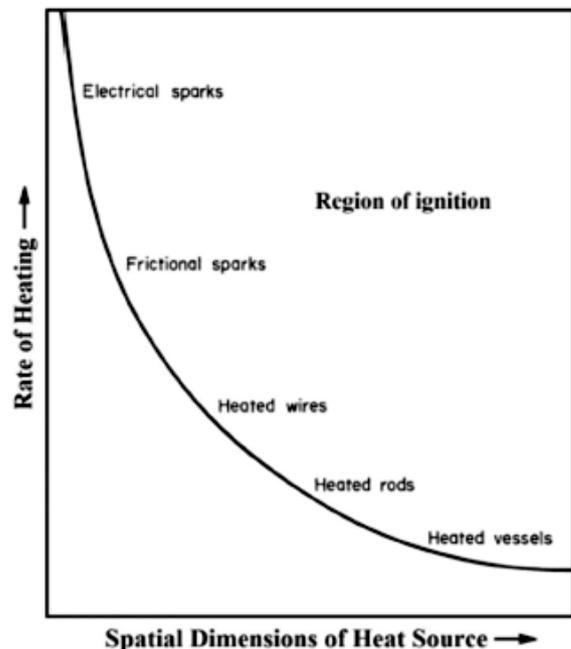
Figure 5: Rate of heating with spatial dimensions

It may be noticed from the figure that sources which generate sparks may be very small, but their heating rate and temperature are relatively very high. Moreover, the ignition energy required by methane is very low. However, based on BV's occasional survey report (that all electrical equipment in the vicinity was in order), an electrical failure / spark was ruled out as the source of ignition. Moreover, the safety investigation could not determine whether smoking took place inside the space, although no cigarette butts were found on site.
