SAFETY INVESTIGATION REPORT

REPORT NO.: 22/2021

MV ALEXANDRA A **Man overboard** **in position 37° 34.58' N 023° 44.55' E** **(Saronikos Gulf), Greece**

03 October 2020

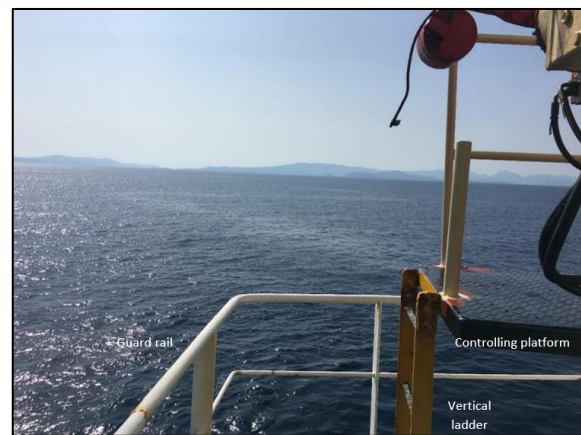
The provisions crane was designed to load provisions and to launch and recover of the vessel's rescue boat and / or liferaft. It was fitted aft on the poop deck, on starboard side. The crane was operated from an open control platform, fenced by fixed metal railings, and located 1.33 m above the poop deck. The joysticks mounted on the platform controlled the slewing, crane jib, and cargo winch. The platform was accessed via a fixed vertical ladder, fitted about 0.80 m from the ship's starboard guardrail (Figure 1).

Figure 1: The provisions crane's controlling platform, fixed vertical ladder, and guard rail.

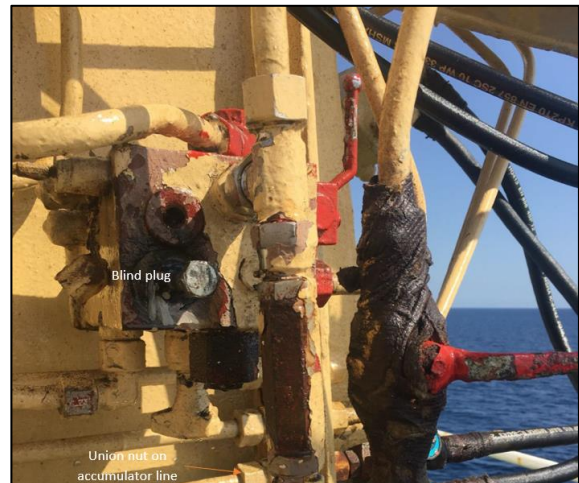
The fitter discovered that the oil leaking was from the blind plug, but it had been previously welded in position and required grinding off before the leakage could be rectified.

Although a valve (with a cap) on the hydraulic line was closed, he noticed that the flexible accumulator circuit underneath had to be slightly moved to operate the angle grinder. The fitter reported that he gently moved the accumulator circuit⁴ (Figure 2). Suddenly, he heard a strong noise and hydraulic oil spurted out with an overwhelming force. The AB and cook heard the blast and noticed that the fitter had fallen overboard. The AB immediately notified the bridge. The accident occurred at 1102 and the man overboard (MOB) position 37° 34.58' N 023° 44.55' E was logged.

Figure 2: Photo showing blind plug and union nut on accumulator circuit.

In all probability, the (loosened) union nut dislodged from its housing when the fitter moved the flexible accumulator circuit⁶. Although the system had been isolated, it was still under residual pressure, which had not been relieved. The hydraulic fluid, under considerable N₂ pressure, leaked out from system to atmospheric pressures. The fitter, very likely, startled by the sudden and unexpected outburst (not least the sound generated by the differential pressure), instinctively withdrew back, and fell over the crane's platform and the ship's guardrail.

1. The cause of the accident was attributed to the fitter's reflex action when hydraulic pressure relieved inadvertently through a loosened union nut;
2. The (loosened) union nut dislodged from its housing when the fitter moved the flexible accumulator circuit;
3. The release of the union nut was not anticipated by the crew members;
4. Information available to the MSIU suggests that the task of eliminating oil leak was treated as a routine job because hot work and the handling of the accumulator circuit was not anticipated;
5. Seen as a trivial task, his actions were neither supervised nor did he report his intentions to the senior crew members.

- Lessons learned from this accident were circulated to all fleet vessels and included in the monthly safety and security meetings. The internal investigation report was incorporated in the Company's internal training programme;
- It was agreed that SMS procedures on work pressure systems had to be reviewed and revised, as necessary;
- Frequency of man overboard drills will be carried out with the participation of all personnel on board.
