## SAFETY INVESTIGATION REPORT

REPORT NO.: 13/2021

### **MV APL CALIFORNIA** **Serious injury to a crew member** **while letting go the towline** **at the port of Ningbo, China** **14 May 2020**

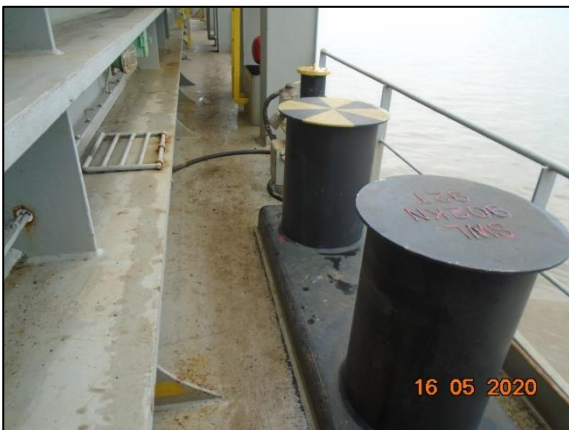
The vessel was fitted with mooring equipment at its forward upper deck area, on her port and starboard sides. The equipment was installed abreast of Bay 15 and consisted of two mooring bitts and an air-driven capstan (Figure 1). The capstan had a rated load of 0.4 mt and a speed of 34 m min<sup>-1</sup>.

Figure 1: Mooring bitts where the tug's line was made fast for departure

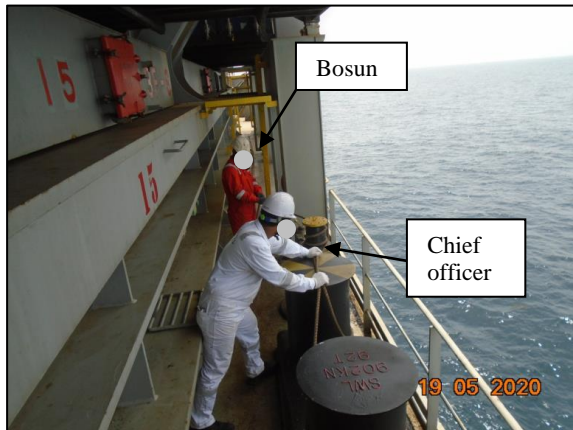
ordered the forward party to cast off the forward tug's line. Upon arriving near Bay 15, the bosun cleared the pick-up gear of the tug's line and made turns of it around the nearby capstan, to release the tug's line from the vessel's mooring bitts. Once tension was taken on the capstan, the chief officer cleared the tug line's eye from the mooring bitts (Figure 2).

**Figure 2: A photo simulation of the bosun holding on to the pick-up gear and the chief officer clearing the eye of the tug's line from the mooring bitts**

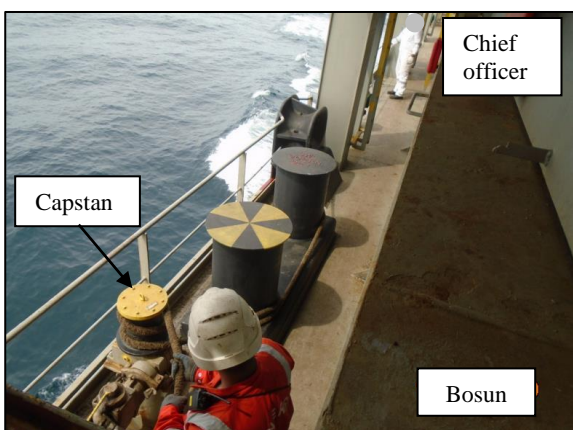
The bosun then started to control the lowering of the tug's line by easing the tension on the pick-up gear (Figure 3). At this stage, the chief officer moved further aft to keep clear of the moving line.

**Figure 3: A photo simulation indicating the bosun and chief officer's positions while the tug's line was being lowered**

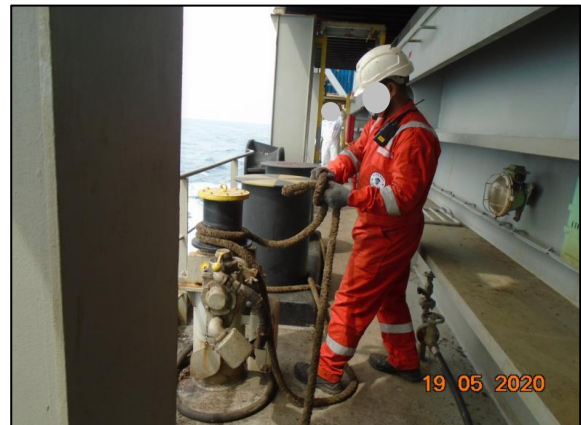
At 2118, the eye of the tug's line reached the waterline, and the chief officer reported to the bridge that the forward tug was cast off. At this time, while the pick-up gear was still moving under tension, the bosun noticed that the vessel's messenger line was still attached to the pick-up gear by a knot. While he attempted to disconnect these ropes<sup>6</sup> (Figure 4), his left leg was caught between the pick-up gear and the mooring bitts (Figure 5).

**Figure 4: A photo simulation of the bosun attempting to disconnect the messenger line and the pick-up gear**

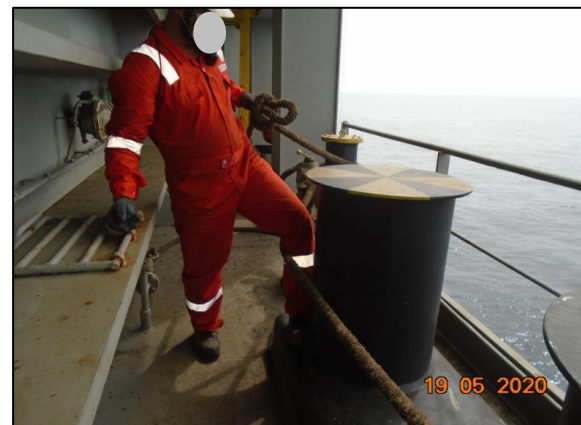
**Figure 5: A photo simulation of the bosun's left leg getting caught in between the pick-up gear and the mooring bitts**

While the tug's line was being retrieved by the tug during the casting off operation, the bosun realised that the vessel's messenger line and the tug's pick-up gear were still attached. During an attempt to undo the knot connecting these lines, his left leg was caught by the running line. Consequently, his leg was pressed against the mooring bitts, leading to serious injuries.

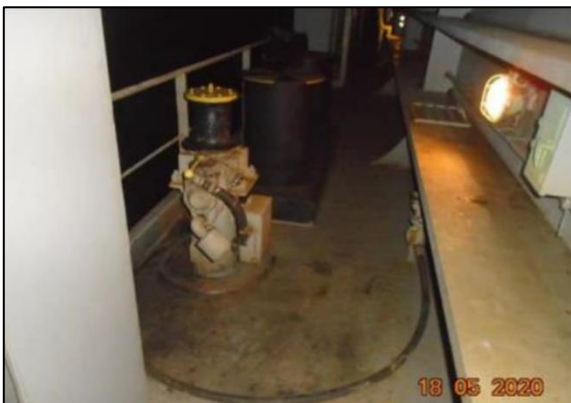
Additionally, since the operation was being carried out during night-time, the crew had to rely on the fixed illumination fitted on deck, which emitted a yellow light (Figure 6).

**Figure 6: Accident site illuminated at night-time**

The fixed light's position was well intended to illuminate the work site. However, its position could have also contributed to shadows being cast in the area, while crew members handled the ropes. The shadows may have been the cause of the bosun's initial oversight of the attached lines as well as of his foot position while he focused on releasing the vessel's messenger line.
