SAFETY INVESTIGATION REPORT

REPORT NO.: 17/2018

September 2018

MV APL CORAL Serious injury to a crew member Approximately 250 nautical miles off Shekou 09 September 2017

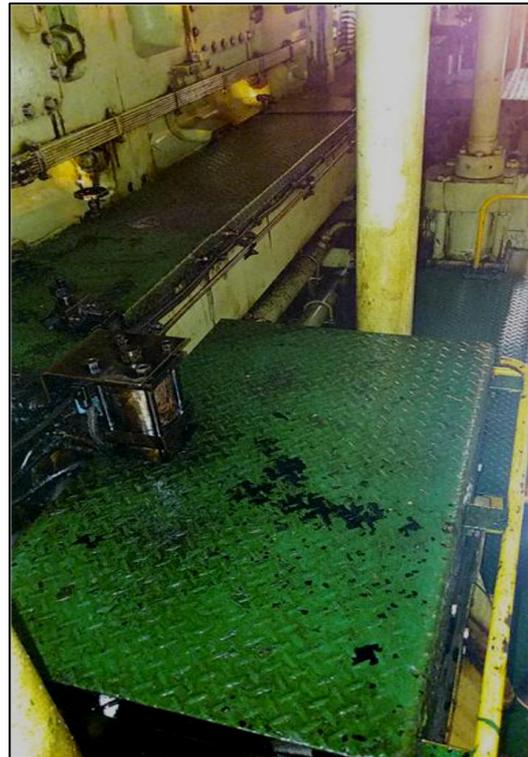
In order to gain access, the second engineer had to squat and adopt this position to use the ring spanner on the valve on the fuel pump for no. 10 cylinder. In the meantime, the third engineer, who had also climbed up after the second engineer (Figure 1), positioned himself next to the second engineer, but stood up on top of a pipe guard, which ran along the main engine casing.

Figure 1: Platform where the second and third engineers were standing

Both the second and third engineers had climbed up above the main engine middle platform to a position where there was a small platform (75 cm x 30 cm), complete with two stanchions. The positions where the two engineers stayed were slippery and covered in oil from the leaking high-pressure hose. Furthermore, the safety investigation did not have evidence to suggest that the two engineers were wearing their safety helmets and fall preventers at any time during the work which they were carrying out.

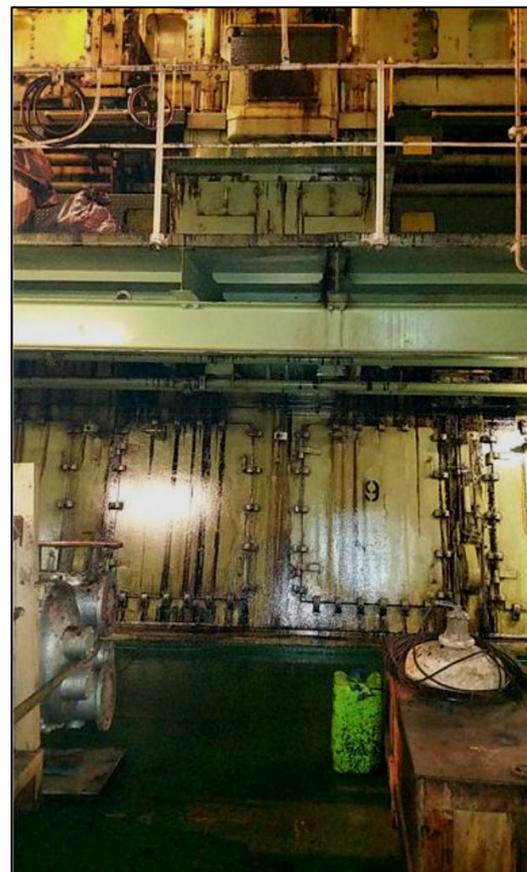
In the meantime, the second engineer proceeded to use the ring spanner on the valve in order to close it. At one point in time, the ring spanner slipped out of the valve and consequently, the second engineer lost his balance, fell backwards, through the space between the middle guardrail and the toe board, onto the middle platform, approximately 2.5 m below. The second engineer then bounced, rolled and went through the horizontal guardrails of the middle platform and fell again another 3.0 m, until he landed on the main engine bottom platform (Figure 2).

Figure 2: The middle platform and the bottom platform where the second engineer finally landed

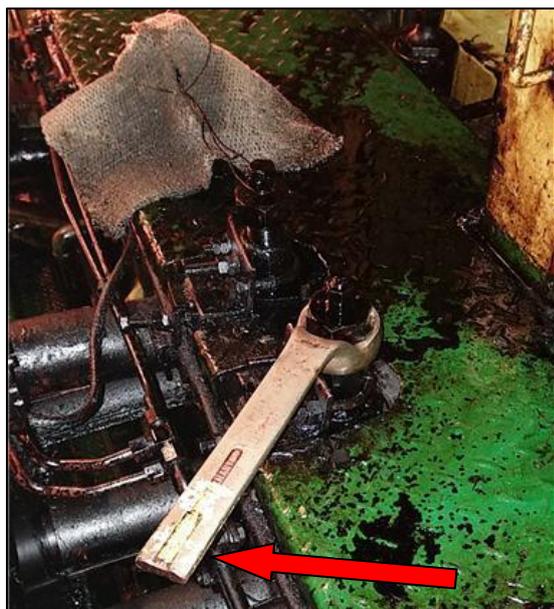
By adopting a squatting position, the chief engineer's centre of gravity was shifted towards the edge of the platform. The adapted ring-spanner, with a shorter lever (Figure 2), would have reduced the grip exerted on the spanner.

Figure 2: The adapted spanner used by the chief engineer

A jolt by the crew member, especially if either the grip slipped or the spanner itself slipped from the valve's nut, would have been enough to imbalance the crew member from the small platform. Moreover, the third engineer was unable to do anything to prevent the fall because even he was standing in a dangerous position and would have lost his balance and fall to the middle platform.

- a risk assessment is always carried out in order to identify hazards;
- safety gear is used at all times;
- adequate housekeeping is maintained at all times;
- 'non-standard tools' are removed and only standard tools are used;
- engineers are retrained in the proper use of safety gear and the right tools for the right jobs;
- considerations are made for the fabrication of a proper platform below the main engine fuel pump unit in order to have easy access to the inlet/outlet valves; and
- a vertical round bar is fabricated to divide the railings into smaller sections.

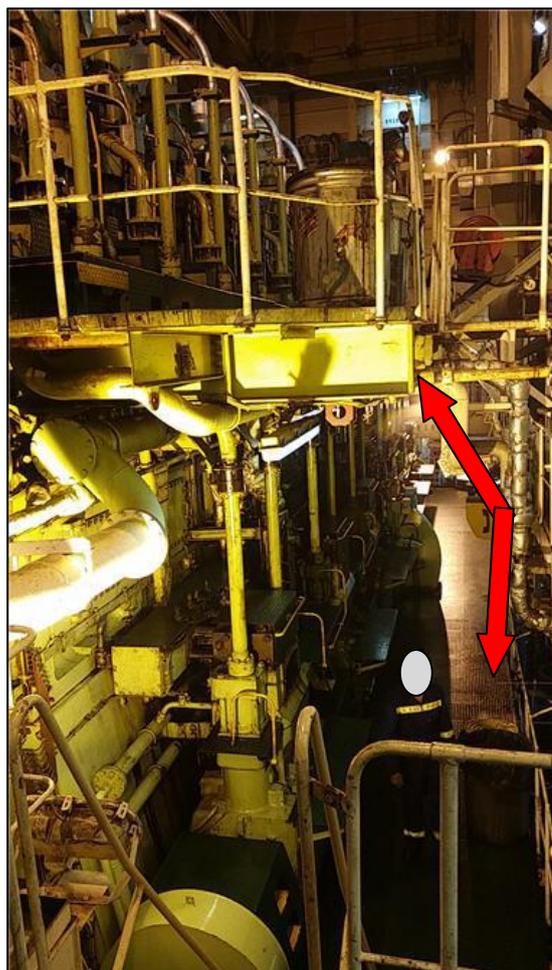
IMO and IACS regulations require that platform guardrails are one metre in height, with one middle guardrail and a toe board. This makes the gap / distance between the middle guardrail and the bottom plate of the platforms approximately 0.5 m in height. The safety investigation concluded that the guardrails around the middle platform (Figure 3) were in accordance with these requirements.

Figure 3: Top and middle platforms
