## SAFETY INVESTIGATION REPORT

REPORT NO.: 16/2018

### **MV ALPHA CONFIDENCE** **Serious injury to crew member** **in the port of Hedland, Australia** **07 September 2017**

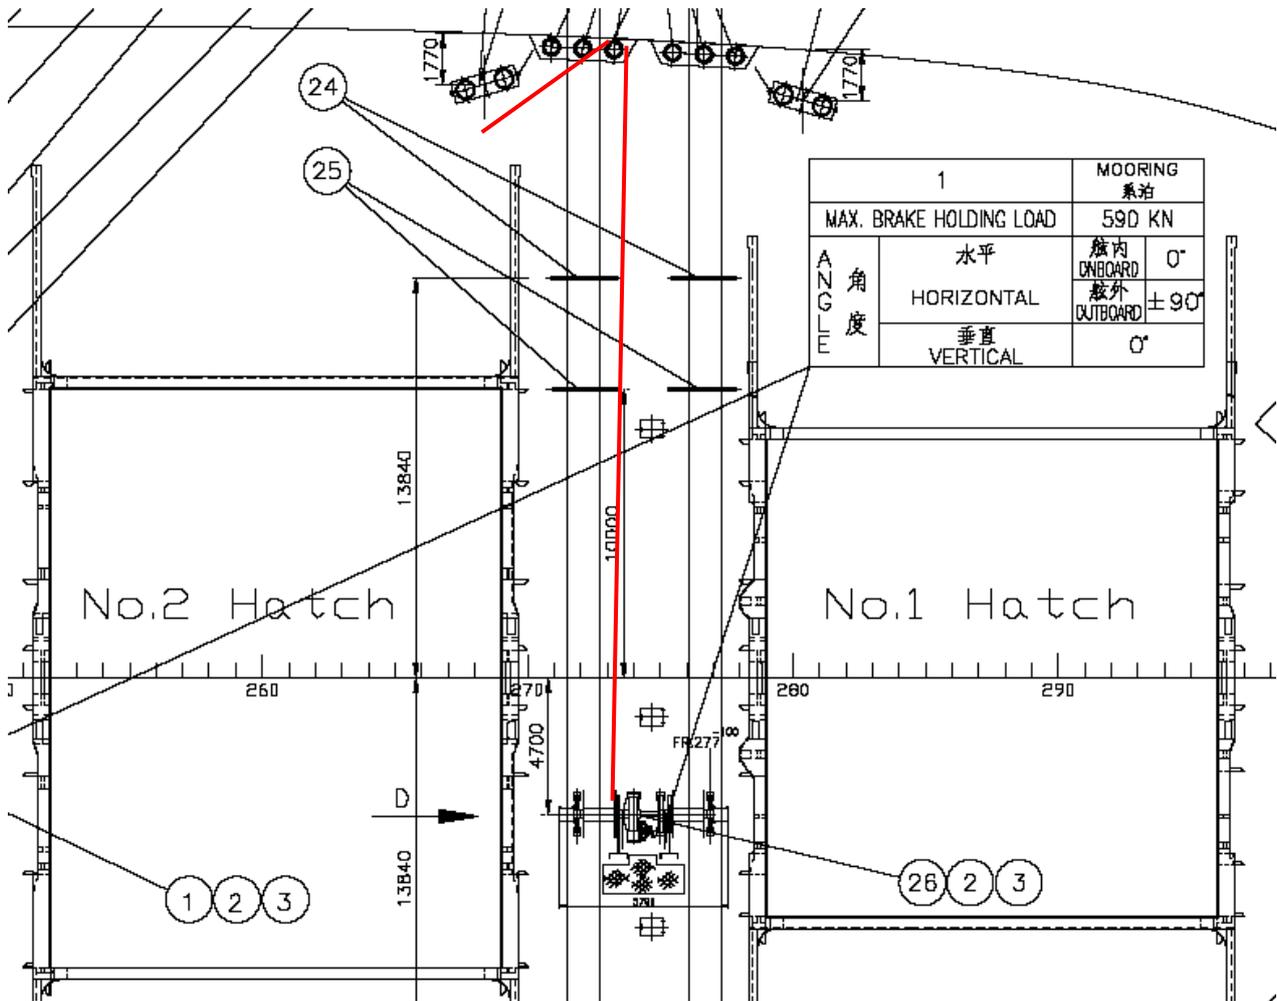
The bosun was operating the winch and an able seafarer was guiding the free end of the messenger line, which was wound on the warping drum (Figure 1).

Figure 1: Layout of mooring equipment and messenger line (red)

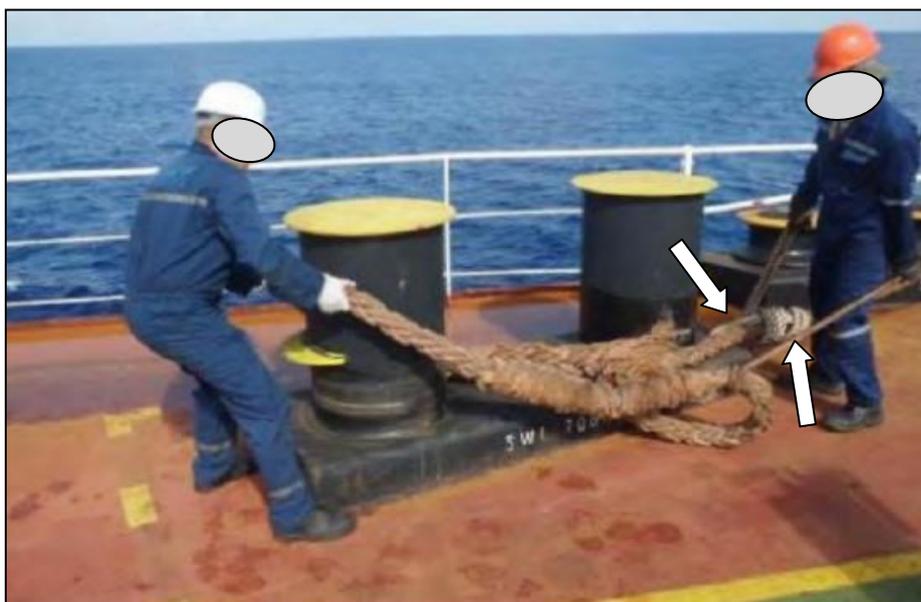
Once the eye was pulled free, a rope stopper<sup>2</sup> was secured to the towline and held by one of the ordinary seamen (Figure 2). The messenger line was taken off the warping drum and the eye was thrown off the bollard by the second ordinary seafarer and chief mate. Before the messenger line could be belayed around the bollard for a controlled release of the towline, the

ordinary seafarer lost his hold on the rope stopper.

Figure 2: Simulated photo showing seafarer standing in the open bight

It is likely that earlier successful operations involving tug boats may have been influential in the decisions taken by the crew members; the lead chosen by the mooring crew and the risk of injury to the seafarer standing inside the open bight was either overlooked or not spotted by the chief mate.

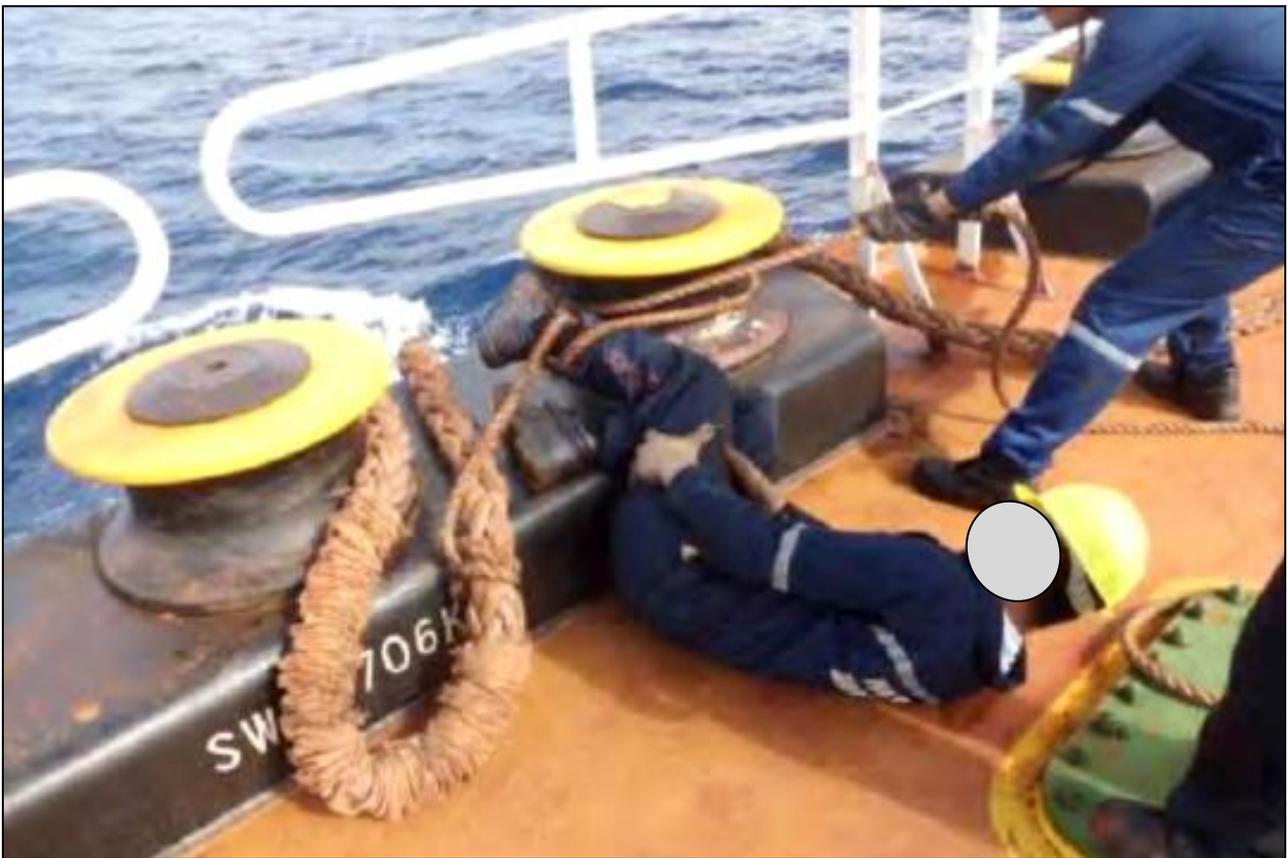
The unrestrained messenger and towline, running free over the ship's side snagged his legs, pulling him along the deck to the roller fairleads (Figure 3). The second seafarer rushed to his aid, firmly gripped the messenger line and signalled the tug to stop heaving.

**Figure 3: Simulated photo showing messenger line wrapped around the seafarer's legs**

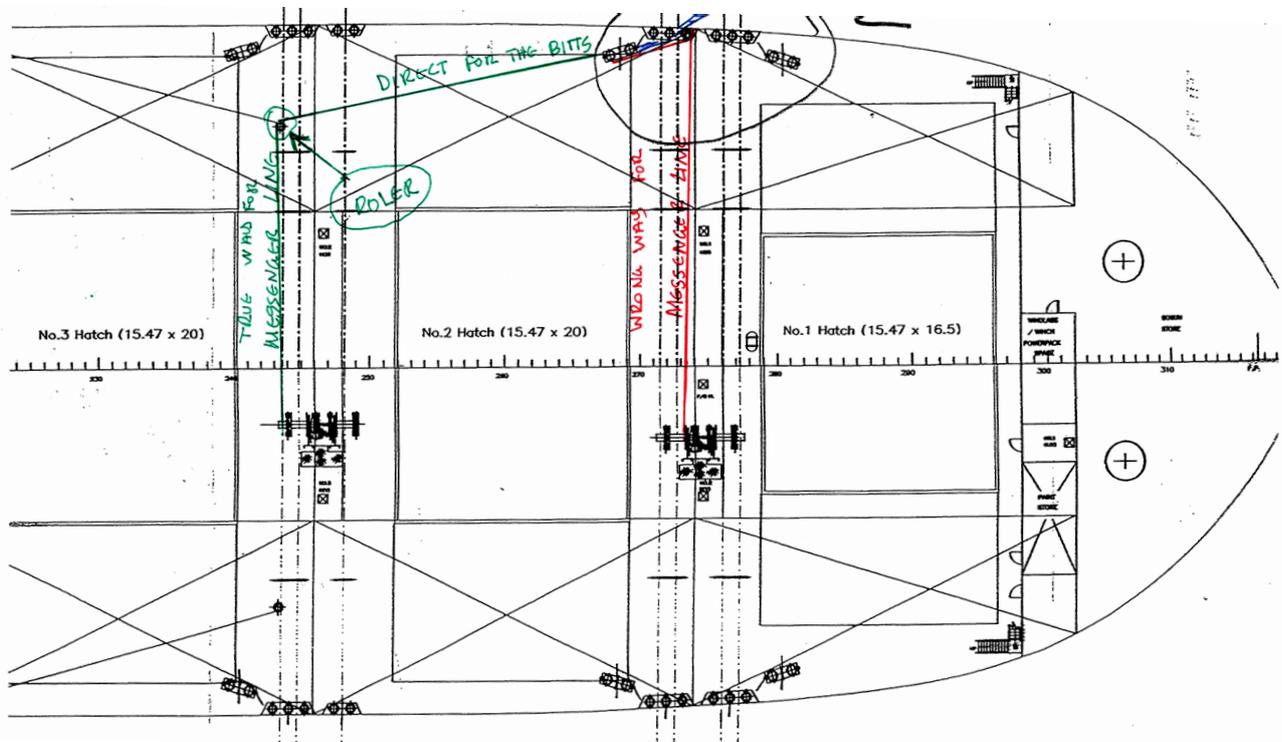
Figure 4: Alternative arrangement of messenger line lead (green line)

Following the accident, an alternative and safer arrangement of messenger line submitted by the vessel is shown in Figure 4.
