SAFETY INVESTIGATION REPORT

REPORT NO.: 12/2019

July 2019

MV ALTENAVI
Fatal fall in the cargo hold
in position 37° 30.4' N 008° 07.2' E
19 July 2018

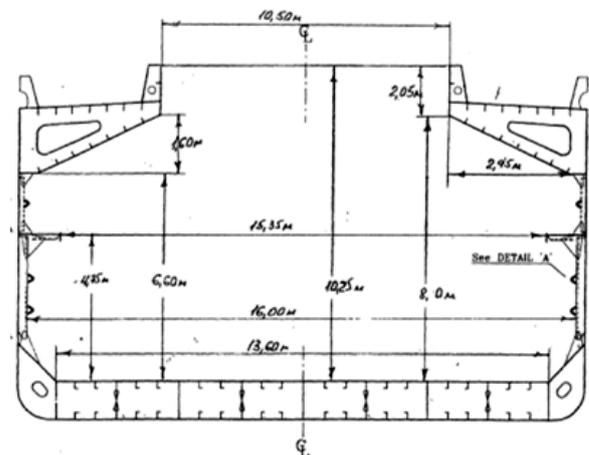
Figure 1: *Altenavi* midship section

The vessel is fitted with three cargo holds, divided into a lower hold and tweendeck. Reportedly, tweendeck pontoons had been removed in the past and since then, they have not been used any longer as the vessel was carrying only general and bulk cargoes. The tweendeck level was 4.05 m below the main deck, while the tank top was 4.75 m below the tweendeck (Figure 1).

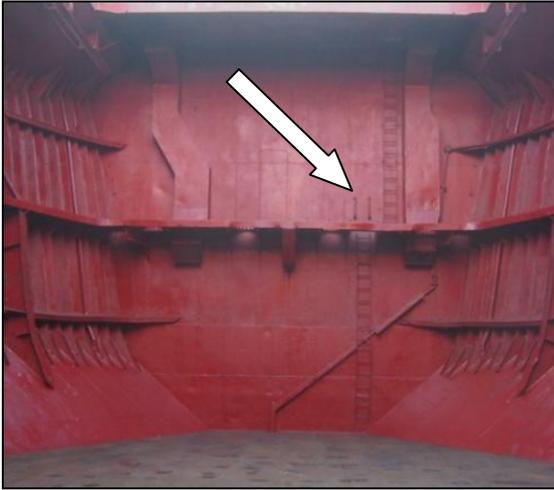
Figure 2: Forward bulkhead and access ladders

Access ladders were split in two sections, with the uppermost section terminating at the tweendeck level (Figure 2).

During the visit on board, following the accident, it was noticed that the vertical ladder to the tweendeck was only half a metre away from the second ladder leading to the lower spaces of the cargo hold. Thus, it was hypothesized that had the lights been positioned as described by the bosun, then Seafarer A would have only stepped on tweendeck platform to hold to the second ladder leading to the cargo hold tank top.

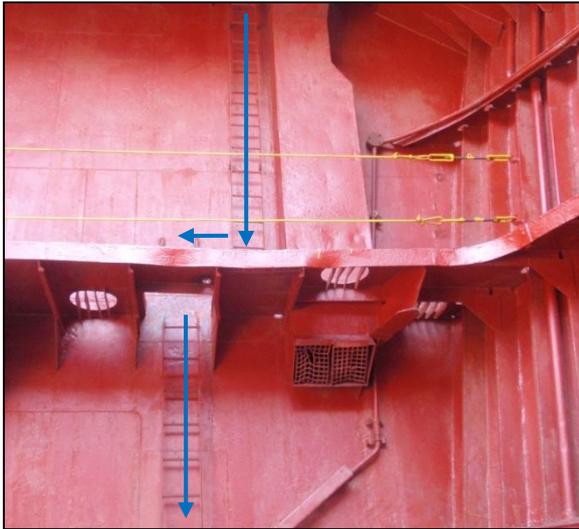
Seafarer B recalled that after reaching the tween deck level, Seafarer A walked out of his direct line of sight, presumably to proceed down to the cargo tank top (Figure 3).

Figure 3: The way towards the lower cargo hold (yellow wire rope was fitted after the accident)

Although the sequence of events as recalled by the two crew members are not similar, it was plausible to conclude that in all probability, Seafarer A had entered cargo hold no. 1 in order to arrange the illumination of the working site and before proceeding to the tank top, he fell from the tweendeck to the tank top in the cargo hold.

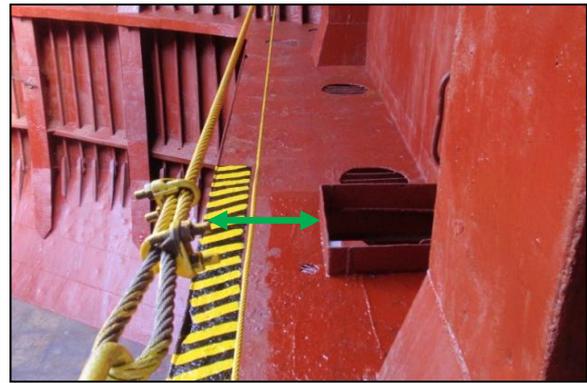
It was also noticed that had Seafarer A proceeded immediately to the ladder leading to the tanktop in the cargo hold, Seafarer B would not have lost sight of him. This was therefore indicative that Seafarer A was engaged in doing something else whilst standing on the narrow tweendeck platform (Figure 4) (e.g., arranging the lights).

Figure 4: Narrow tweendeck platform in cargo hold no. 1 (post accident photo showing the wire rope)

It would also appear that these were very critical systems in cargo hold no. 1 (where the accident happened), given that in comparison to the tween deck width in cargo hold no. 2 (Figure 5), the former was much narrower.

Following the accident, two wire ropes were fitted throughout the entire run of the tween deck. Moreover, high-visibility markings were also painted in close proximity of the access ladders. These physical and symbolic safety barrier systems, however, were missing at the time of the accident.

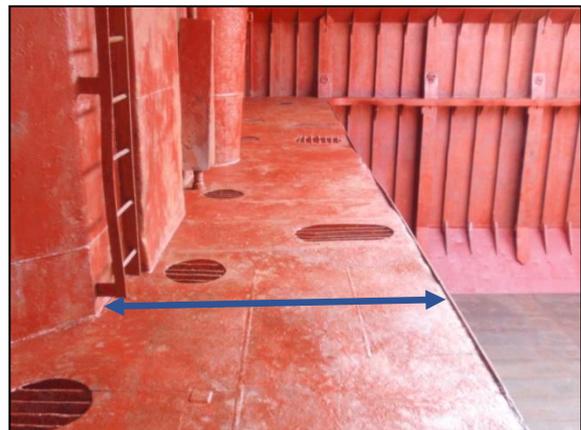
Figure 5: A much wider forward tweendeck platform inside cargo hold no. 2 (although the absence of physical and symbolic barrier systems are apparent)

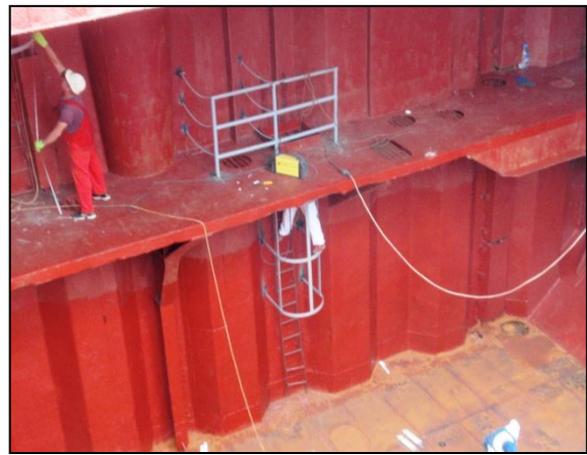
Figure 5: Physical barrier systems fitted after the accident

A fixed safety line system (to attach the lanyard with a safety harness) was fitted at the location of the accident. Hi-visibility yellow/black markings were painted on the tweendeck platform (Figure 5).

Railings and cages around access ladders were installed on the tweendeck platforms.
