## SAFETY INVESTIGATION REPORT

REPORT NO.: 19/2019

October 2019

### **MV *BALGARKA*** **Crew members' fatality and serious injuries** **during repairs in a shipyard** **28 October 2018**

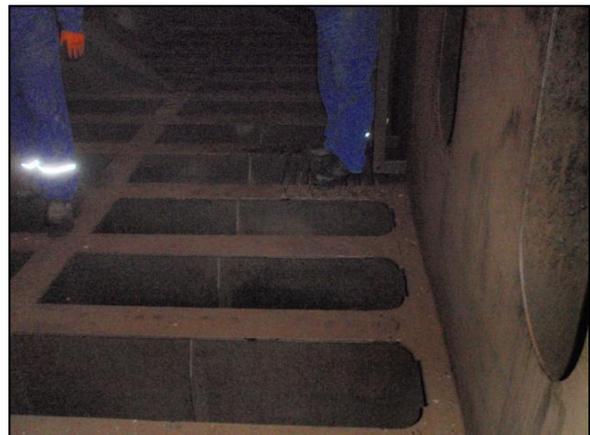
Figure 3: Platform no. 5 with deep wells

While platform nos. 1 to 4 were fully configured platforms with access and drain openings (Figure 2), the bottom most platform no. 5 (where the accident happened) was structured differently, with deep longitudinal girders and face plates of the bottom longitudinal stringer (Figure 3).

The depth of the bottom longitudinal girders was about 1.9 m, and the face plates were about 0.25 m wide, providing just enough stepping space.

Oxygen is denser than air and therefore any leaked gas would have possibly sunk into the lower spaces, similar to the ones below platform no. 5.

Although the exact source of oxygen could not be identified by the safety investigation, the possibility of a leakage in the oxygen pipe connected to the torch, causing an increase in oxygen concentration inside the space at platform no. 5 was initially not excluded, although the same school of thought would have applied for the possible leakage of acetylene, applies in this instance as well. However, at a very late stage during the safety investigation process, the MSIU was informed that laboratory tests on the gas cutter and the hoses revealed no damages/defects.

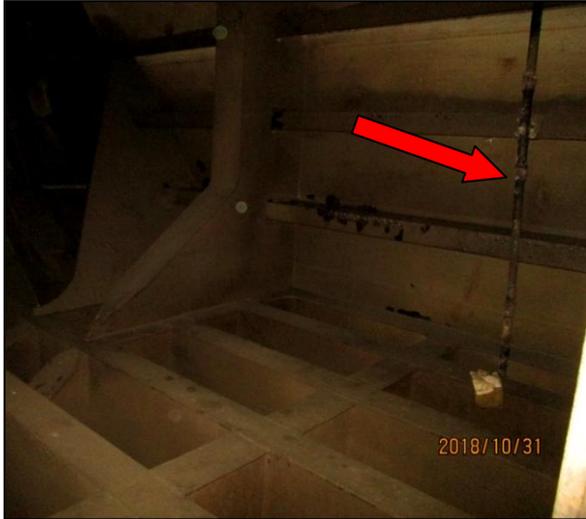
**Figure 4: Valve spindle inside the forepeak tank**

spindle passing the whole height of the tank, split in sections by cardan joints and supported at several locations through the platforms. The valve spindle (Figure 4) was located about 1.5 m from the access ladder.

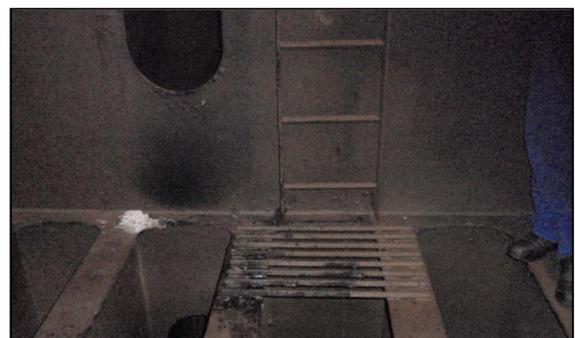
**Figure 5: Vertical ladder on platform no. 5**

Soon after, both fitters’ clothes were on fire; while fitter 2 managed to reach the ladder and climb up to the upper platform (Figure 5), fitter 1 did not manage and remained trapped inside the bilges of the forepeak tank (Figure 6).

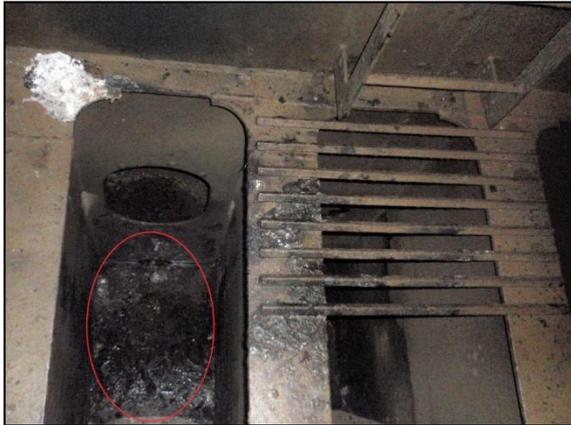
**Figure 6: Bilges inside the forepeak tank**

There were no structural damages reported as a result of the fire inside the forepeak tank. However, smoke damage was visible, especially inside the space bilges. In view of the missing physical evidence, the MSIU was unable to determine whether any of the equipment used by the fitters had been damaged.
