## SIMPLIFIED SAFETY INVESTIGATION REPORT

REPORT NO.: 23/2017

November 2017

## MV CATHERINE Serious injury to crew member In the port of Leixos, Portugal 05 November 2016

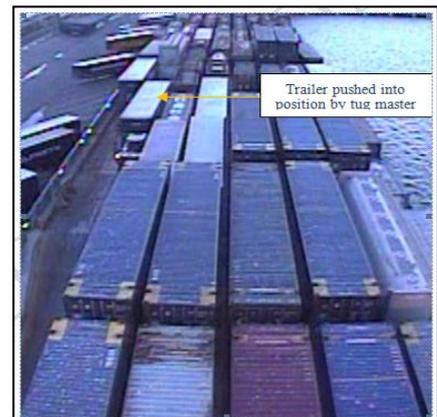
Sunset was at 1825 and the deck lights were switched on. By around 1800, only a few ro-ro units were left for loading (Figure 1). The ro-ro units were marshalled in by a port stevedore, driving a tug master. No other stevedores were engaged to undertake the loading operation.

Figure 1: Loading of trailers on weather deck

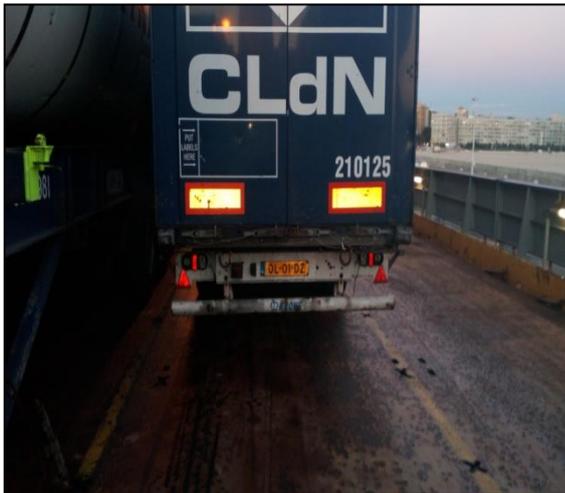
At about 1821, one of the trailers (Figure 2) was hauled up the weather deck at the rear of MAFI<sup>1</sup> roll-trailer.

**Figure 2: Photo of trailer involved in the accident**

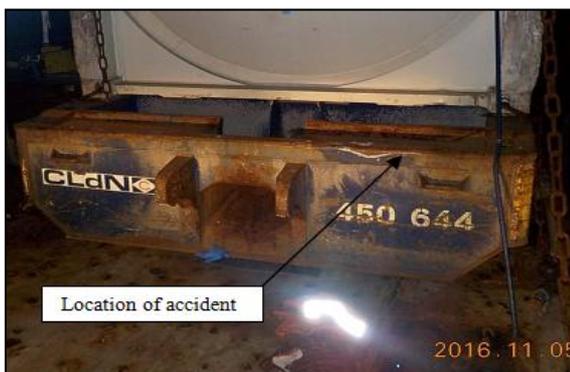
Meanwhile, the first AB walked behind the trailer to lash roll-trailer. Evidence available indicates that the driver reversed the tug master, entrapping the AB between the trailer and the MAFI (Figure 3).

**Figure 3: The MAFI roll-trailer and approximate position of accident**

The direct cause of the injuries was the AB becoming entrapped between two cargo units during the cargo loading operation.
