## SAFETY INVESTIGATION REPORT

REPORT NO.: 01/2019

### *MV DORIS* Collision with fishing vessel *ZHE XIANG YU 24005* in position 29° 28' N 123° 13' E (East China Sea) 13 January 2018

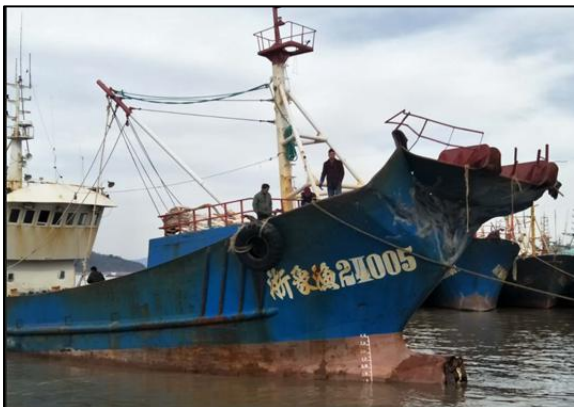
**Figure 3: Fishing vessel *Zhe Xiang Yu 24005* in Shipu after the collision**

- the stem, bulbous bow and forecastle deck structures were heavily deformed;
- the fore peak tank was deformed and the bow thruster damaged; and
- four batteries were damaged, and two anchors and anchor chain were lost.

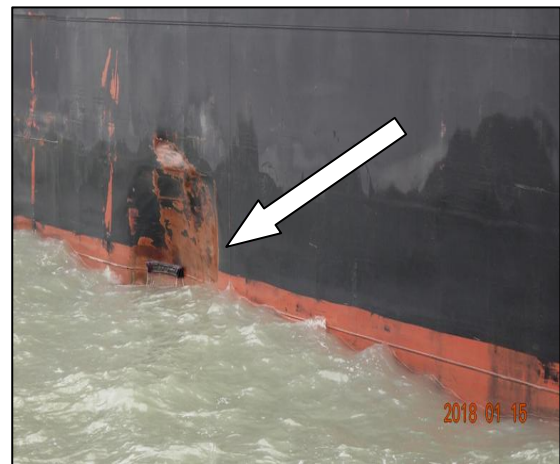
Figure 4: Fractured section of the hull plugged by the crew

At 0126, *Doris* dropped anchor in position 29° 28.3' N 123° 14.4' E. The crew carried out a visual inspection of the cargo hold and engine-room. A small fracture in the hull close to the waterline in way of frames 46 to 49 was plugged (Figure 4) and the water in the bilges of cargo hold no. 5 was pumped out. On 14 January 2018, the master was instructed by the Chinese Maritime Safety Agency to proceed to Ningbo, China.

- a breach in the hull measuring 60 cm x 1cm at 9.80 m above keel starboard side between frame 47 and frame 50;

- indentation of shell plate between frame 50 and frame 52 in way of top side water ballast tank; and
- broken handrail, air vent and accommodation ladder.

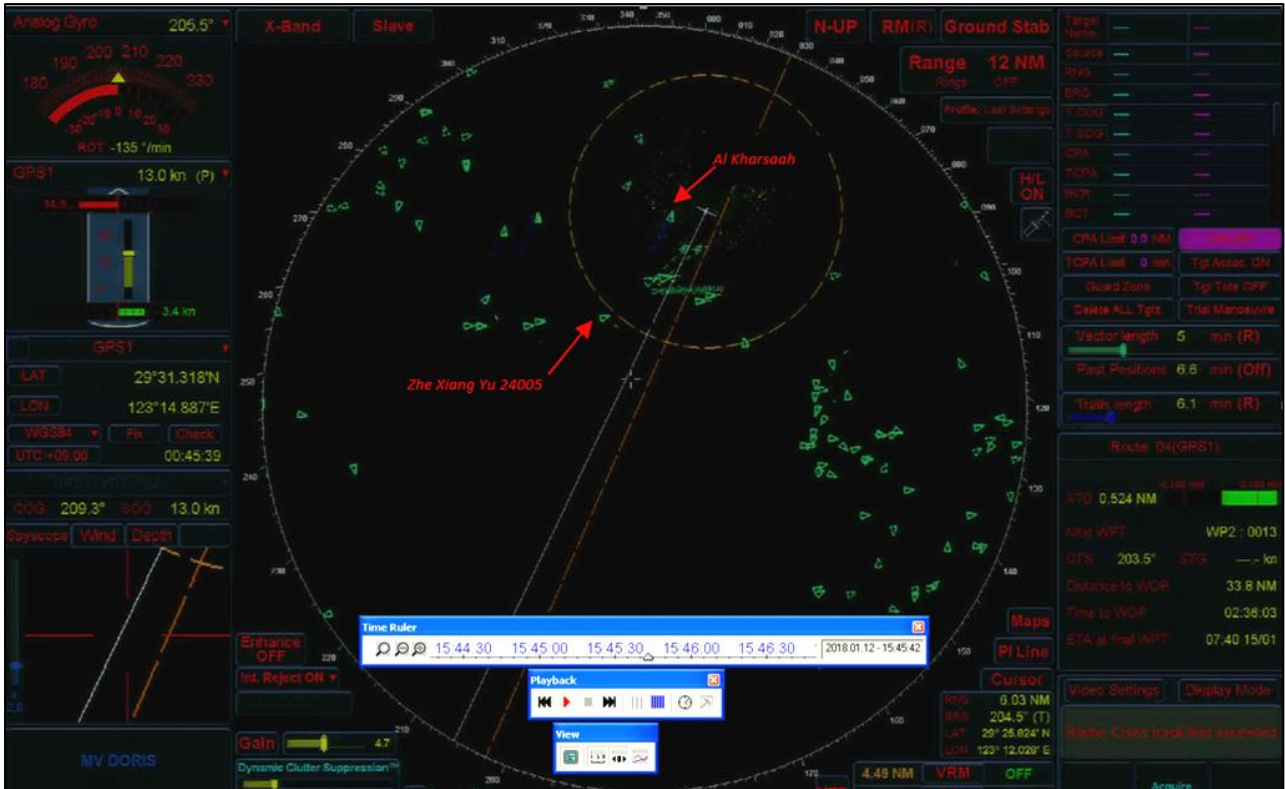
Figure 5: Screen shot at 0045 showing Al Kharsaah and Zhe Xiang Yu 24005

Except for *Al Kharsaah* which was at anchor, a number of fishing vessels in the immediate vicinity of *Doris* were underway and crossing from starboard to port. This necessitated small but frequent adjustment of course to starboard. At around 0045, *Zhe Xiang Yu 24005* was estimated to be 2 points on the starboard bow, at a distance of 4.6 nm (Figure 5) and heading East at 7.5 knots.

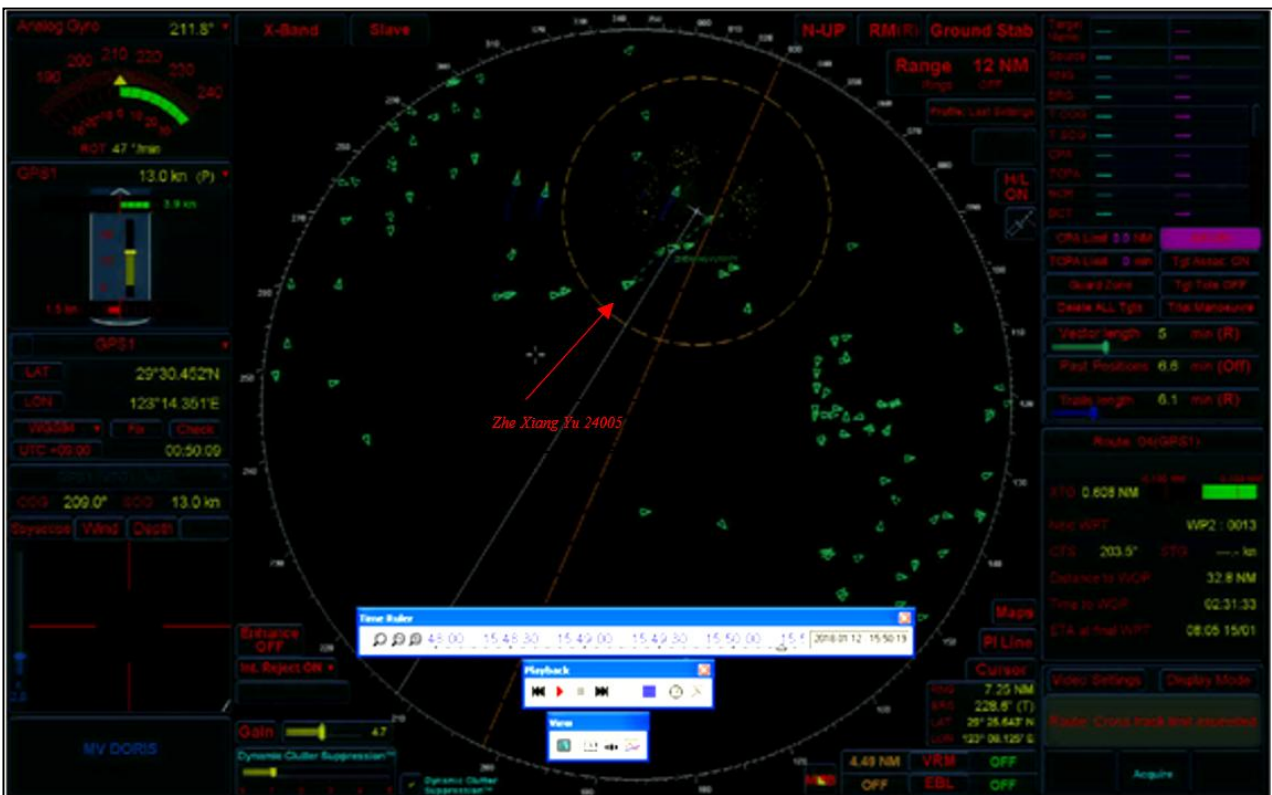
Figure 6: Screen shot at 0050 - approximate range to Zhe Xiang Yu 24005 is 3.0 nm

the OOW on board *Doris* ascertained that both vessels were on a collision course (Figure 6).

Based on visual observations and no change in the relative vector of *Zhe Xiang Yu 24005*,

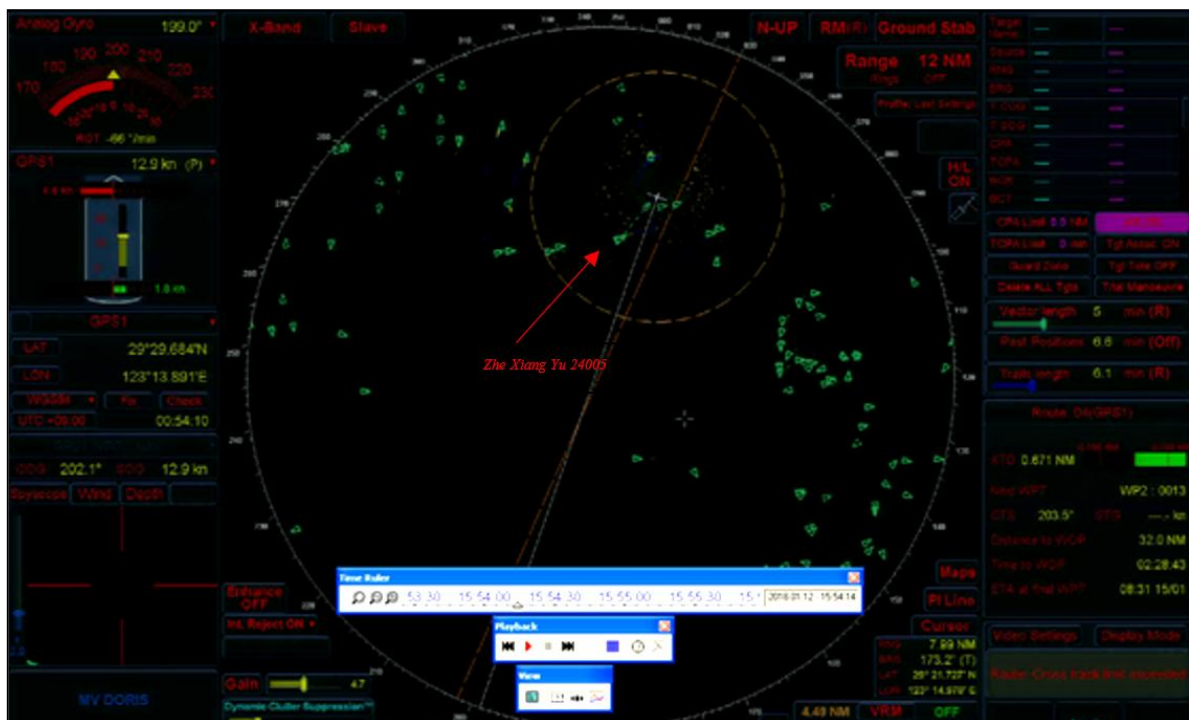
Figure 7: Screen shot at 0054. - approximate range to *Zhe Xiang Yu 24005* is 1.5 nm

Contradictory to what the OOW had stated, the navigational data captured from the VDR indicated that at 0054, the vessel's course was initially altered to starboard (Table 1). When the heading had reached 220°, he abruptly altered course to port, before steadying the vessel on a course of around 200° (Figure 7), which a few minutes later resulted in a close quarter situation. The safety investigation noted no traffic on the starboard side of the vessel and could not

establish why the OOW changed his decision to alter course to port.

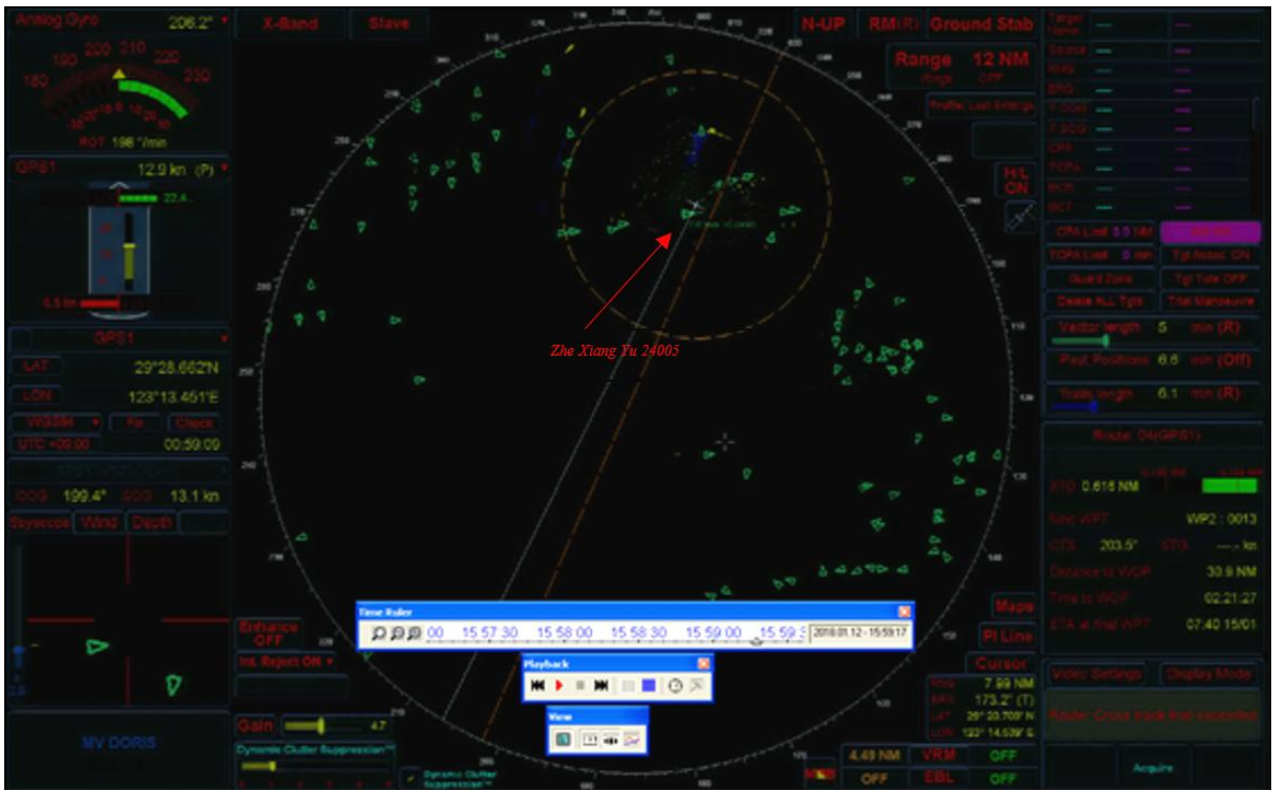
Figure 8: Screen shot at 0059 showing *Zhe Xiang Yu 24005* close ahead of *Doris*

At about 0058 (Figure 8), when collision seemed imminent, the OOW ordered the helm hard to port and at the same time sounding the ship's whistle to attract the attention of *Zhe Xiang Yu 24005*.

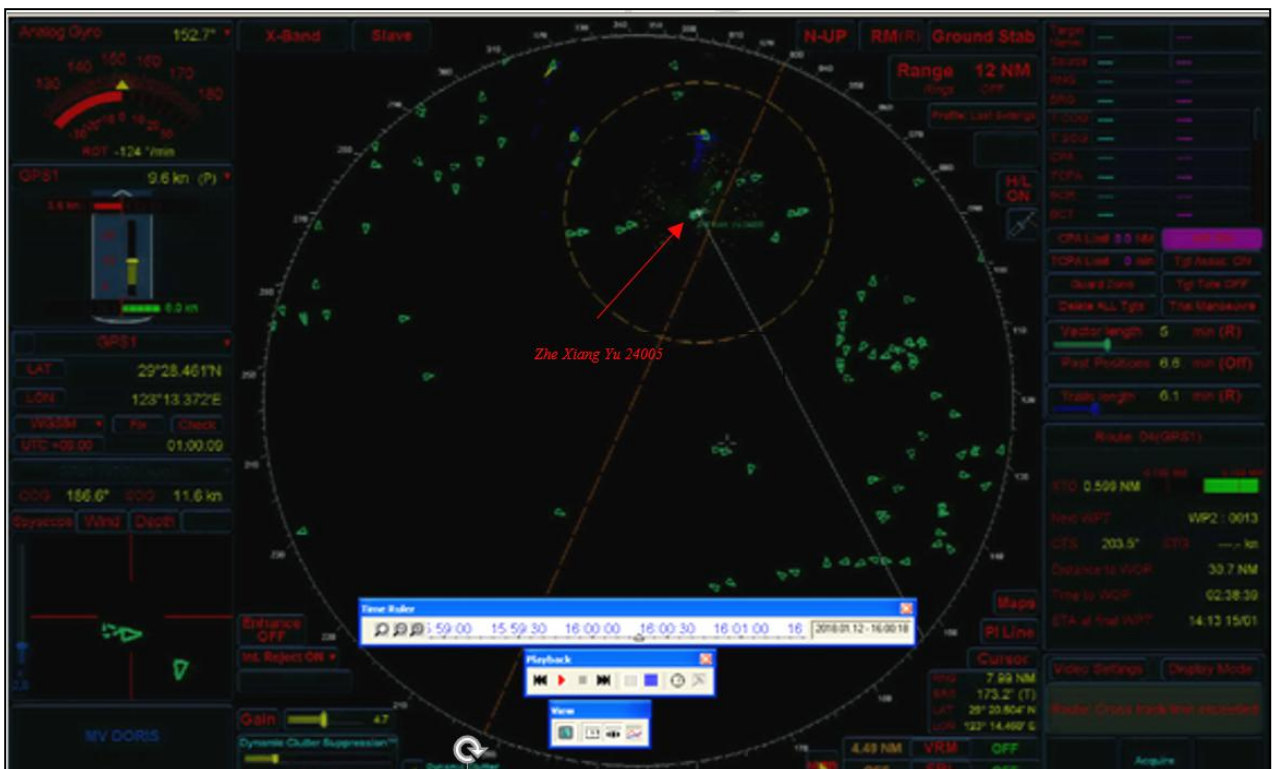
Figure 9: Screen shot showing collision at 0100/9s

Meanwhile, the deck-hand on *Zhe Xiang Yu 24005* was aware of the developing situation. Anticipating *Doris* to keep out of the way, he maintained his course and speed. He neither called the skipper, who was asleep on the bridge, nor sounded any warning signal (five short and rapid blasts<sup>7</sup>) on the whistle to indicate doubt as to whether sufficient action was being taken by *Doris*.

It was only when *Doris* was very close that he stopped the main engine. However, this action was too late to be effective and avert the collision (Figure 9).
