SAFETY INVESTIGATION REPORT

REPORT NO.: 13/2018

MV FREYJA

Grounding while on passage from Florø to Svelgen, Norway

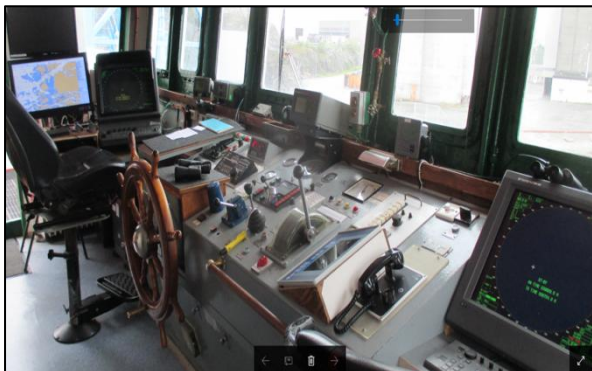
Figure 2: Layout of navigational equipment

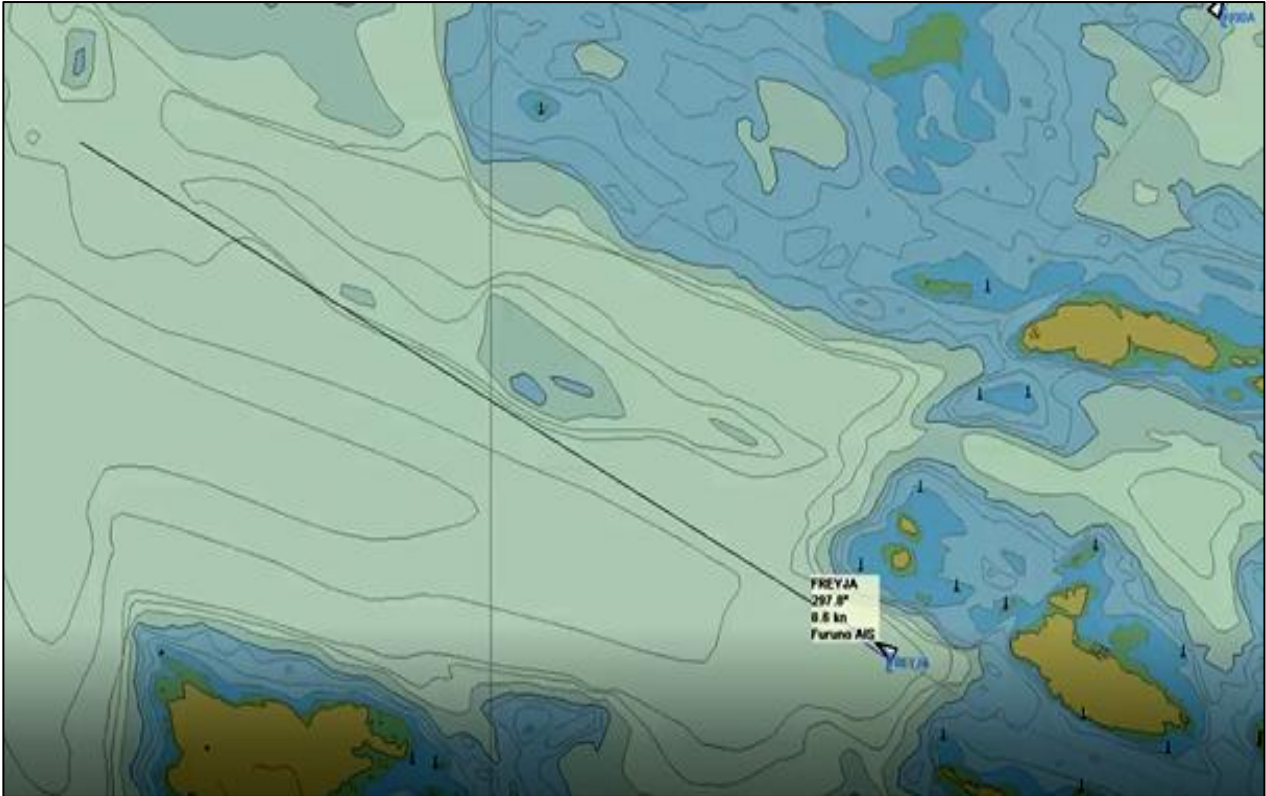
At about 1250, the second mate arrived on the bridge and made his way to the chartroom to write the logbook. At the time, the master had the con. Approximately one minute later, *Freyja*, was in the open water segment of the voyage, approaching waypoint no. 3. The next course to steer was 316° (Figure 3 and 4).

Figure 3: Image from ECDIS replay showing position of *Freyja* at 1251

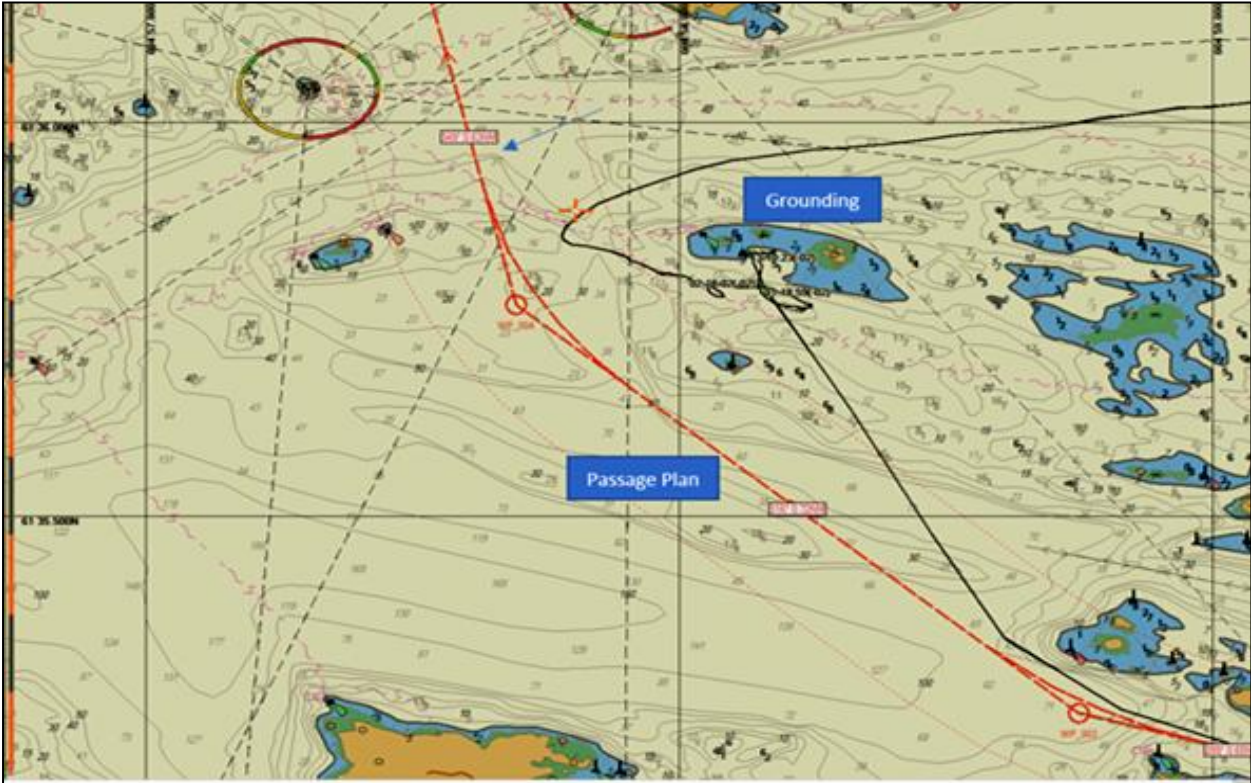
At 1255/20s, *Freyja* ran aground in position 61° 35.83' N 004° 58.13' E (Figure 4).

Figure 4: Image from ECDIS display showing passage plan (in red), vessel track and position of grounding (in black)

Moreover, it seemed that the autopilot gyro setting had neither been adjusted nor aligned with the planned course. The vessel turned to starboard, settled on a gyro heading of 336° and headed towards the rocks. The ECDIS display and radar were centred around the helm console position and there was no clear explanation as to why the master could not monitor the vessel’s GPS position, use line of position, parallel indexing or clearing range to define the vessel’s safe passage.
