SAFETY INVESTIGATION REPORT

REPORT NO.: 15/2021

MV *IOLCOS UNITY*

Fatal injury to a crew member in Aratu, Brazil 28 June 2020

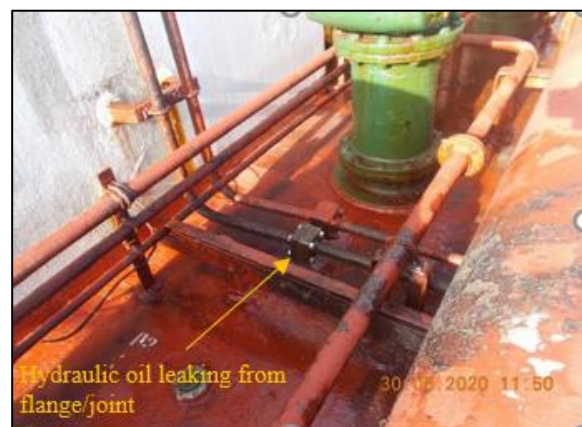
At about 0245, hydraulic oil was noticed leaking from a flange fitted on the hydraulic line, which operated the ballast line valves (Figure 2).

Figure 2: Photo showing location of the flange (photo taken after the repairs had been completed).

The flange was fitted on the main deck starboard side between cargo holds nos. 5 and 6. The chief officer immediately stopped the ballast operations, closed the valve, and depressurised the hydraulic line. Along with the bosun, several crew members mopped up the oil and removed it to the forecandle store.

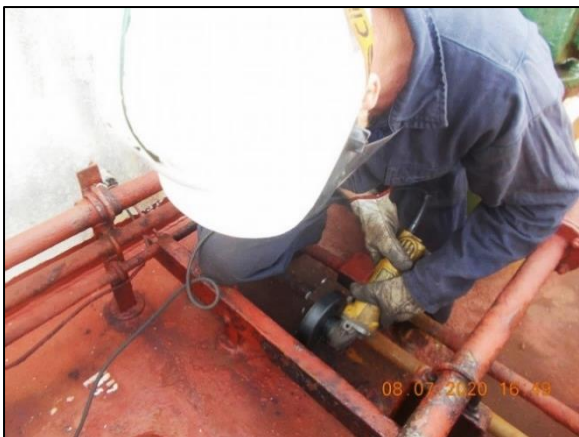
The available information suggested that the position of the repair site necessitated the crew member doing the repairs to kneel to access the flange (Figure 3).

Figure 3: Simulated photo showing crew operating portable angle grinder on leaking flange.

In that position, the fitter's overall would have been permeated with hydraulic oil, collected under the leaking pipe. The fitter struggled to release the nuts and bolts and therefore resorted to use the portable angle grinder. The site was deemed hazard free

The metal sparks generated by the angle grinder ignited the fitter's overall, and the oil-contaminated synthetic fabric rapidly increased the burning rate⁴. While the physical and chemical hazards of burnt hydraulic oil on burn injuries could not be precisely known, its probability of causing

15/2021_R1 Amend SMS procedures on the use of portable angle grinders, and include portable angle grinding as a hot work activity.
