SAFETY INVESTIGATION REPORT

REPORT NO.: 09/2020

MV KLARA

Collision with Singapore registered general cargo / container ship POSIDANA and the Belgian tug BRAAKMAN in position 51° 16.875' N 003° 15.342' E

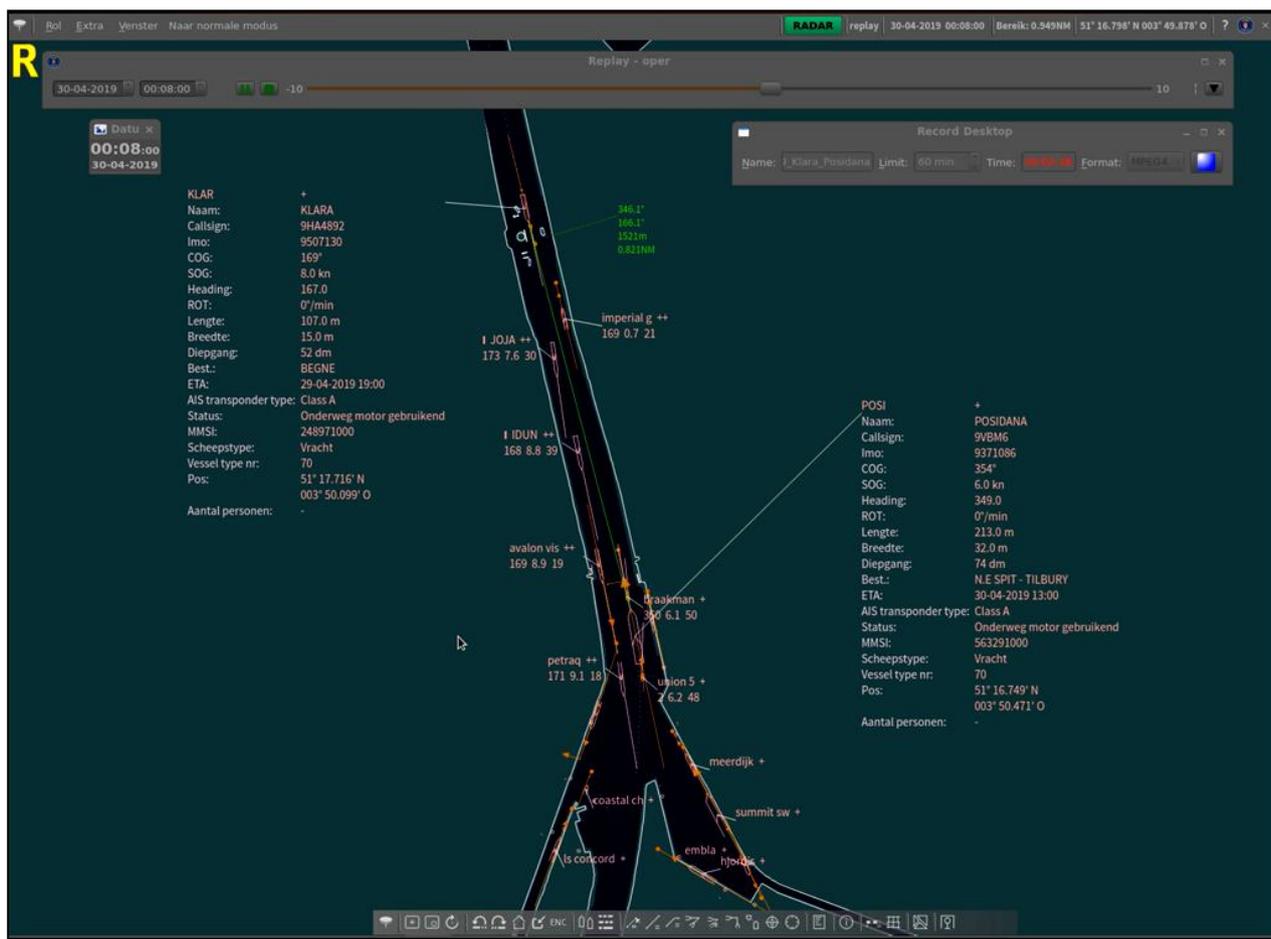
Figure 4: VTS image showing traffic situation at 0008

Posidana was under propulsion, with tug *Braakman* made fast, assisting on the bow. Tug *Union 5* was fast aft. *Posidana* was slightly to the starboard side in the straight section of the Canal, steering 349° and making 6.1 knots (Figure 4). She was exhibiting three all-round red lights, indicating that her draft of 7.40 m in relation to the available depth of water in the Canal. She was constrained by her draft and severely restricted in her ability to deviate from her

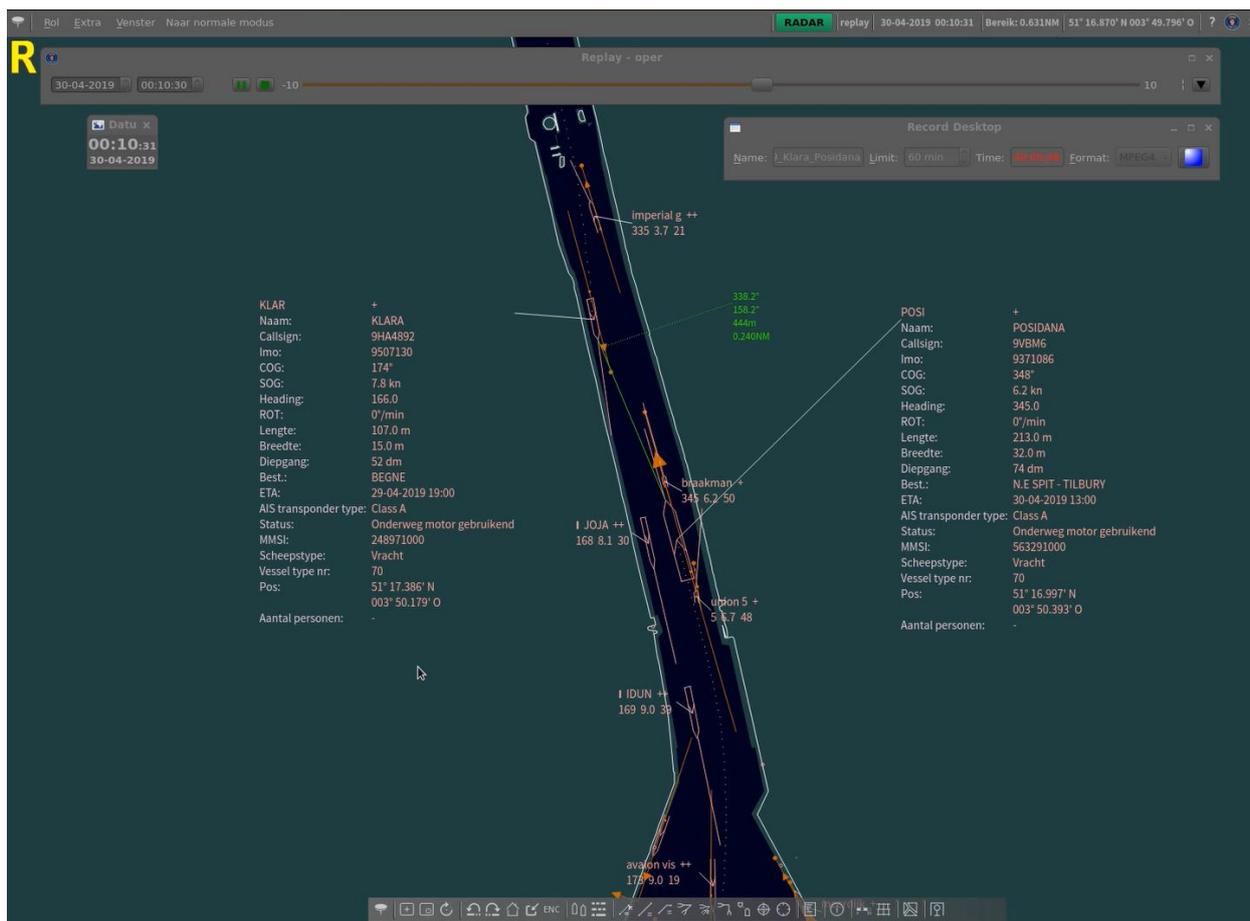
Figure 5: VTS image showing traffic situation at 0010/30s

On reaching Height Marker 9.4 Kilometre, and with *Posidana's* bow around 450 m away, *Klara* started to turn quickly to port. The helm was put hard over to starboard and the engine telegraph briefly set back to

Notwithstanding these actions, the vessel continued swinging rapidly to port; the main engine was then put to full ahead and the bow thruster to starboard to restraint the rate of turn of the vessel.

In less than a minute, however, *Klara* veered to around 30° from her original heading. The pilot on *Klara* advised *Posidana* and set *Klara's* telegraph to full astern to break the ahead movement, whilst *Posidana's* pilot immediately directed the aft tug to go full astern and the ship's engine dead slow, stop, and slow astern. Meanwhile, tug *Braakman's* master, observing *Klara* still swinging to port, immediately released the towing gear and put the engines full astern to avert the collision.

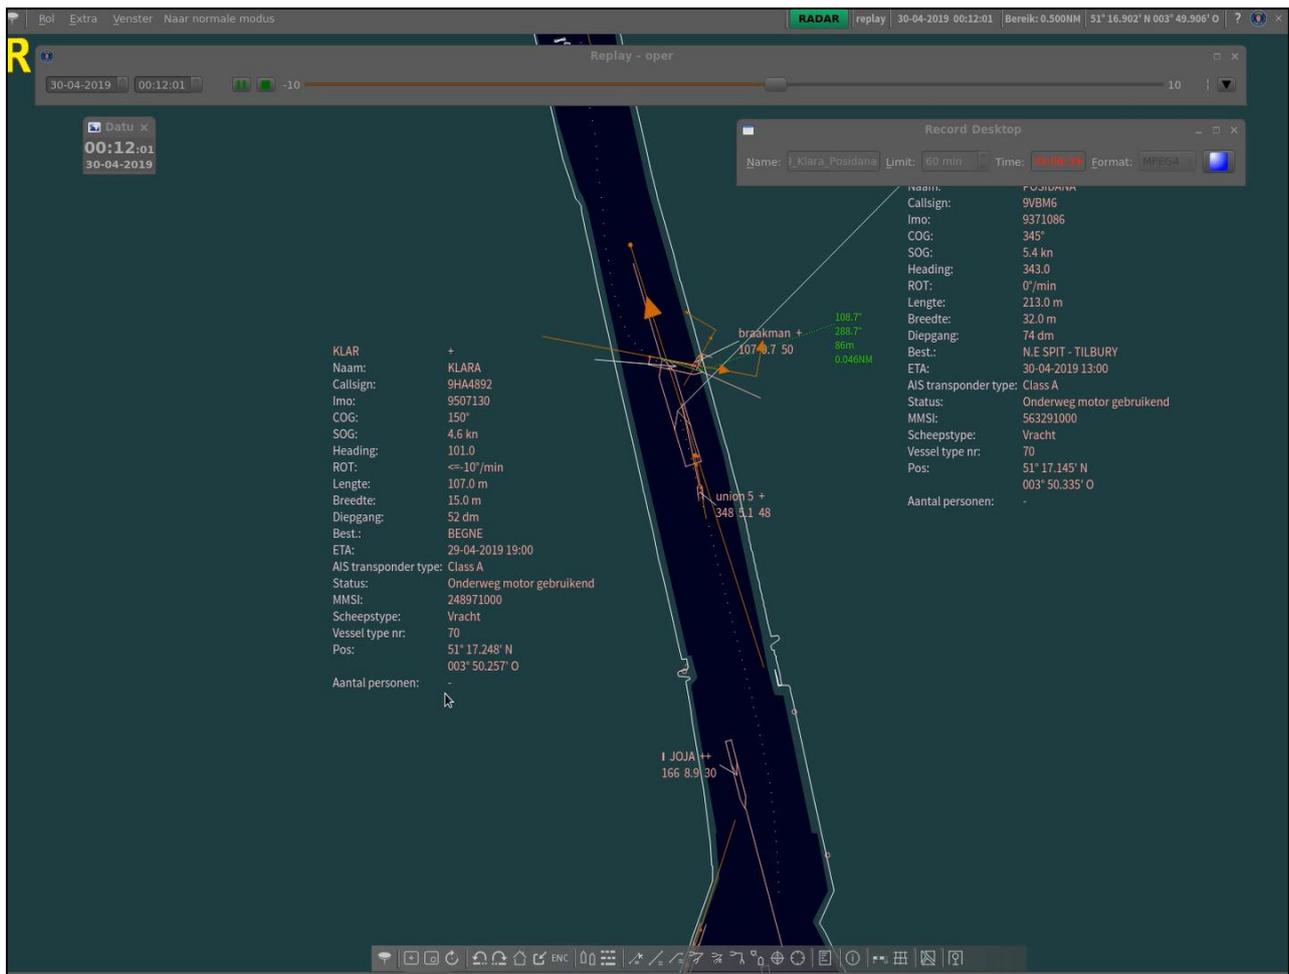
Figure 6: VTS image showing collision between *Klara* and *Posidana*

At 0011/30s on 30 April 2019, *Klara* collided into tug *Braakman* and pushed her against the opposite bank, sustaining serious damages. Thereafter, *Klara* ended up almost across the bow of the container ship. About 30 seconds later, *Posidana's* stem struck *Klara* on her starboard midsection between frames 56 and 74 (Figure 6). The collision occurred in the Dutch sector of the Ghent-Terneuzen Canal in position 51° 16.875' N 003° 15.342' E (Height Marker 9.1 Kilometre).

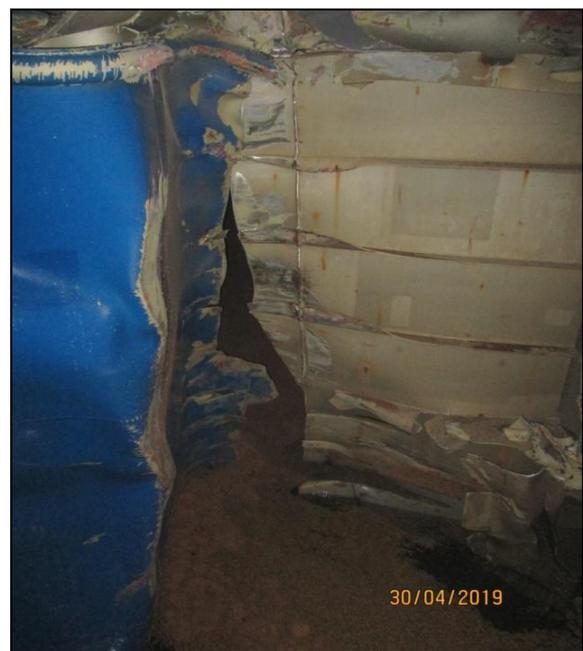
Figure 7: Structural damages in way of the cargo hold

As a result of the collision, *Klara* sustained severe damages to the main deck structure and fittings, and her hull between frames 56 and 74 (Figure 7). Cargo hold no. 2 was breached with reported water ingress. Part cargo of linseed spilled into the sea (Figure 8).

After carrying out temporary repairs and discharge of cargo, *Klara* proceeded to a shipyard for a detailed structural damage survey. On 14 May 2019, RINA recorded damages to the starboard side shell plating, starboard longitudinal bulkhead and transverse bulkheads, inner bottom, main deck stringer plate, hatch covers and hatch coamings starboard side and partly port side.

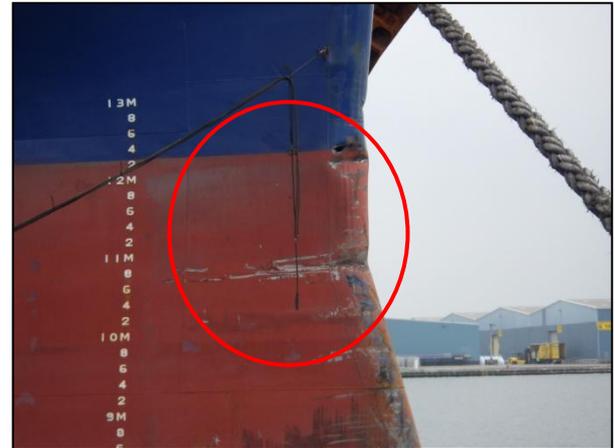
Figure 9: Shell plate damage on *Posidana*'s stem

Posidana had contact damage above the waterline. The Class surveyor reported damages in the forepeak tank (stem area), deformed shell plating and damages to the centre girder at the stem. Other shell plating damage was observed at the stem, towards the port side (Figure 9). There was also perforation of the shell plating in two locations on the stem.

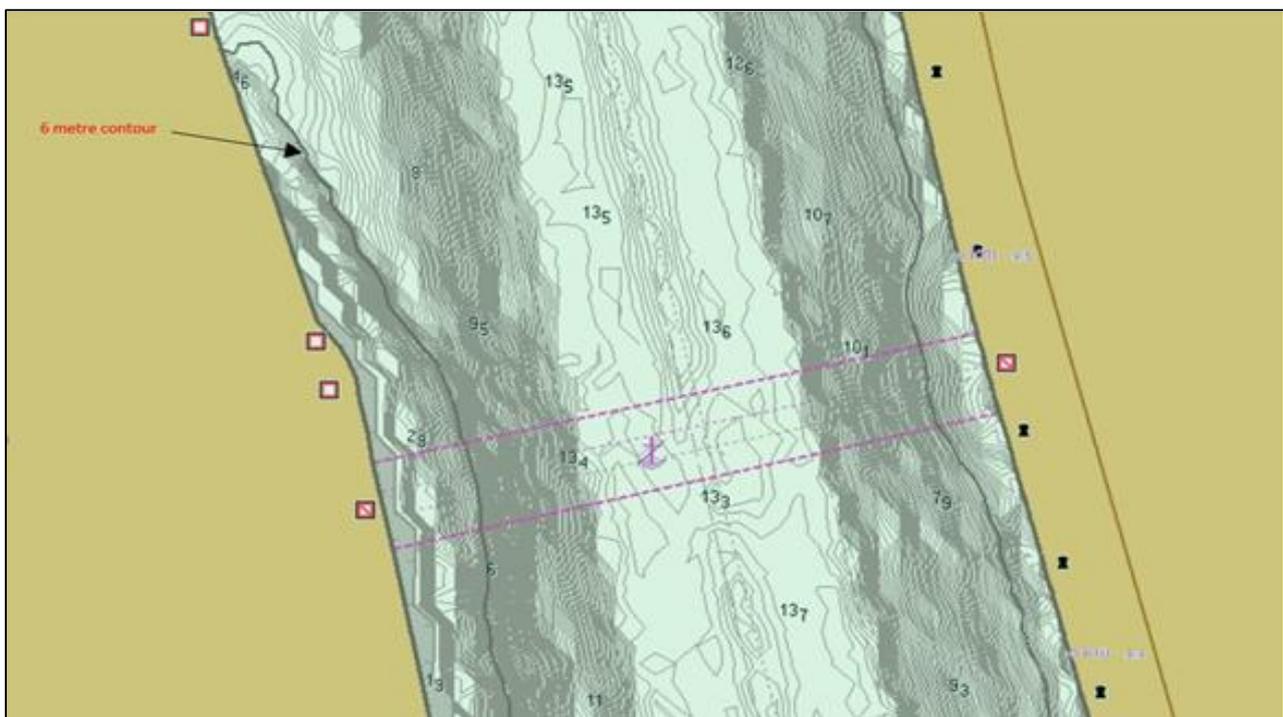
Figure 10: Bathymetric chart showing six metre contour and sharp elevation of the Canalbed

On the West side of the Canal, the charts documented a sharp fall of water depths, suggesting heavy sedimentary deposits. Another sharp elevation of the Canalbed was noted from the six-metre contour, up to the shores of the bank. The six-metre contour set-off near Height Marker 9.6 Kilometre and spreads out to about 25m (Figure 10) into the Canal and stretches along the Canal beyond Height Marker 9.1 Kilometre.

The contours and sediment deposits had an effect on the hydrodynamic interactions of the vessel, which will be explained in more detail in the following sub-section.

The hydrodynamic forces intensified and the bow took a violent sheer to the port and across path of the approaching vessels. Given the ship's speed, propeller action and asymmetrical water flow around the vessel, it was very likely that the stern pulled towards the bank and amplified the rotational speed of the sheer to port.
