SAFETY INVESTIGATION REPORT

REPORT NO.: 15/2020

July 2020

MV KLIMA
Allision with the Marshall Islands
bulk carrier *SPRING SNOW* and the
Singapore registered bunker barge *LIBRA*
in the Eastern Special Purpose Anchorage,
Singapore
05 July 2019

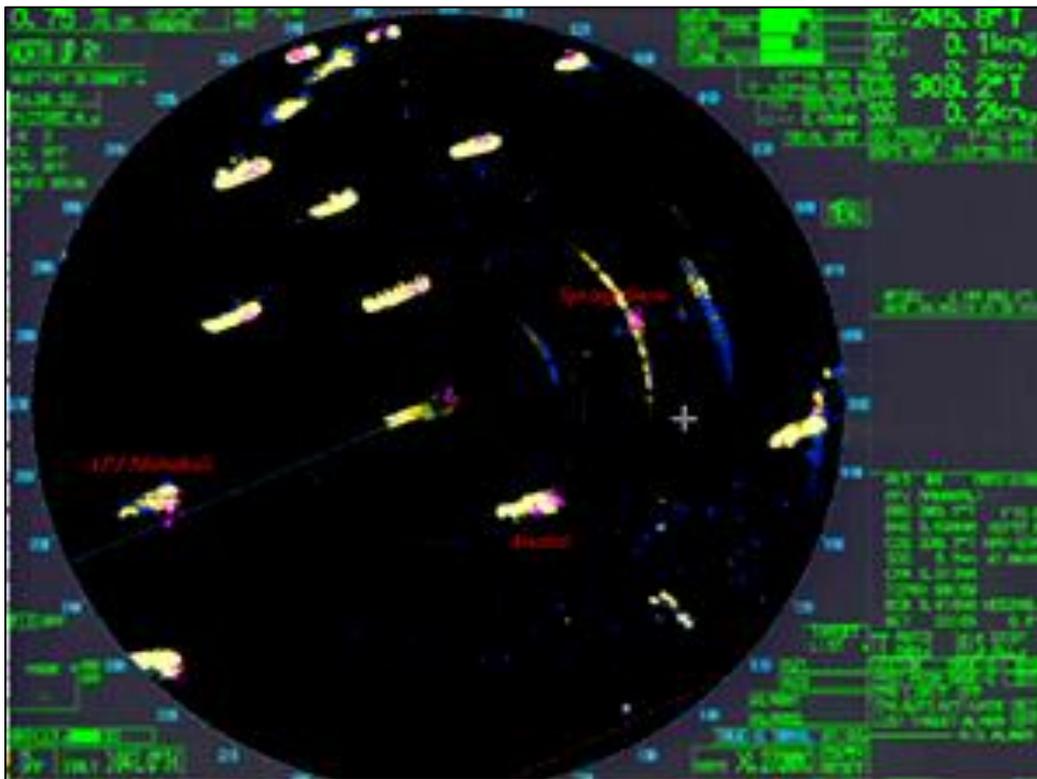
Evidence showed that the master observed the vessel's position on the radar and ECDIS upon being called to the bridge. At that moment, *Klima* was about two cables from *Anatoli* (Figure 5). As noted above, there was no immediate danger although yaw and sporadic rotational motion may have brought her unacceptably close to *Anatoli*.

Figure 5: Image from X-band radar (Scale 0.75 nm) showing *Klima*'s position at 0520

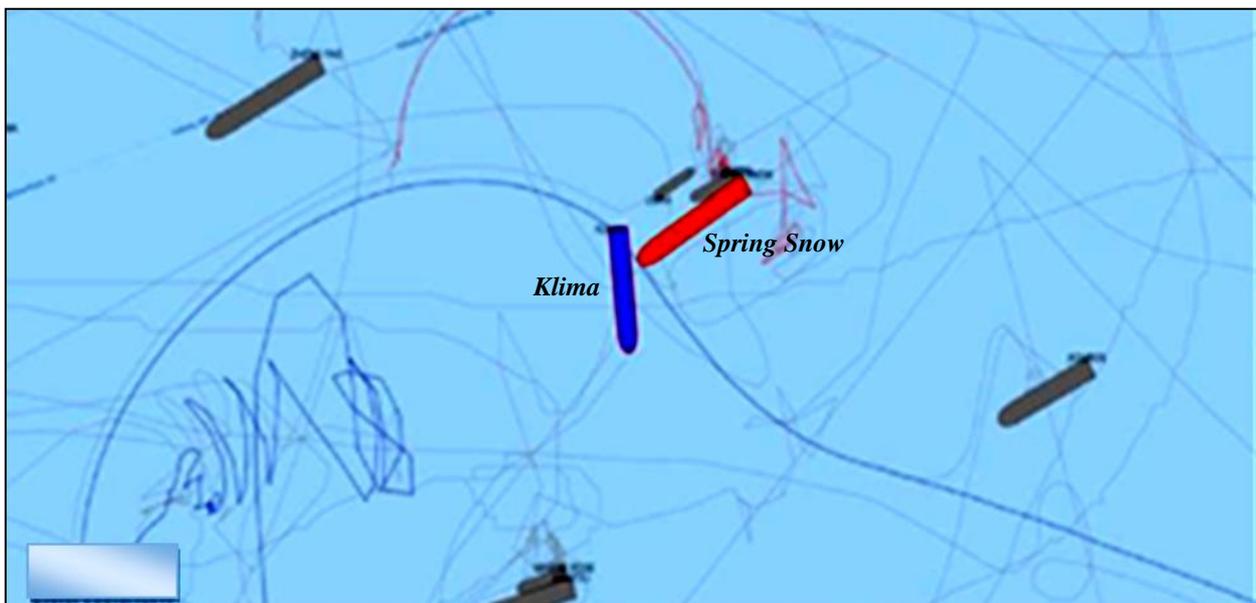
Thus, the perceived and actual situations were not aligned, leading to the collision. In particular, the course of *Klima's* movement to secure a suitable anchor position, proximity of anchored vessels, impact of tidal stream on manoeuvrability and the limited options available to the master to counter the vessel's drift towards *Spring Snow* (Figure 6) had contributed to the complexity of the already evolving situation.

Figure 6: AIS showing *Klima's* track and collision with *Spring Snow*
