## SAFETY INVESTIGATION REPORT

REPORT NO.: 23/2020

### **MV LA SOLOGNAIS** **Serious injury to a crew member** **in the grey water tank** **in position 07° 43.5' N 076° 08.0' E,** **26 December 2019**

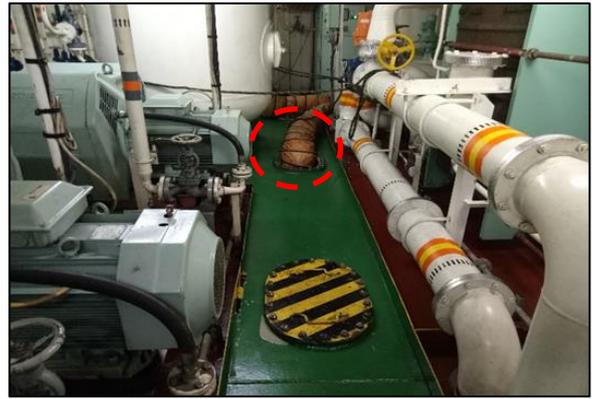
At around 0800, the manhole of the grey water tank was opened, and ventilation was commenced via a portable blower and duct (Figures 4 and 5).

**Figure 4: Access manhole of the grey water tank with the ventilation duct in place**

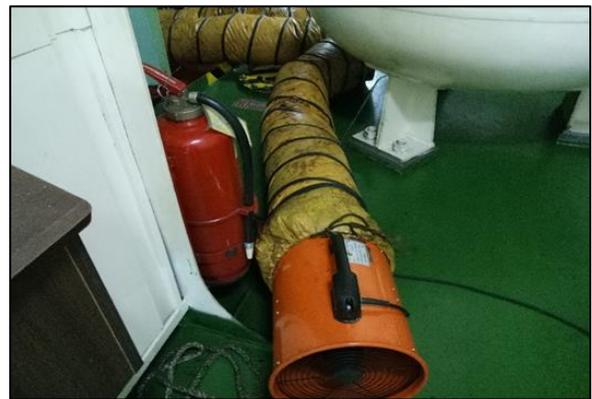
**Figure 5: Portable blower used for ventilation**

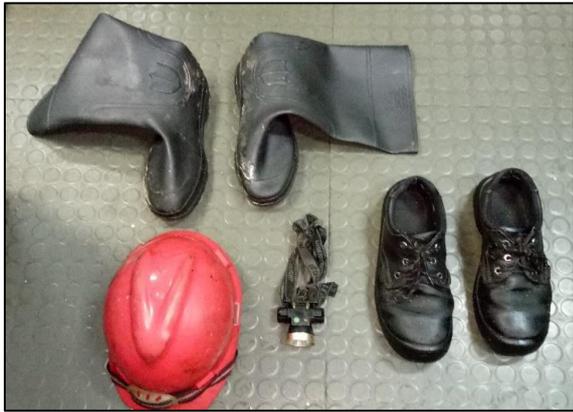
**Figure 6: PPE worn by the injured wiper (the safety shoes were worn while he was outside the tank)**

Considering the injury on the wiper's forehead, the safety investigation concluded that the chin strap of the wiper's helmet had not been properly secured when he entered the grey water tank. Consequently, the helmet slipped off his head at some point during the fall.

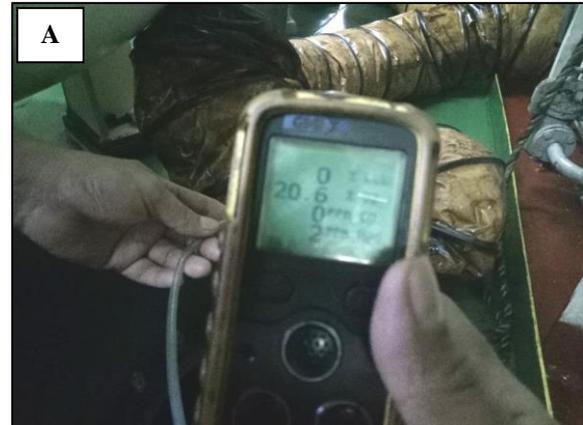
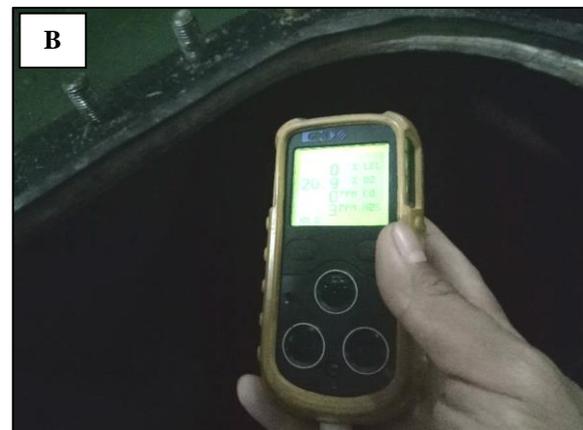
The vessel carried two portable multi-gas detectors on board (Figure 7A and 7B). Both detectors could measure the percentage of oxygen, hydrocarbon (in percentage of the

**Figure 7: Multi-gas detectors on board (representative photographs)**

The MSIU was informed that the gas detector used on the day of the accident had been last calibrated in December 2019<sup>7</sup>. Reportedly, a fresh air calibration was conducted on this gas detector, prior to measuring the gases in the grey water tank. A two-metre long gas sampling tube was used to measure the gases during the pre-entry tests.

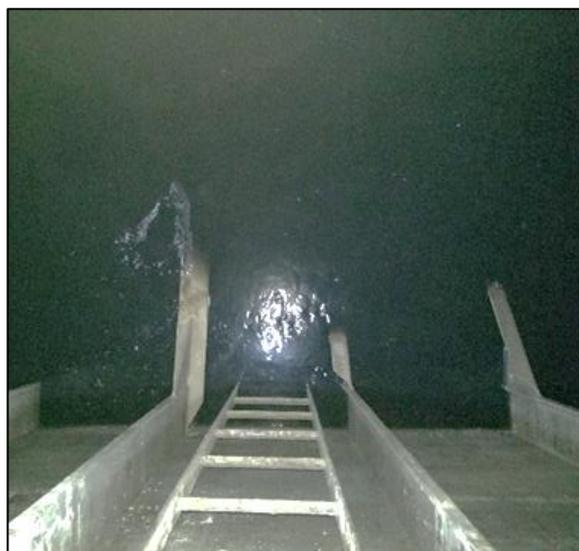
It is highly likely that the injury was sustained when the injured wiper struck his head either against the ladder or against the stiffeners in the grey water tank (Figure 8).

**Figure 8: Ladder and fittings in the grey water tank, against which the wiper may have struck his head**

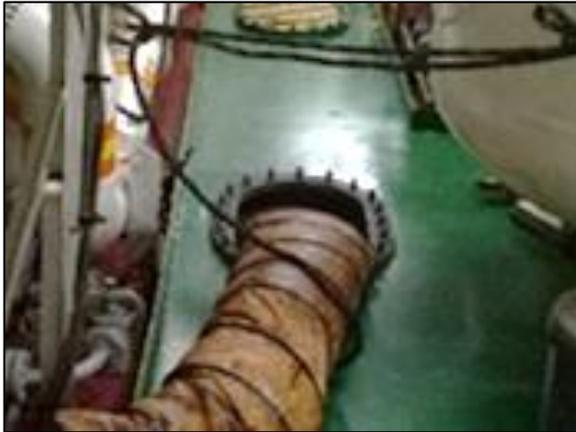
While the enclosed space entry permit indicated that the grey water tank's atmosphere was safe for entry, the gas measurements were taken before the tank was washed from above, using a fire hose. It is highly likely that the jet of water disturbed pockets of H<sub>2</sub>S, which may have gone undetected at the time of measuring the tank's atmosphere.

around the manhole perimeter rather than the from the air vent at the funnel (fitted 26.08 m above the grey water tank).

Nonetheless, the gas measurements taken after the ventilation was stopped, indicated that the tank was free of gases, which would have given the crew a sense of security and no reason why the tank should not be accessed.

**Figure 9: Ventilation duct passing through the grey water tank manhole**
