SAFETY INVESTIGATION REPORT

REPORT NO.: 05/2020

MV LEOPOLD LD
Failure of auxiliary engines and the emergency generator leading to total loss of power in position 06° 08.58' N 014° 40.65' W 14 March 2019

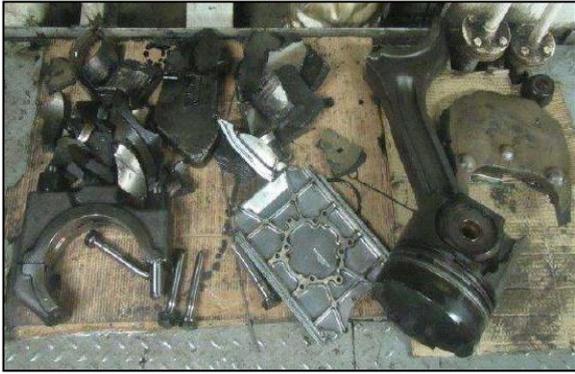
Preliminary investigation on A/E no. 2 by the crew revealed that the piston assembly, liner, connecting rod, crankshaft counterweight and the engine block were damaged. Further investigation by the service technicians revealed that A/E no. 2 had sustained severe damages (Figure 3) due to which, amongst other components, the complete engine block, the crankshaft with counterweight and bolts, piston rings, big end bearings, the main bearing and thrust bearings would have to be renewed.

Figure 3: Damaged components on A/E no. 2

Within 10 minutes of starting A/E no. 2, it sustained damages which rendered it out of service. Investigation by the Company and the service technicians suggested a defect in the connecting rod bolt of cylinder no. 1.

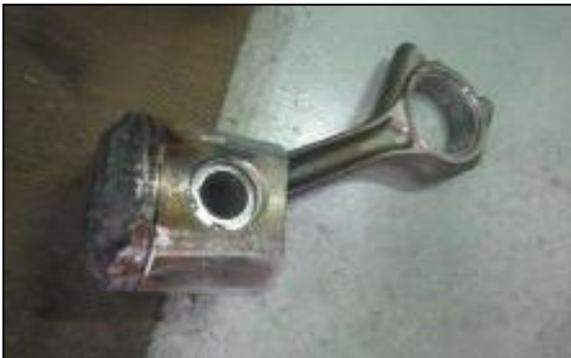
Investigation of the emergency generator by the service technicians revealed that the piston assembly, the connecting rod assembly, the liners, the big end bearings, the main bearing, the thrust bearings of all cylinders of the generator were severely damaged and would require renewal. In addition, it was also found that the cylinder block would have to be renewed. Figures 4 and 5 show the extent of damages sustained by the emergency generator.

Figure 4: Damaged piston and connecting rod of the emergency generator

The damages to the running gear were attributed to the generator being operated with a leaking radiator, which would have compromised the cooling of the engine.

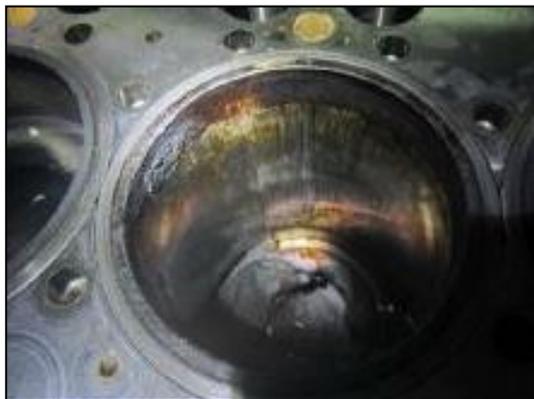
Figure 5: Damaged cylinder liner

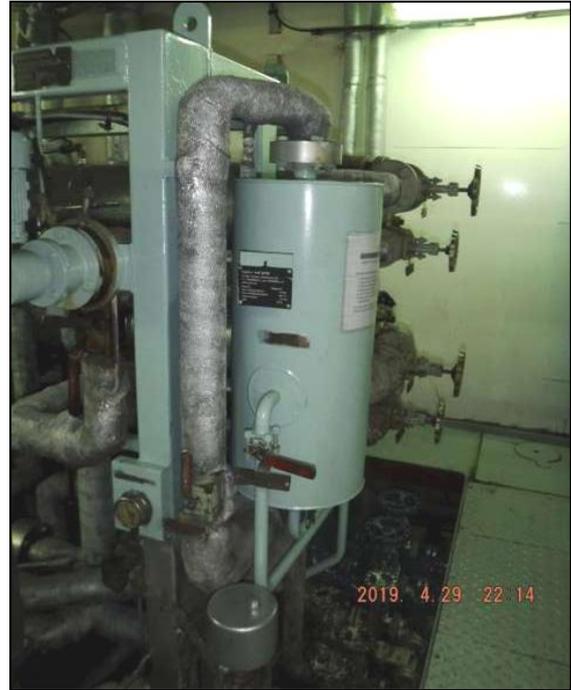
Figure 6: Compensation damping tank

Investigation by the Company and the technicians revealed that the compensation fuel damping tank, which should have been pressurized, was empty.

As mentioned in the narrative section of this report, the crew members noticed that A/E no. 1 and A/E no. 3 were turning on air, but there were no signs of combustion in any of the cylinders of the A/Es. This was due to insufficient fuel oil pressure in the lines. Had the compensation damping tank been kept charged in accordance with the manufacturers' instructions, sufficient HFO pressure would have been available for A/E no. 1 or A/E no. 3 to be restarted.

During the course of the safety investigation, it transpired that none of the engineer officers aware of the manufacturers' instructions (that the compensation damping tank had to be kept charged). Moreover, this procedure had not been incorporated into the vessel's planned maintenance system. The lack of awareness was evident through the actions of the crew members, whereby they recalibrated the fuel injection valves of

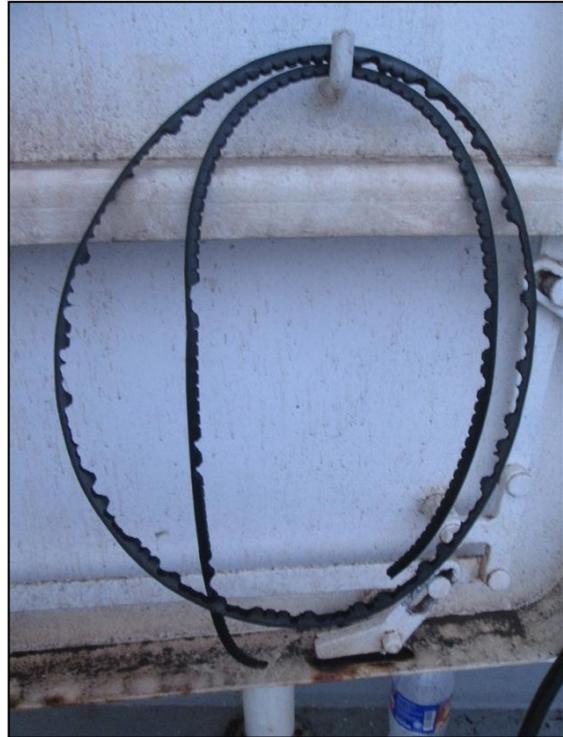
Nearly after 12 hours of continuous running, two belts of its fan broke. The condition of the belts (Figure 9) revealed that it had sustained severe wear which, in the opinion of the safety investigation, could not have occurred during this period of twelve hours.

Figure 9: Broken belts of the emergency generator fan

In order to verify the condition of these belts, one would have to remove them from the assembly and flip them over. A visual inspection from above would be inadequate to verify its physical condition and the severity of the cracks. Although this generator was subjected to weekly checks and tests, the last one carried out was about five days before the occurrence; however, there was no available information to indicate that the condition of the belts was verified during the checks.

Bearing in mind that this generator had only run for about 53 hours, it was highly likely that checks on the condition of the belts were either missed or deemed unnecessary by the

- The SMS has been amended and the maintenance schedule for the radiator fan belt has been reduced to six months from the 12 month interval. The second engineer (Senior Engineer) is now assigned to this critical job;
- A 14-day routine to drain the fuel and ensure build-up of 100% air cushion has been added in the vessel's PMS and included in the ship-specific familiarization checklist.
