SAFETY INVESTIGATION REPORT

REPORT NO.: 12/2018

MV MSC RAVENNA **Fatal fall overboard of a crew member** **in the port of M'Xlokk** **22 June 2017**

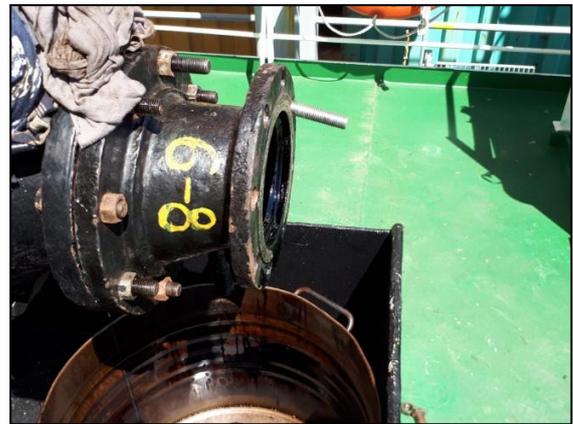
Figure 4: Reducer stub piece

room team. The bunker hose flange was connected to a reducer stub piece (6 inch : 8 inch) at 2215 (Figure 4).

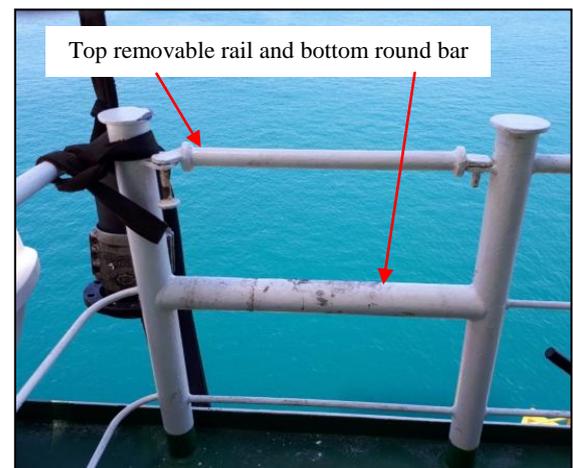
Figure 5: Railing at the port side bunker station

The bunker hose was supported at the ship's side, abreast of the manifold, by passing it over a round bar, fitted in a fore and aft axis along the shipside railing (Figure 5) to protect it from sharp edges and obstructions.

At the edge, the fitter lost his balance when his legs hit the horizontal pipe for the bunker hose support (bottom round bar in Figure 5). The

During the bunkering operation, the top hinged shipside railing (Figure 5) had been opened and hooked to the railing, forward of the liferafts. When the fitter's back legs hit the bunker hose support bottom round bar, he lost balance, released his hold on the bunker hose, fell backwards and overboard on to the bunker barge. The provisions crane wire with the suspended bunker hose came to rest on the outboard side of *MSC Ravenna's* shipside railing.

12/2018_R1 re-design the railing section in way of the bunker hose access point to ensure that the area remains safe for the crew members attending the bunkering operation.

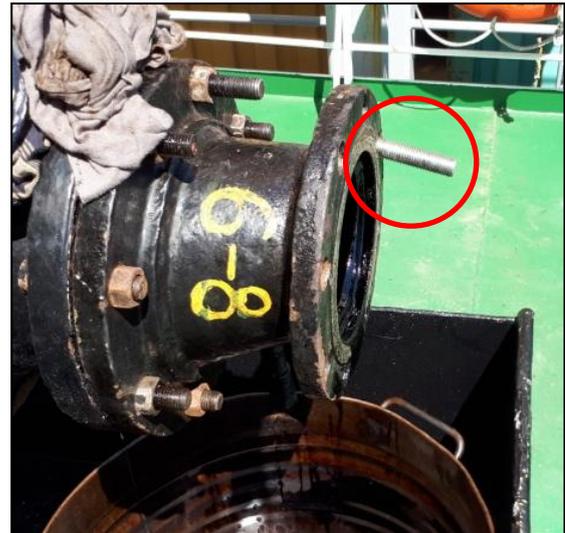
Figure 6: Last bolt still in place after the accident

Together they removed seven out of the eight bolts between the bunker hose and the reducer flanges. The last bolt (Figure 6) was slackened and before releasing the last nut, the fitter instructed the wiper to be careful not to get injured should the bunker hose swing towards him as soon as it was freed.

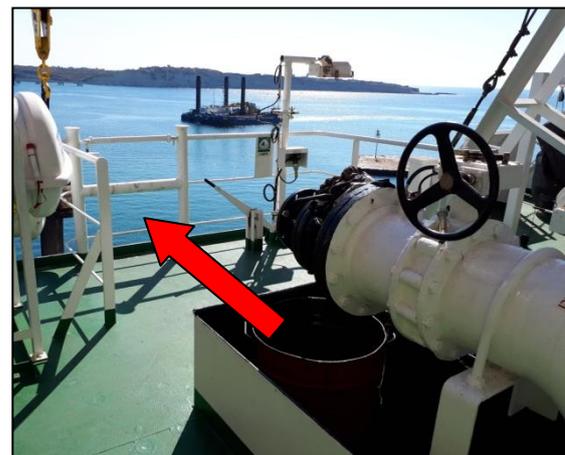
Figure 7: Direction in which the fitter was being pulled

As soon the bunker hose flange cleared the bolt, the wiper saw the fitter being pulled backwards and still bracing the bunker hose as it swung towards the shipside (Figure 7).

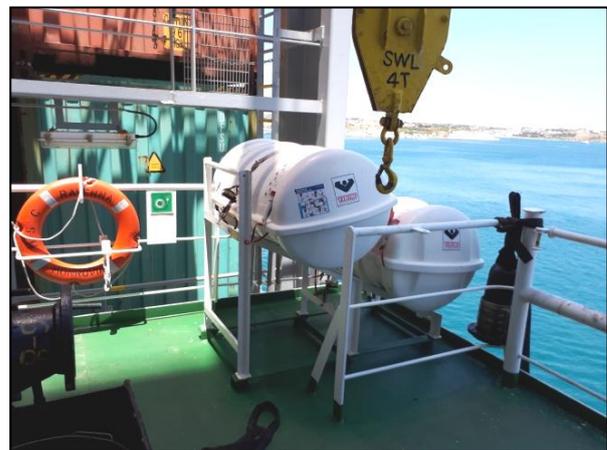
Figure 9: Position of the crane hook at rest (after the bunker hose was removed)

The paid-out wire of the crane was allowed to settle at its natural vertical position, in line with the provisions jib head. It was noticed that the resting position of the crane hook was closer to the shipside railing than the reducer flange (Figure 9).

It was evident that once the bunker hose flange was disconnected from the reducer, a pendulum effect was created. The suspended weight of the bunker hose oscillated towards the shipside as a result of the force acting in that direction, pulling the fitter in the same direction. The restraining force of the fitter could not counteract the swing of the wire rope.

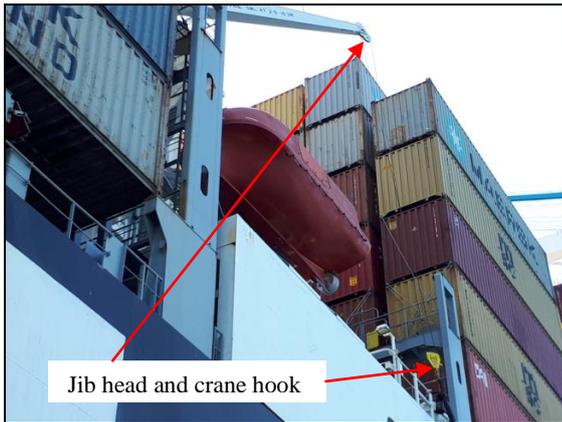
Figure 10: Paid out wire length from the jib head to the crane hook

The length of the paid-out wire was calculated to be approximately 13 m (the height of about five containers) from the jib's head to the crane hook (Figure 10).

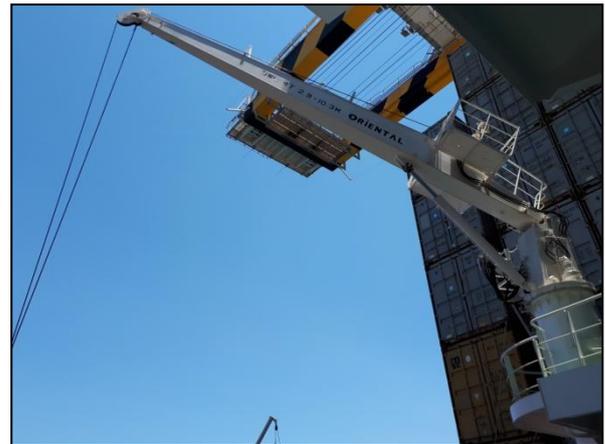
Figure 11: Port side provisions crane

Adjustment of the jib length was not possible because the jib was of a fixed length (Figure 11).

Since this provisions crane was regularly used for bunkering operations, it was not excluded that the angle of the jib (as set) was considered to be the most ideal one to support the bunker hose length from the ship side to the bunker manifold.

Technically, it was possible for the jib to be slewed further inboard to minimise (or neutralise) the component of the force created by the bunker hose, hanging from the shipside. However, the crew members had no cues that the bunker hose would swing to an extent that it would have pulled the crew member over the side². Then, all previous bunkering operations were carried out in a similar manner and no accidents or incidents had been reported to the Company.

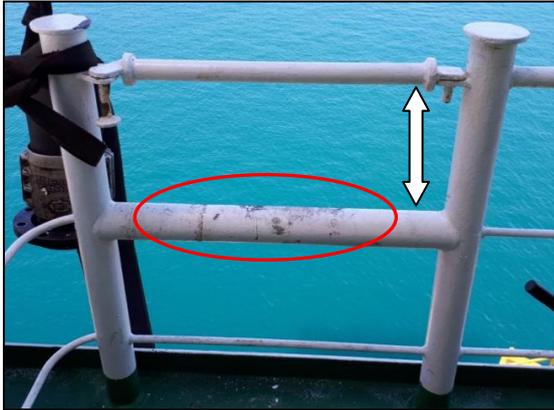
Figure 12: Bunker hose markings on the bottom round bar

It may be considered that the open hinged bar was actually a missing physical barrier system, which could have prevented the fatal fall from happening.

Rather than being forgotten, a closer analysis of the situation revealed that it was normal for the hinged bar to be left open during bunkering operations; this would permit the bunker hose to be guided over the ship's side and pulled on deck towards the bunker manifold.

Figure 12 indicates that the bottom round bar carried markings made whenever the bunker hose is pulled over it. However, it may also be noticed that the top removable rail is clean and free from any markings, suggesting that it is always out of the way during bunkering operations.

The distance between the bottom round bar and the top removable rail was small (even less than the distance between the deck plating and the bottom round bar). To this effect, the curve of the bunker hose at the ship side did not permit the top removable rail to be put back in place when the bunker hose is connected to the bunker manifold on board.
