SAFETY INVESTIGATION REPORT

REPORT NO.: 08/2019

MV NS TERA **Serious injury to stevedore** **at Laboratory Wharf, Valletta** **17 April 2018**

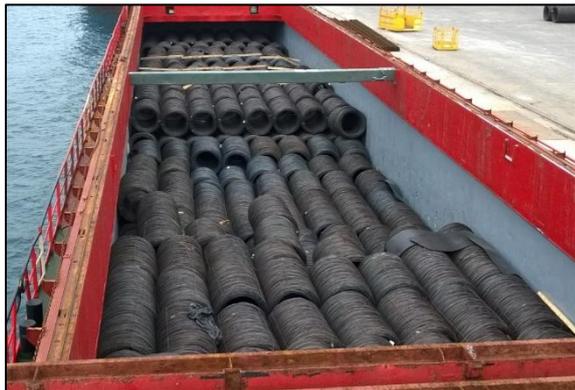
NS Tera loaded a full cargo of steel products consisting of steel beams / pipes, heavy plates and bundles of reinforced steel coils, at the Italian port of Nogaro. The consignment of steel coils was stowed in regular tiers athwartships, reaching from side to side of the vessel, with the major axis of the coils horizontal and in the fore and aft line (Figure 1).

Figure 1: Steel coils stowed in the cargo hold

It was also noticed that successive tiers of coils were stowed in a tight block stow, each coil overlapping the coils below, up to the cargo hatch coaming to prevent the transverse movement of the cargo in a seaway (Figure 1). Although wire coils settle and mesh together, the arrangement of the

While the applied stowage arrangement would have prevented cargo shifting during the sea passage, the stow would have been broken as soon as the cargo discharge operations commence and the steel coils may become unstable and liable to move.

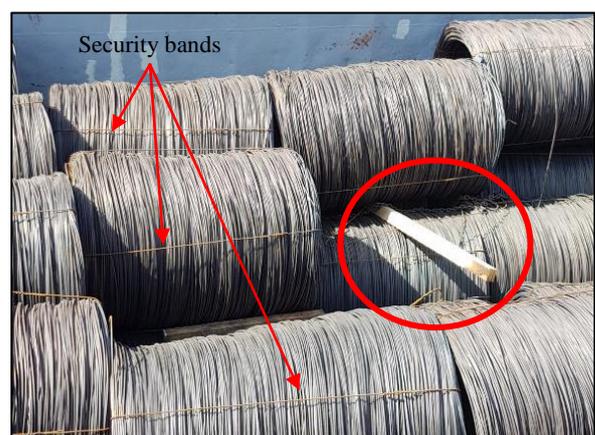
Cargo discharge operations started at around 1830, soon after the vessel docked at Laboratory Wharf on 16 April 2018 at 1705. The stevedores were using steel chain slings, discharging one steel coil at a time. They were also using 4" x 4" timber to wedge and temporarily secure steel coils during the slinging operation to try and prevent any movement of the steel coils (Figure 2).

Figure 2: Security bands and 4" x 4" timber used to wedge the steel coils

During the course of the safety investigation, it was observed that the steel coils were stowed with their major axis leading fore and aft and fastened together with security bands to form a unitised coil bundle to hold coils from opening up under the longitudinal forces of the vessel's motion (Figure 2).

It is highly probable that irrespective of the 4" x 4" timber used by the stevedores, the steel coils moved slightly during the discharge operations, consequently pinning the stevedore's shoulder while slinging the coil.

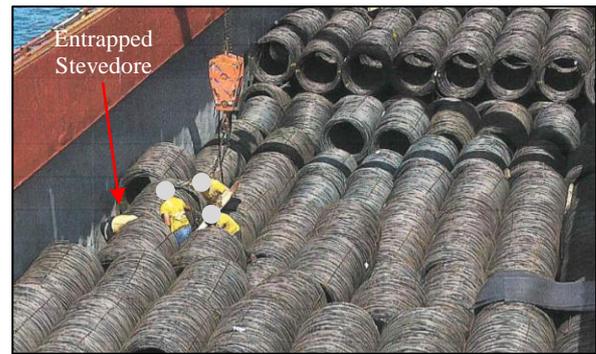
One of the stevedores moved down between two adjacent coils to try to pull the chain sling through the coil manually. As he did so, the steel roll being slung moved slightly and caught him by the shoulders against adjacent steel coil (Figure 3). His shoulders and torso were pressed, only leaving his head free inside the coil. The time was about 1440.

Figure 3: Location of the accident

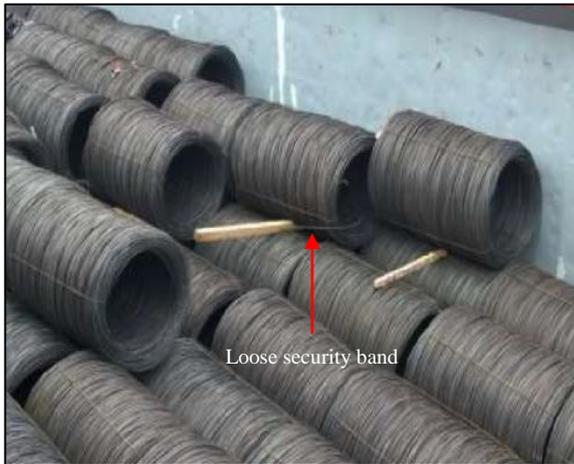
The MSIU does not believe that this had a contributory role in the dynamics of the accident. Irrespective of whether or not a signalman was present on deck, the steel coil would have nonetheless become unstable, once the security band holding the coil together had come undone; freeing a section of the coil to move longitudinally at the

critical movement of slinging the bundle (Figure 4).

Figure 4: Photo showing a loose security band

5. The security band around the steel coil bundle had become undone, freeing the top section of the coil which then moved slightly, pinning the stevedore against the adjacent steel coil;
6. The dynamic characteristic of the situation *per se* puts a significant burden on the stevedores who, while being occupied with the cargo operations, are also tasked to keep a watchful eye on how a wider context is evolving;
7. Although not contributory to the accident, the absence of full complement of stevedores and another person overseeing a cargo operation remains, in terms of safety, a missing barrier system.
