## SAFETY INVESTIGATION REPORT

REPORT NO.: 02/2019

### ***MV NEW HAMPSHIRE TRADER*** **Boiler furnace blowback and injuries to two crew members about 30 nautical miles from Qingdao Pilot Station 31 January 2018**

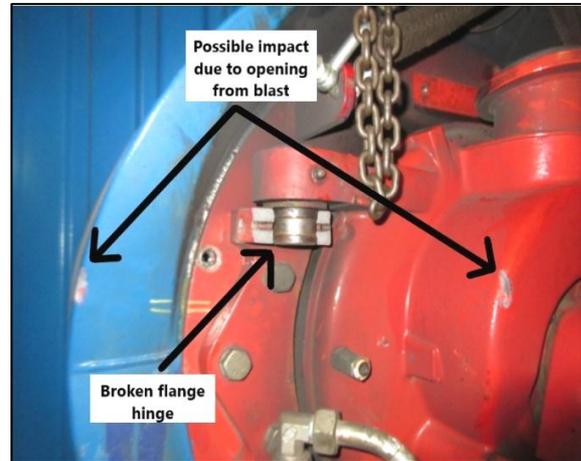
- hinge mounting of the rotary cup burner was cracked and the upper hinge pin house was broken (Figure 2);
- locking pin of the burner house was found broken (Figure 3);
- burner motor was found cracked on the forward end, at the connection plate to the motor housing; and
- the control panel was malfunctioning.

Figure 2: Cracks to the mounting and damaged upper hinge

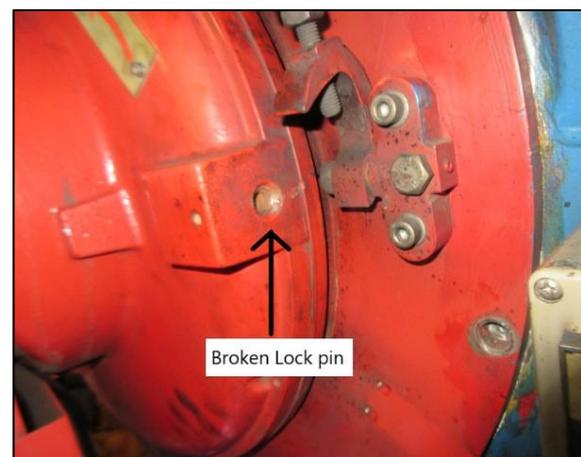
Figure 3: Broken locking pin
