## SAFETY INVESTIGATION REPORT

REPORT NO.: 12/2020

### **MV *PERSENK*** **Collision with cargo vessel** ***AHMET CAN*** **in position 40° 46.0' N 027° 35.7' E** **on 18 May 2019**

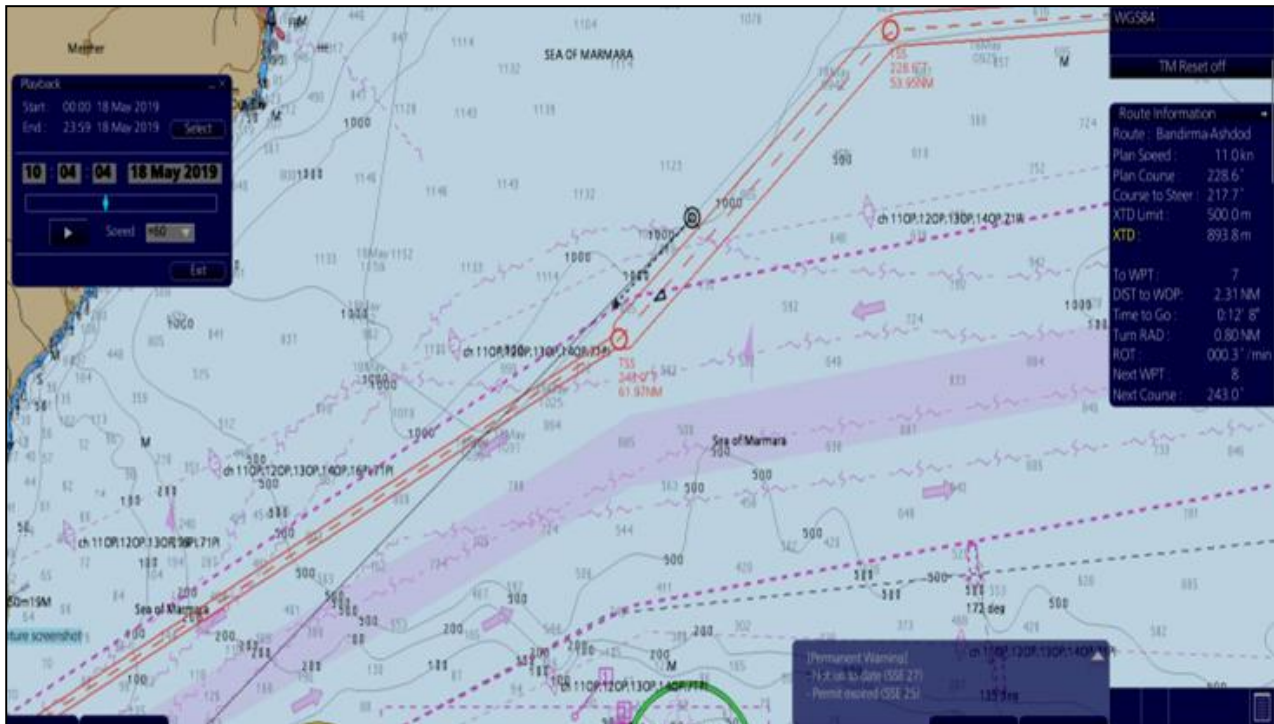
Figure 4: Image from ECDIS playback showing a segment of passage plan in the Sea of Marmara

*Persenk's* passage plan was prepared from Istanbul Anchorage to Ashdod, Israel. The courses and XTDs were plotted on the ECDIS (Figure 4).

At the time, *Persenk's* course and speed over the ground were 228.7° and 11.4 knots respectively (Figure 4). However, no course changes were made.

At 1304, *Persenk's* position and track was outside the XTD limit and running parallel to the planned course 228.6°. The S-band radar was on stand-by. Route information on the ECDIS display indicated a direct

9. It is likely that the OOW was not monitoring the radar display or trying to correlate the target with visual sightings;
10. *Persenk* was sailing outside of the planned XTD limit. No course adjustment was made to set the vessel on the planned track or to the next waypoint;

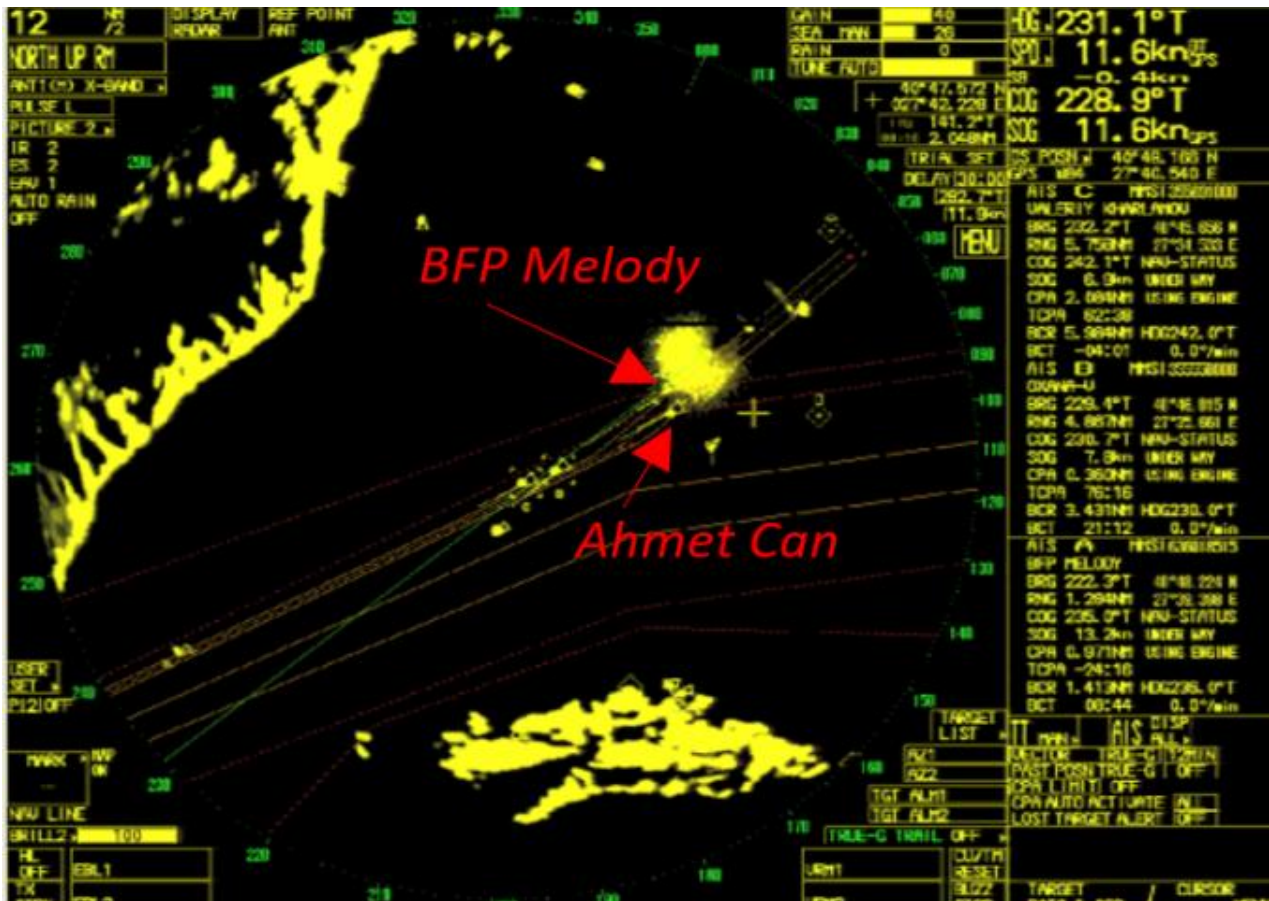
Figure 5: Radar image showing traffic situation at 1300

*Ahmet Can* had not been acquired and displayed no navigational data on the radar. All vessels were moving in the TSS in the same direction within the traffic lane (Figure 5).

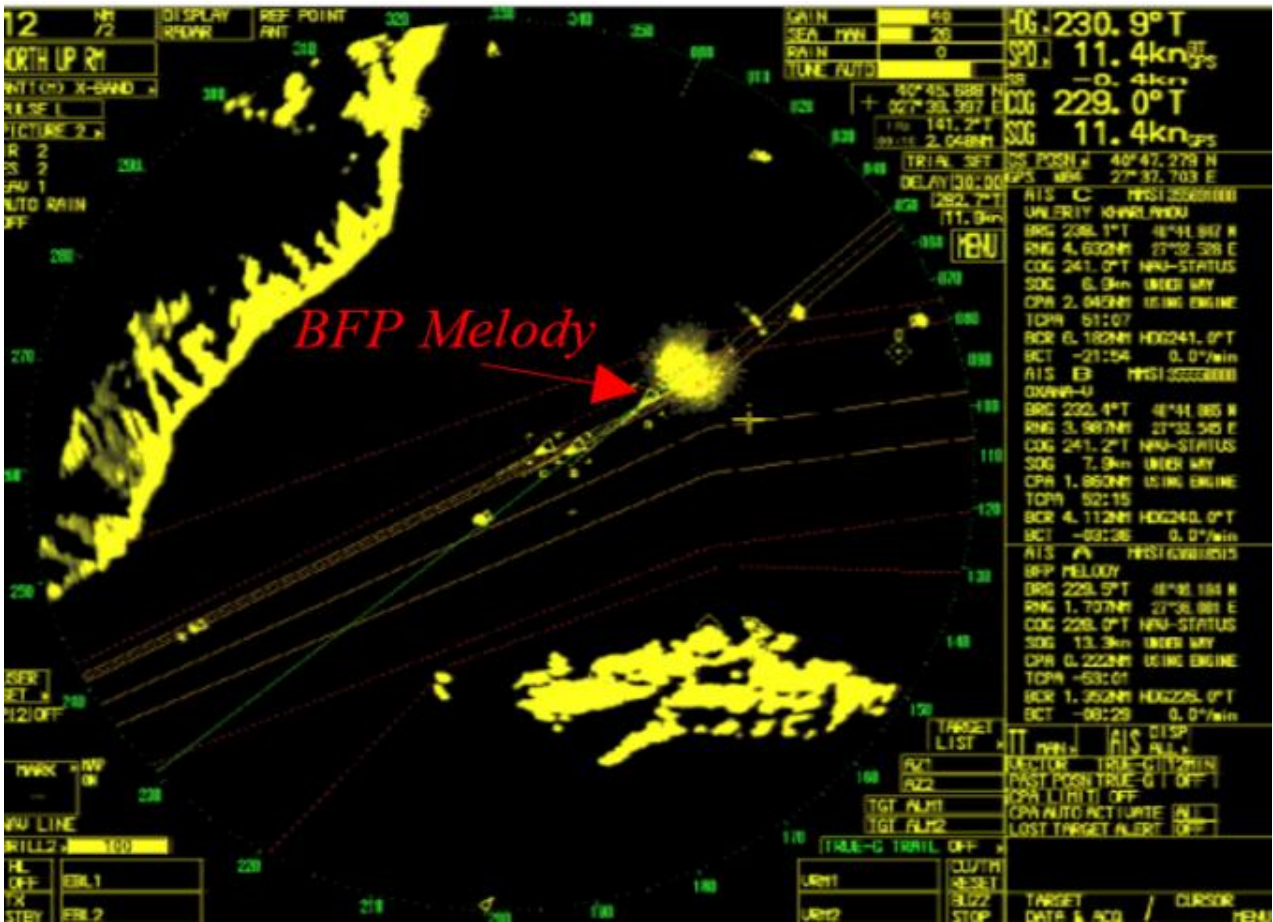
Figure 6: Radar image showing traffic situation at 1315. *Ahmet Can* echo concealed by clutter / bright patch

A few minutes after 1315, *Persenk* passed waypoint 7. The vessel's next planned course was 243°. The course was not changed and the vessel continued on her previous heading of 228.6° to decrease the XTD deviation. At this point, both *Persenk* and *Ahmet Can* were on slightly different but converging courses. *Persenk* at 11.4 knots was gradually drawing closer to *Ahmet Can*, whose radar echo had by now masked by the clutter / bright patch (Figure 6).

The S-band radar was off and the X-band radar, though operational, was permanently left on the 12 nm range. There was no attempt to scale down the display to a suitable range and the cursor was not moved. ARPA was not used and *Ahmet Can* displayed no CPA or TCPA on the radar screen. Moreover, the clutter function had not been adjusted and as *Ahmet Can* approached closer, the bright patch around the PPI masked her radar echo.

7. ECDIS, AIS and other navigational aids were not effectively used and the risk of collision with *Ahmet Can* was not recognised;
8. *Ahmet Can*'s radar echo masked by the sea clutter / bright patch was not detected;

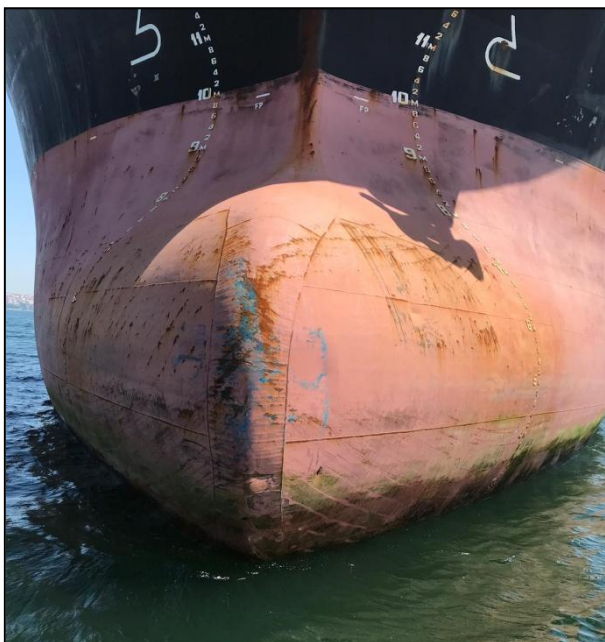
The OOW and look-out stated that at 1324, *Persenk* and *Ahmet Can* were on parallel courses, and *Ahmet Can*, without any warning or signal altered her course to starboard. The OOW immediately called the master and a minute later, the bulbous bow of *Persenk* struck *Ahmet Can* on her transom (Figures 7 and 8).

As a result of the collision, bow plating and associated internal structural indentations was reported by Class surveyor. A damage survey report on the structural damages sustained by *Ahmet Can's* transom was not available to the MSIU.

Figure 7: Photo showing slight damage to *Persenk's* bulbous bow

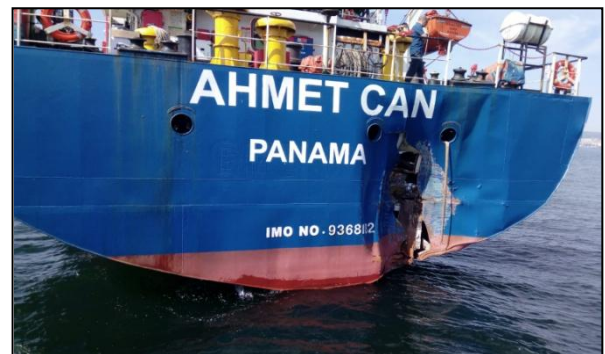
Figure 8: Photo showing damage sustained by *Ahmet Can*

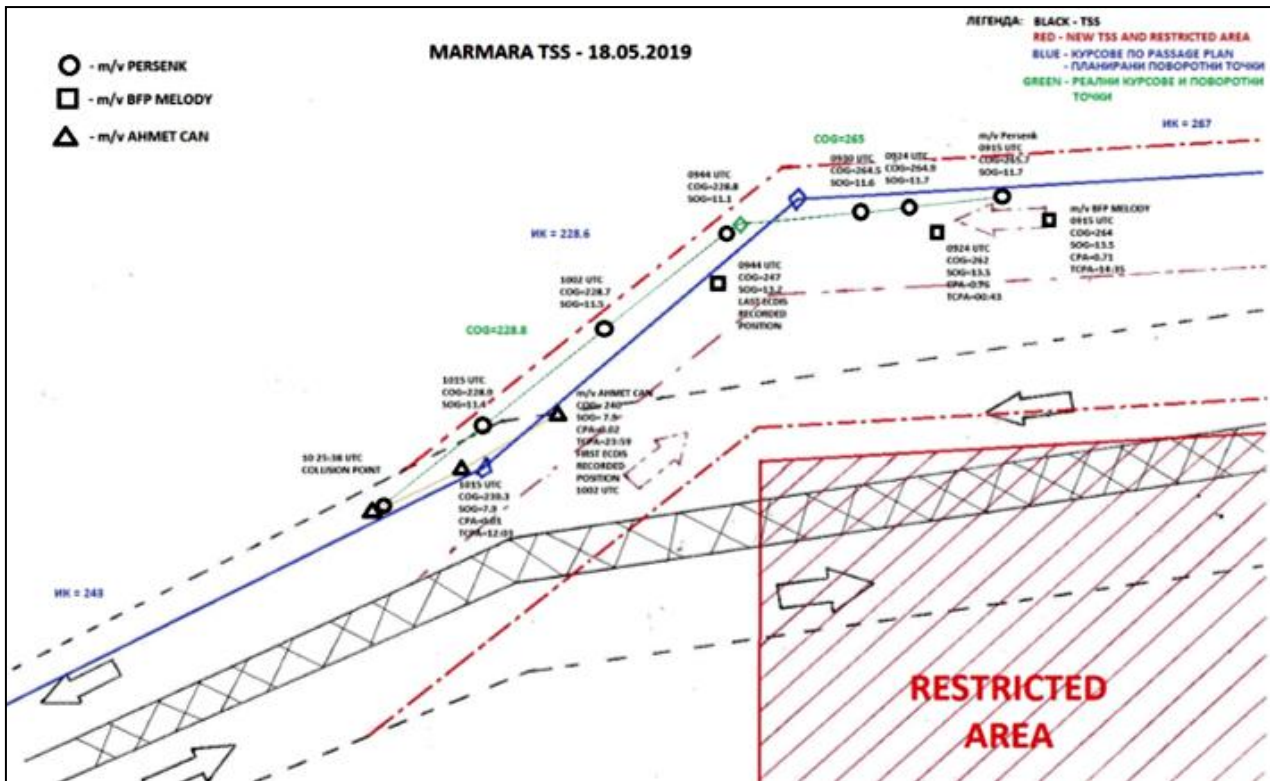
Figure 9: Schema showing navigational information and overview of vessels' movement between 1215 and 1325

The OOW and lookout stated that both vessels were on a parallel course and that *Ahmet Can* altered her course to starboard and collided with *Persenk*. However, according to the information contained in the incident schematic overview, submitted by the managers of *Persenk* (Figure 9), at 1002 UTC, *Persenk* was making good a course of 228.7° and speed 11.5 knots, whilst *Ahmet Can* was making 7.9 knots.

The TCPA was 23.59 minutes and CPA was 0.02 nm which, the safety investigation believes is a clear indication of a collision risk. It was evident from the schematic diagram that for almost 24 minutes, no action had been taken to keep clear. Moreover, it seemed that *Ahmet Can*'s bridge team were unaware of the developing close quarter situation and only sighted *Persenk* just before the collision.

As no information concerning measures taken by *Ahmet Can* was available to the MSIU, the safety investigation was unable to verify the watchkeeper's claim that *Ahmet Can*'s alteration of course to starboard had caused the accident. However, given the situation and evidence available to the MSIU, it was considered likely that the change in direction by *Ahmet Can*, one minute before the condition, as reported by the OOW on board *Persenk*, may have been an attempt to get out of the way of *Persenk*, although no prior warning was sounded.
