# SAFETY INVESTIGATION REPORT

REPORT NO.: 08/2018

## **MV POMPANO** **Fall from a height into a cargo hold** **resulting in fatal injuries to one crew member** **in Port Hedland Anchorage, Australia** **08 April 2017**

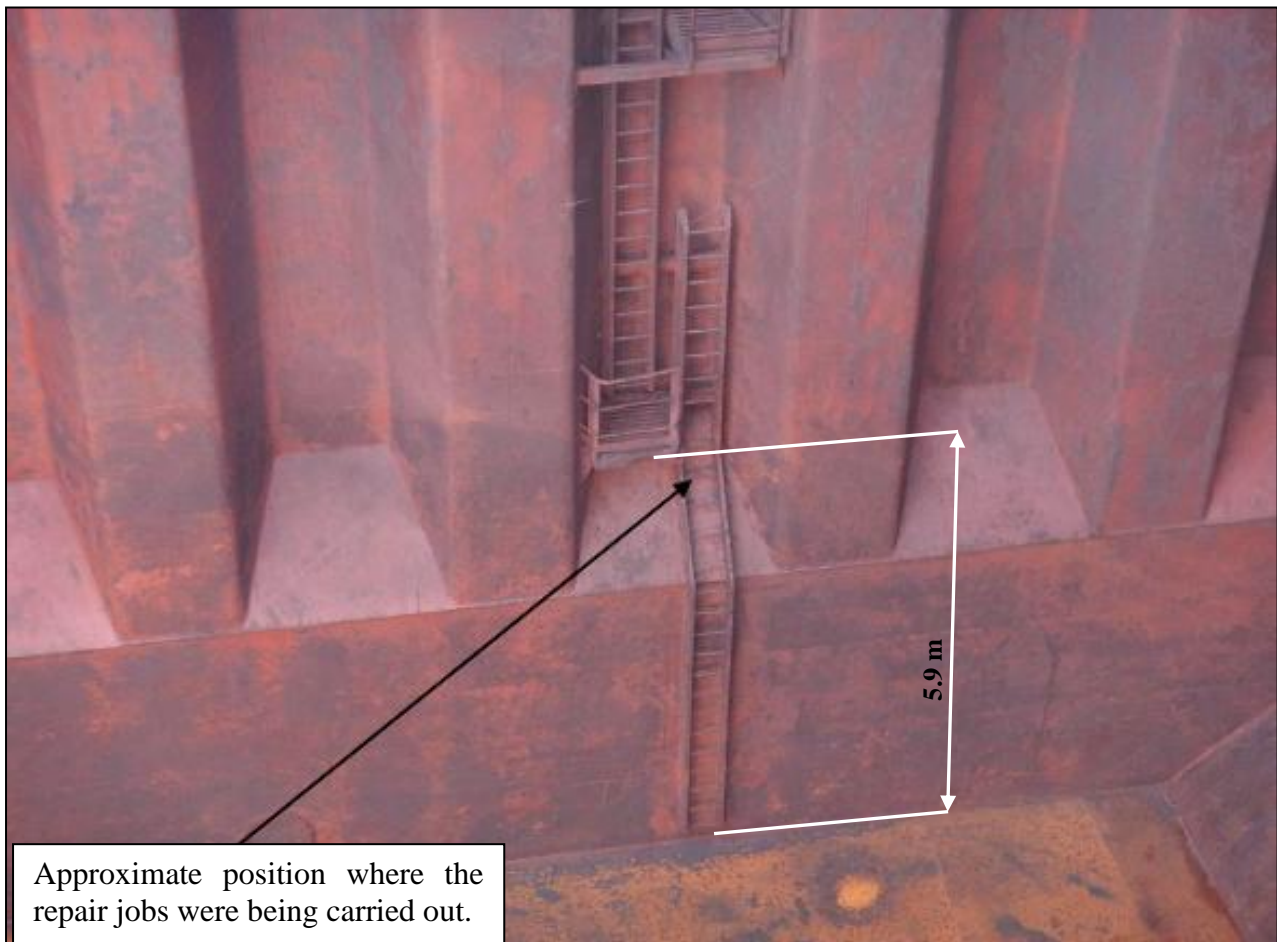
The third engineer was wearing a safety belt and a safety helmet, in addition to welding PPE. The repairs had to be carried out in way of the lower platform, which was about 5.9 m above the tank top (Figure 1).

**Figure 1: The ladder down cargo hold no. 3**

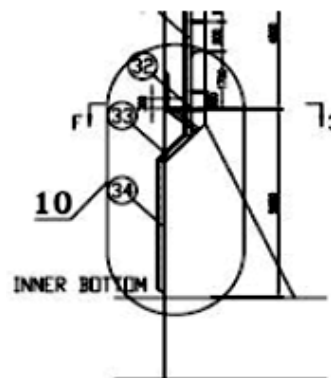
The ladder providing access to the cargo hold was considered to be of the conventional design, going down along the corrugated transverse bulkhead, over the bulkhead's lower stool and down to the tank top (Figure 2).

Figure 2: Ladder along the length of the corrugated transverse bulkhead

In view of this arrangement, it may be noticed that the ladder's vertical angle had to decrease against the lower shelf plating and then increase against the inner bottom plate. Although the ladder was in a good condition, it was not excluded that the third engineer lost his footing as he negotiated the different

1. Conducted a fleet wide review of safety harnesses, with either upgrading or replacements carried out where necessary;
2. Distributed a fleet safety circular, highlighting the issues of risk/hazard assessment, rigour to work permit systems and appropriateness / condition of PPE;
3. Painted the top of the lower stool yellow to highlight the change in the

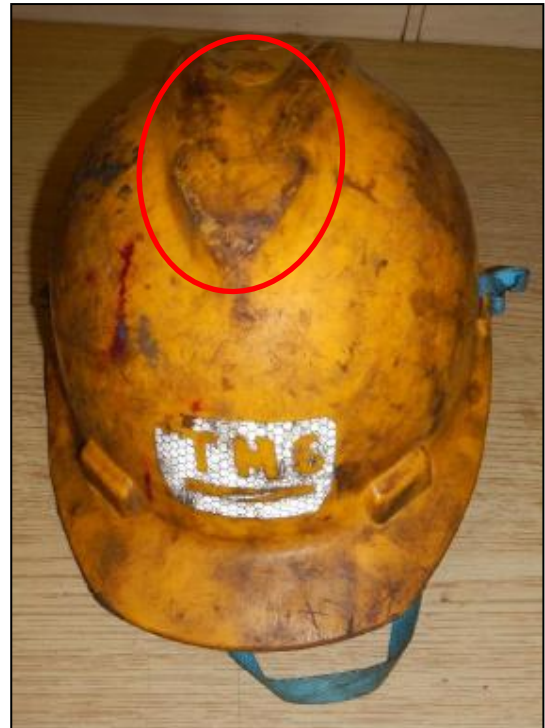
It was noticed that the safety helmet (Figure 3) was old, stained by oil and what appeared to be less than adequate upkeep.

**Figure 3: Safety helmet in use by the third engineer**

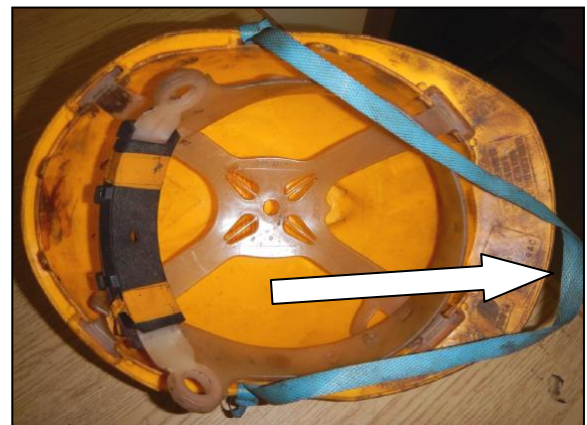
Of more concern, however, was the plastic band, which served as a chin strap (Figure 4). Given that the plastic band was rigid and not elastic, and considering that the safety helmet fell off, it has been concluded that the safety helmet had not been secured to the chin.

**Figure 4: Plastic band serving as a chin strap**

Notwithstanding this, it was highly probable that the safety helmet would have not prevented the head injuries sustained by the third engineer.

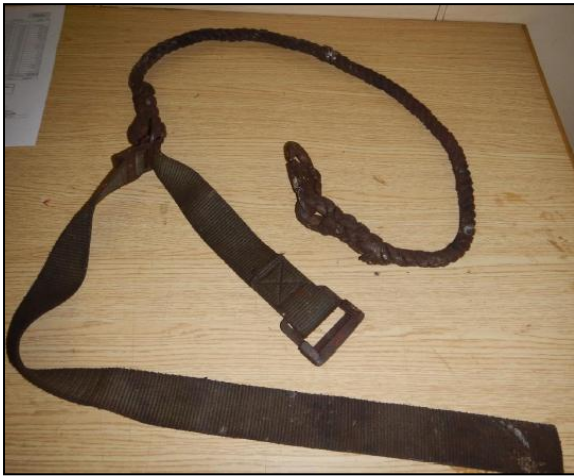
**Figure 4: Safety belt worn by the third engineer**

The safety belt was also observed to be in a poor condition, with a corroded belt buckle, rigid belt lanyard and a defective safety clip. Evidence collected during the course of the safety investigation suggested that a five-point fall arrestor was available on board but not used during the repair works inside the cargo hold.

The type of fall preventer used by the third engineer was not of the best design for vertical movements. For instance, a fall arrestor with a double lanyard would have ensured that a person could move from one anchor point to another, whilst ensuring that there would always be a permanent connection at a time when an accidental fall was more likely to happen, *i.e.* during a transition from one point to another.
