# SAFETY INVESTIGATION REPORT

REPORT NO.: 13/2020

## **MV RIGA** **Fatality following entry into cargo hold** **in position 42° 09.6' N 016° 24.6' E** **27 May 2019**

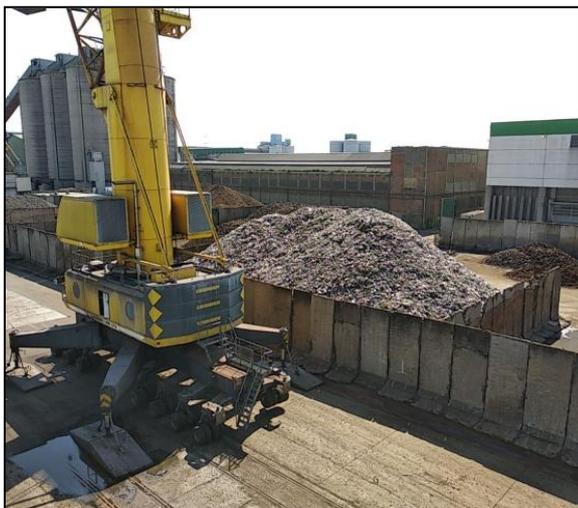
At the time of the accident, the vessel was loaded with 3,926 mt of ‘packaging waste glass cullet’, which was loaded from an unsheltered location on the quay (Figure 2), at Porto Marghera, Italy. It was reported that the cargo, when loaded, was partly wet, as it was raining a couple of days prior to loading.

**Figure 2: Area on the quay from where cargo was loaded**

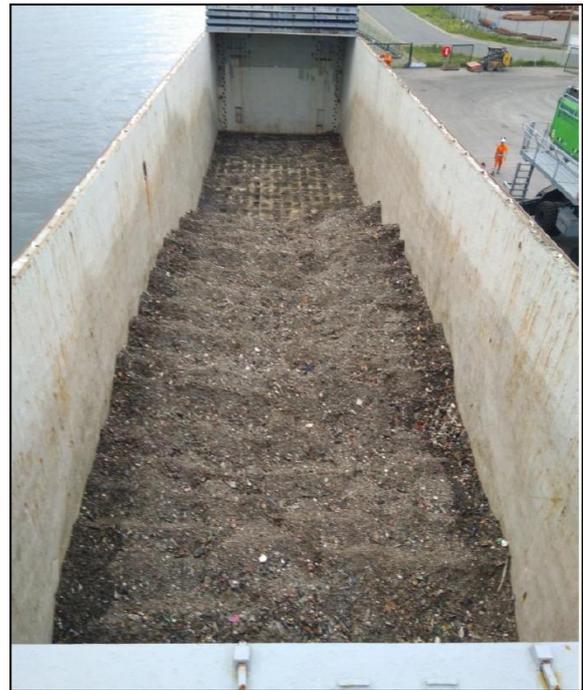
Figure 3: Cargo hold, as seen from forward

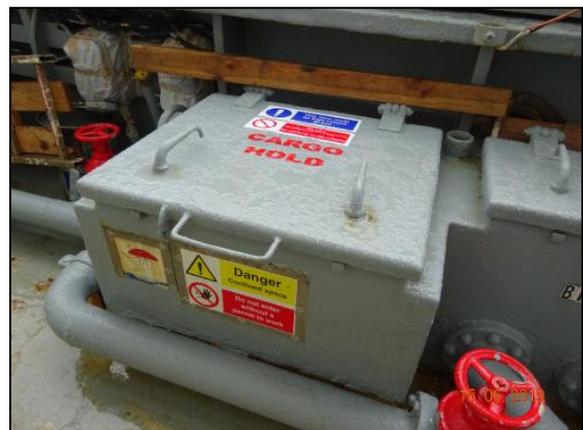
Figure 4: Cargo hold access hatch - aft

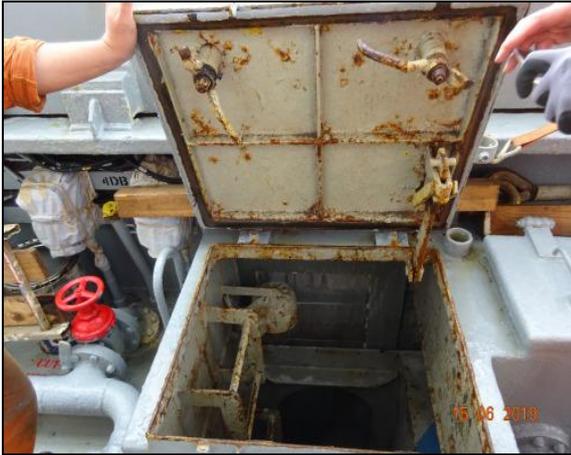
Figure 5: Cargo hold access hatch - aft

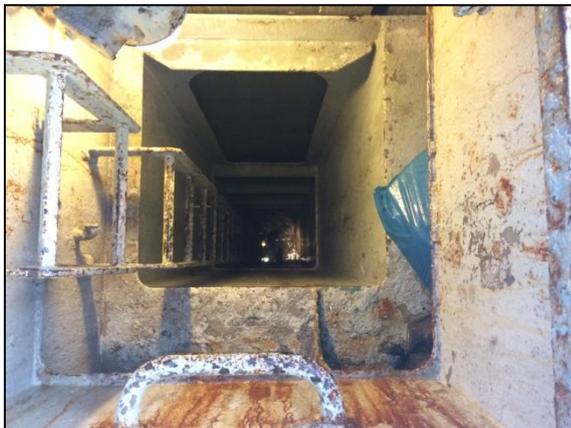
Figure 6: Cargo hold access ladder – aft

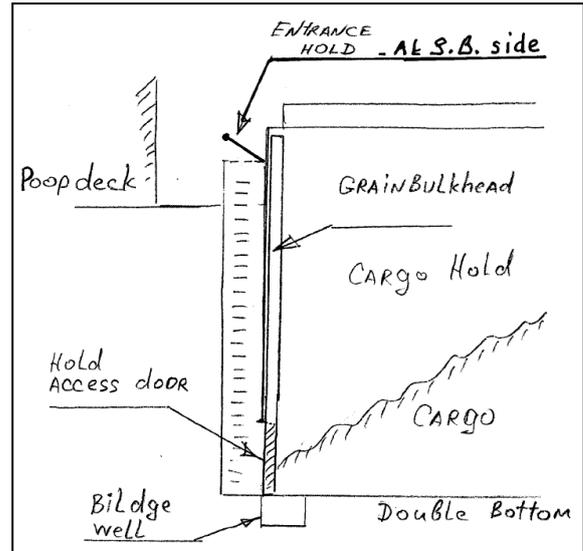
The cargo hold was fitted with two bilge wells – one on the port side and another on the starboard side, both of which were located at the aft of the cargo hold (Figure 7). The bilge wells were fitted with suction pipes to pump out water from them via an ejector. The bilge wells were also fitted with sensors (Figure 9) which triggered an alarm if the level of any liquid inside the wells reached these sensors.

Figure 7: Rough profile sketch of the cargo hold (aft)

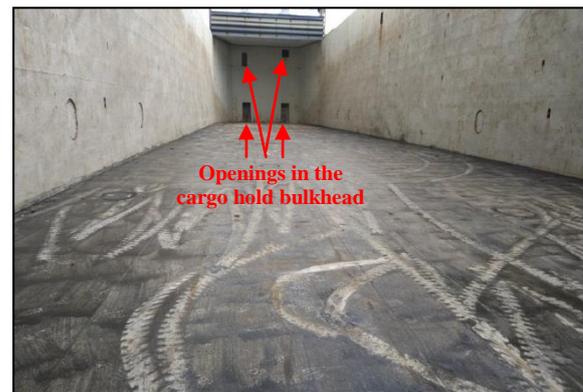
Figure 8: Cargo hold, as seen from aft

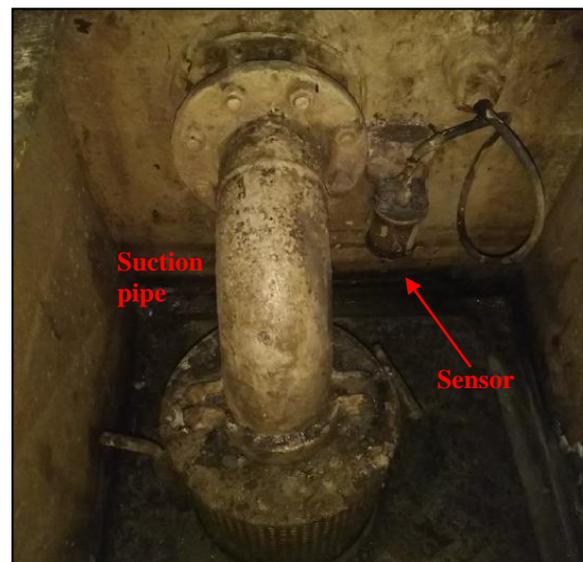
Figure 9: Cargo hold bilge well

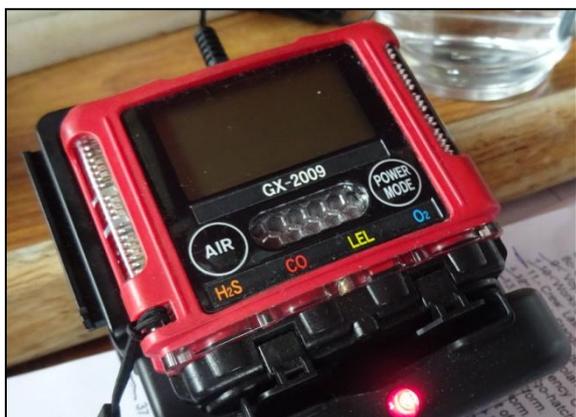
*Riga* was provided with a portable gas detector (Figure 10) for the measurement of Oxygen, Hydrogen Sulphide, Carbon Monoxide and combustible gases in the lower explosive limit (LEL) range.

Figure 10: Portable gas detector on board *Riga*

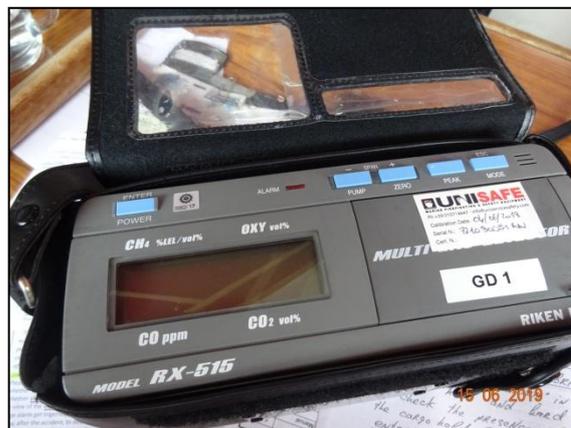
The additionally supplied gas detector was capable of measuring Oxygen, Carbon Monoxide, Carbon Dioxide and hydrocarbons (combustible gases). Unlike the previously mentioned gas detector, this one was capable of measuring the volume

Figure 11: Additional portable gas detector supplied on board *Riga*, after the accident
