SAFETY INVESTIGATION REPORT

REPORT NO.: 18/2021

MV RIMONA **Fatal injury to a crew member** **during cargo loading operations,** **on the pier at the port of Habas, Turkey** **09 September 2020**

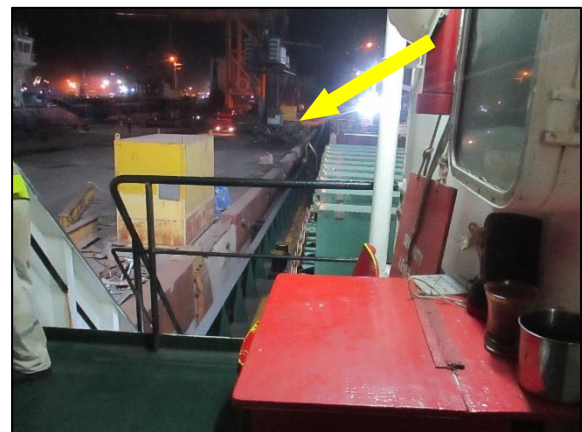
At around 2105, while the deck officer and the AB were at the vessel's gangway, several open trailer trucks arrived with cargo on them. The AB disembarked from the vessel and proceeded towards the shore crane with a cargo tally sheet in hand, while the deck officer remained at the gangway. As the AB went beyond the crane, he was out of the deck officer's sight (Figure 3).

Figure 3: View from the deck officer's position (the shore crane is indicated by the yellow arrow)

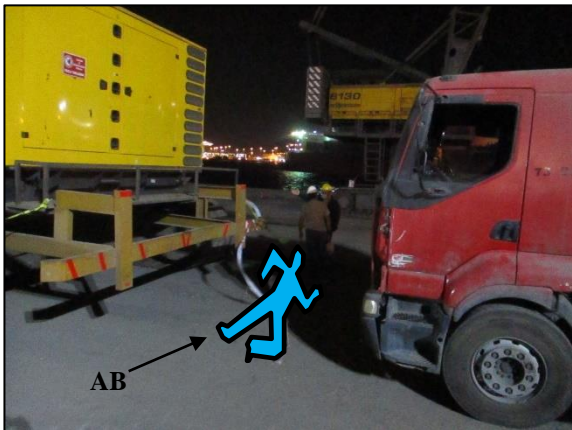
At about 2115, the deck officer heard the AB calling for help over the portable radio. The deck officer rushed to the pier towards the crane. On his way, he observed people shouting and running towards the shore crane. Reaching the forward area of the crane, he saw the AB in pain, lying on the pier, between the shore crane and an open trailer truck (Figure 4).

Figure 4: The accident site

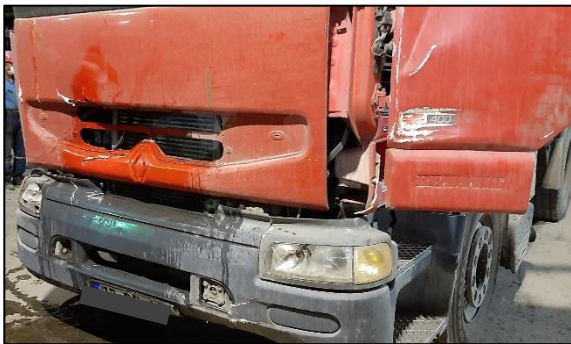
The front bumper of the truck was about three metres away from the shore crane, facing the latter and with signs of fresh damages (Figure 5), while a protective steel

Figure 5: The damaged front of the truck involved

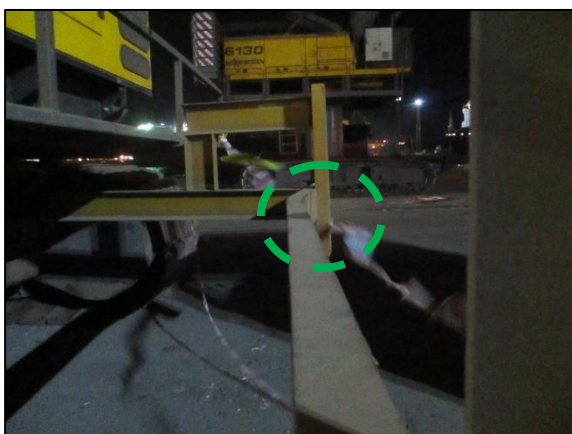
fender bar of the shore crane had been deformed (Figure 6).

Figure 6: Deformed steel fender bar of the shore crane (green circle)

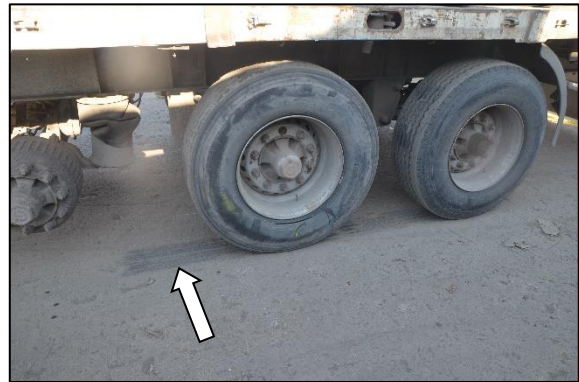
- the hand brake mechanism was found to be fully operational, without any visible damages to its components;
- the tyre treads were in good condition;
- the ground surface, consisting mainly of concrete and partly asphalt, was dry and slightly sloped towards the rear of the truck, *i.e.*, opposite to the direction of the accident;
- engaging the first gear and declutching the gearbox (with the hand brake applied), it was observed that the tyres of the trailer did not turn; and
- tyre marks were left on the concrete / asphalt surface due to the hand brake holding power (Figure 7).

Figure 7: Tyre marks on the ground surface, caused by the tyres of the trailer during examinations by the expert

It was concluded that the truck's brake mechanism and its tyres were in good condition and, thereby, did not contribute to the accident.

The expert also concluded that the hand brake had not been engaged after the truck was stopped to offload its cargo.
