SAFETY INVESTIGATION REPORT

REPORT NO.: 21/2017

MV Samsun Fatality of a crew member in position 12° 12.44' N 064° 25.80' W 20 October 2016

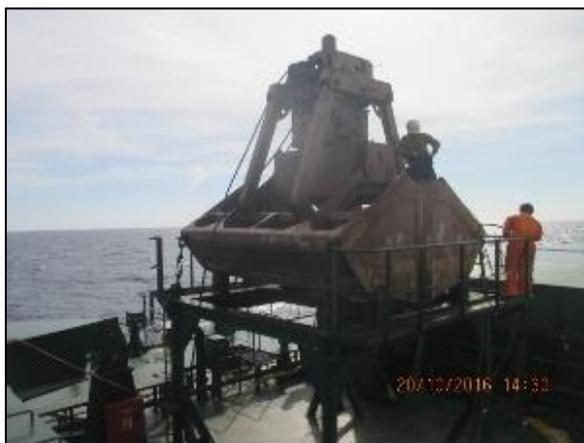
Figure 2: Crew members renewing the wire rope

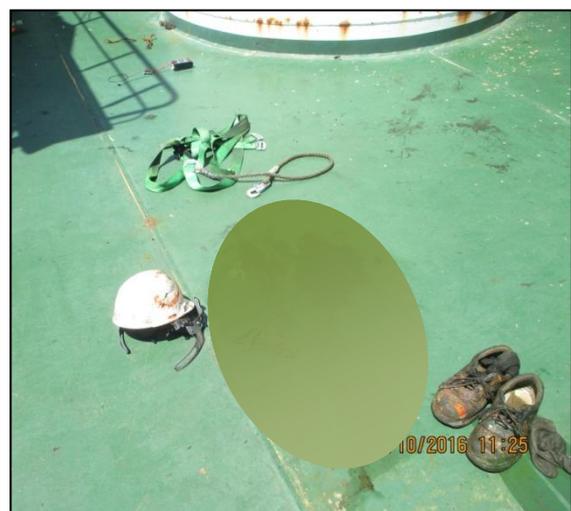
As he unclipped his fall arrester to step down from the grab, he either lost his footing or balance. He fell about five metres on the raised platform/railing and then a further one metre, before landing on the main deck (Figure 3). His colleagues immediately noticed that he was bleeding profusely from the head.

Figure 3: The accident site and safety gear which was worn by the bosun prior to the accident

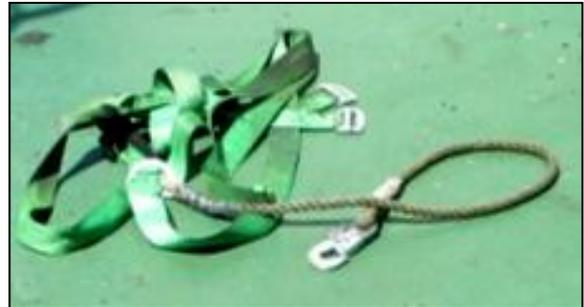
After the completion of the work, disengaging this particular type of fall arrester (Figure 4) from its anchor point was essential for the individual crew member to climb down from the grab.

Figure 4: The fall arrester in use at the time of the accident

It may be submitted that the type of fall arrester used by the bosun was not of the ideal design for vertical movements. This accident has actually indicated that a different type of fall arrester, such as of the type fitted with a double legged energy absorbing lanyards, would have ensured that a person could move from one anchor point to another, and ensuring that there was always a permanent connection. A double legged energy absorbing lanyard was not available on board.

All crew members were informed on the importance of using safety harnesses with a double lanyard, which will be introduced on all fleet vessels.
