SAFETY INVESTIGATION REPORT

REPORT NO.: 09/2019

MV SEASTAR ENDEAVOUR **Man overboard** **in the North Sea Deep Water Route** **20 May 2018**

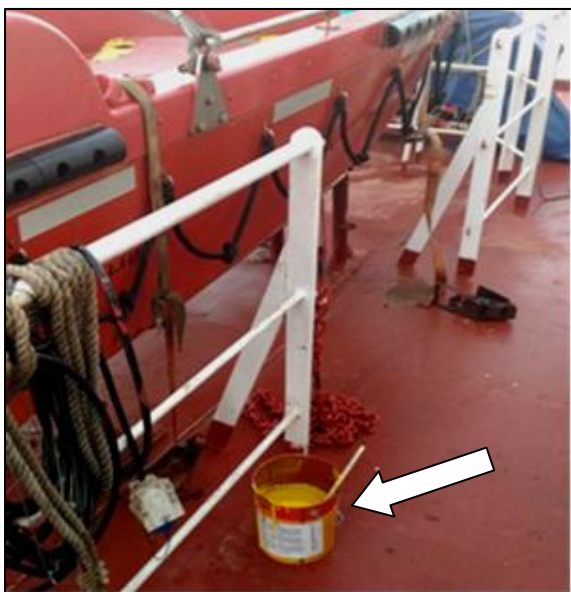
Following discussions with the master, the weather was considered suitable for maintenance work on the vessel's LSA and FFE. The third mate seemingly set out to work inside the rescue boat. A bucket of yellow paint was discovered near the safety railing (Figure 2). Two seats on the rescue boat had been freshly painted (Figure 3). Furthermore, the locker's cover had been shifted and the boat's anchor had also been taken out.

It seemed, therefore, that either the rescue boat or the area around the boat was the likely position of the accident.

Figure 2: The rescue boat and the paint bucket

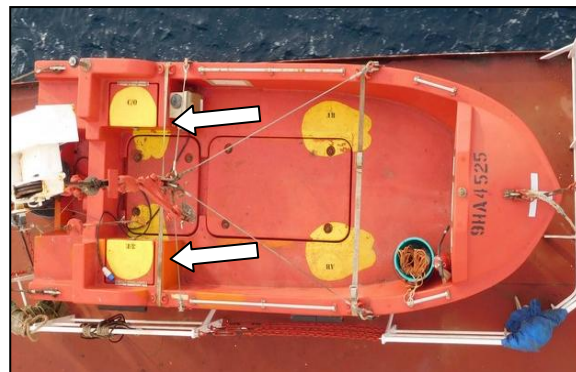
Figure 3: Freshly painted seats

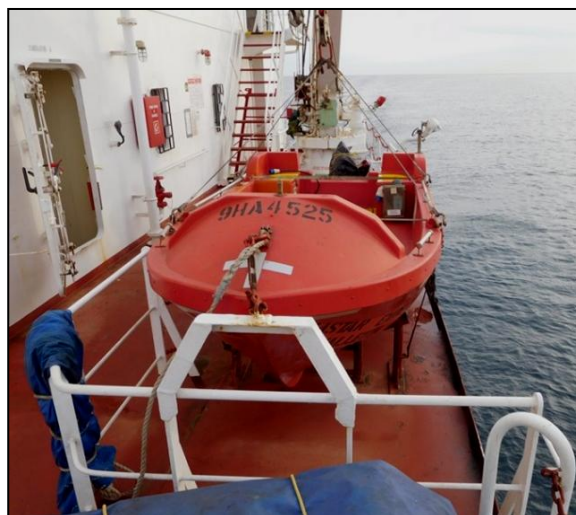
The rescue boat, situated on the boat deck on port side, was outside of the perimeter of the main deck's safety rails and the seaward side of the boat had no effective means of protection (Figure 4).

Figure 4: Location of the rescue boat

The safety investigation neither found evidence of toolbox talk nor a formal risk assessment in the documentary evidence submitted to the MSIU² (addressing identified risks). When last seen, the crew member was not wearing any fall arrestor devices.

This suggested that the risk of falling overboard was not envisaged while working on the rescue boat.

During the course of the safety investigation, the Company prepared and introduced a new procedure on working in areas outside of the safety railing (rescue boat, life boat and life raft) in the Company's Health and Safety Manual. As a minimum, the following precautions are being implemented across the fleet:

1. All work conducted outside the perimeter of the safety rails is to be discussed during the daily work planning meeting. A formal risk assessment has to be conducted, taking into account the following safety controls:

- work must be carried out during daylight hours and in favourable weather condition;
 - personnel conducting the work must be positioned as far as possible from the outer board;

- decks must be free from any grease or other oily substance;
 - use of flotation aid, fall arresters, or safety harnesses is now compulsory;
 - constant or periodic visual supervision or VHF reporting routine must be established, if deemed necessary; and
