SIMPLIFIED SAFETY INVESTIGATION REPORT

REPORT NO.: 04/2018

MV SULTAN BEY **Serious injury to a crew member** **in position 42° 49.6' N 005° 46.5' E** **01 February 2017**

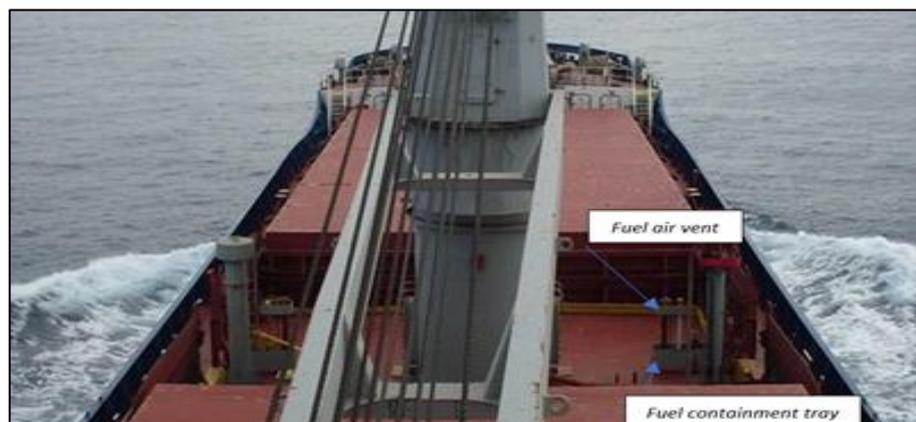
The bosun noticed the motorman and informed him of the plan and cautioned him to stay clear of the area. At 1530, the bosun started opening cargo hold no. 1, when he heard a loud scream. The operations were immediately halted and the motorman was discovered near the starboard over-flow containment tray, bleeding from the nose and ear.

Figure 1: Main deck showing location of the accident

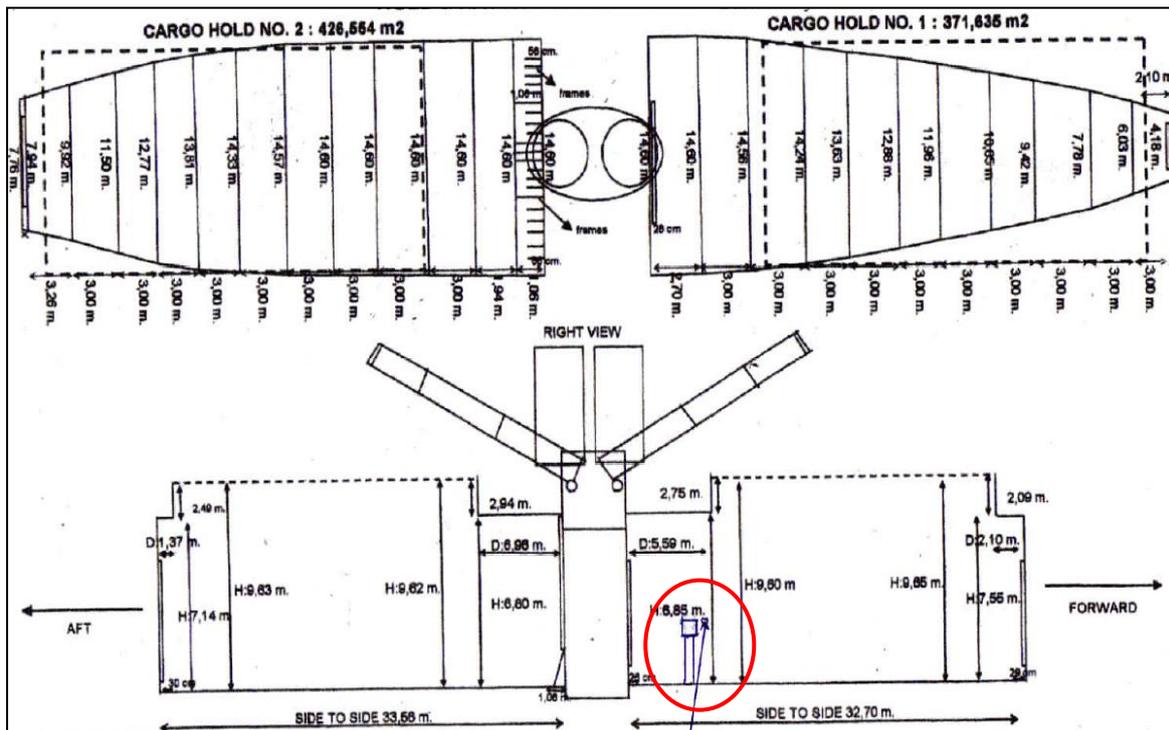
The cargo hatch covers (Figure 2) are of the MacGregor type, consisting of several steel pontoons linked together with a chain. The opening of the hatch cover is controlled from a power control unit. The pontoons move on rollers, running on tracks fitted on the hatch coaming.

Figure 2: Section of the GA plan, showing the location of the accident

When the hatch covers are opened, the individual steel pontoons (pulled by the chain), roll up and tip onto a stowage space behind the hatch coaming. The pontoons in the stowed position tend to sway about the rollers.

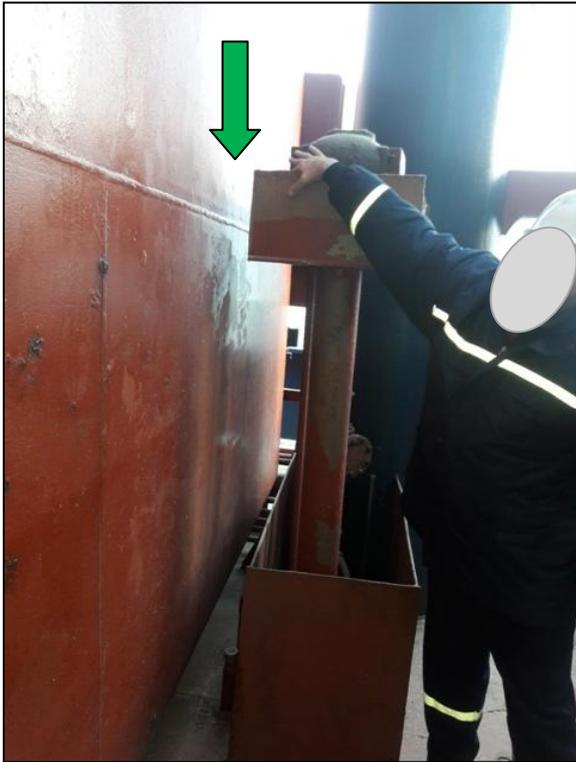
The crew members indicated that the motorman was injured on the upper part of the fuel air-vent post (Figure 3).

Figure 3: Location of the accident as witnessed by the crew members

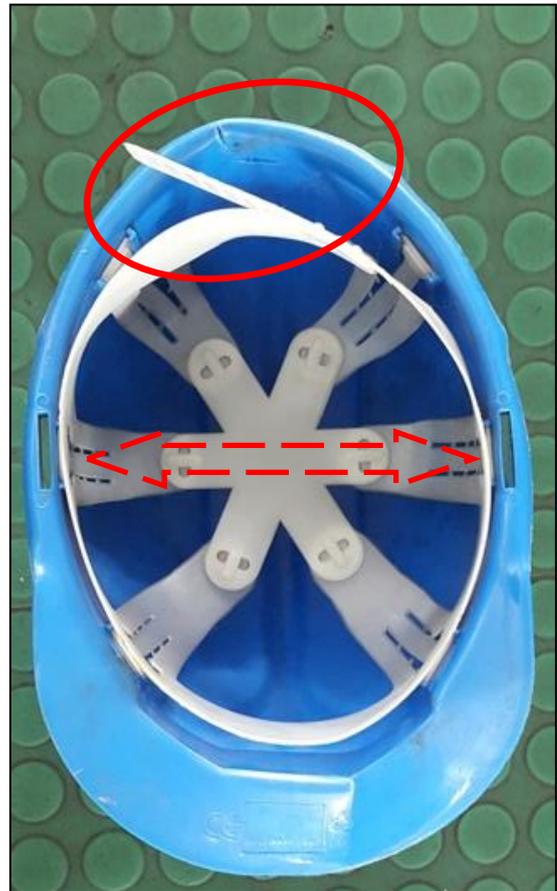
Considering that the injured crew member was wearing PPE, including a safety helmet and that he was not specifically told to reschedule the task, it is very likely that he did not suspect that the pontoon could swing so dangerously close to the fuel air-vent post, entrapping his head as he set about cleaning the containment tray (Figure 4).

Figure 4: Deformed and damaged safety helmet
