SIMPLIFIED SAFETY INVESTIGATION REPORT

REPORT NO.: 22/2017

MV THOMSON MAJESTY

Engine-room fire

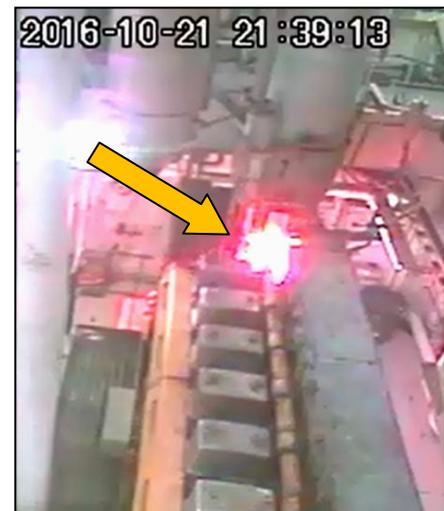
Minutes later, the OOW looked towards the CCTV monitors and observed smoke and flames from auxiliary engine no. 4 (Figure 1).

Figure 1: The start of the fire captured on CCTV

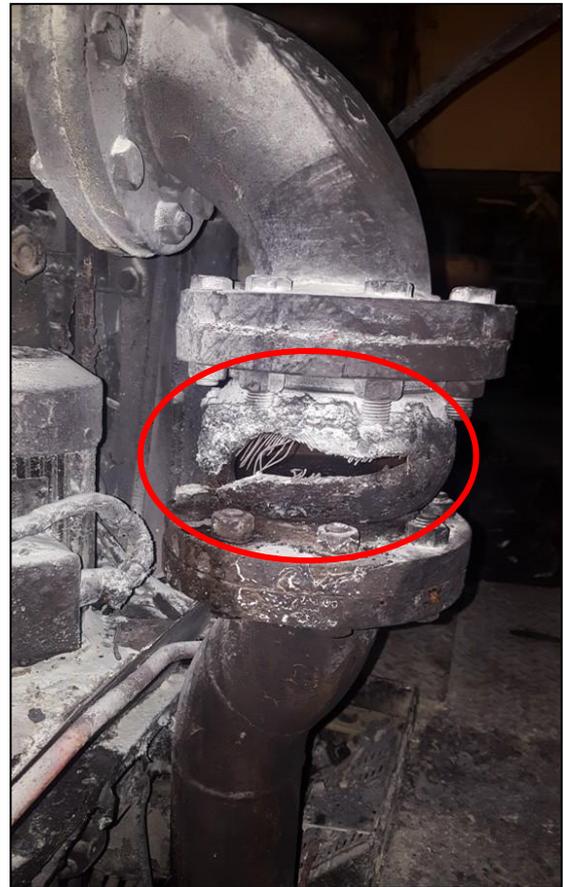
Due to the fire, the rubber bellows fitted on the cooling water line in way of auxiliary engine no. 4 was damaged and leaked heavily (Figure 3). Consequently, before the crew members could identify and rectify the problem, the cooling water expansions tanks leaked dry and the running auxiliary engines

Figure 3: Damaged rubber bellows

Subsequently, the damaged bellows was replaced, the system replenished, and purged from air. Power was restored at about 0200 on 22 October 2016 and the vessel returned to Livorno with two auxiliary engines and two main engines running. No injuries had been reported.

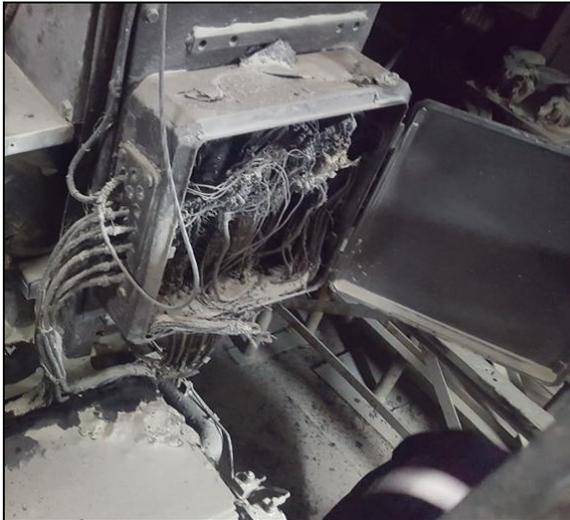
The damages were contained within the proximity of auxiliary engine no. 4. Electrical cables routed above the auxiliary engine and other control cables had to be cleaned and replaced where necessary (Figure 4).

Figure 4: Damaged control cables

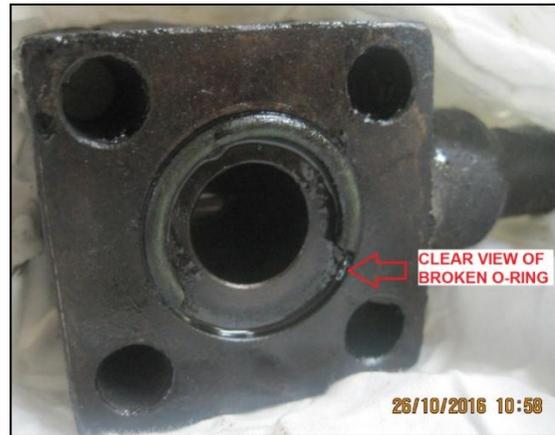
When the fuel oil return pipe was disconnected from the high pressure pump on unit no. 6, it was observed that the O-ring was damaged (Figure 5). The pipe was located very close to the turbocharger and the aft exhaust gas manifold. It was therefore confirmed that the fuel oil leak had originated from the fuel oil return pipe because of the damaged O-ring.

Figure 5: Damaged O-ring

It was also noticed that there were no records to confirm whether the O-Ring had been renewed before the system was boxed up again earlier during the day of the fire. Whereas it was not excluded that the (old) O-ring's physical and chemical characteristics had changed, it was also very possible that the O-ring got displaced before it was fitted and was permanently damaged when the flange was tightened. Consequently, there was no tight seal and eventually, fuel oil under pressure leaked from between the flanges and the spray. It was therefore evident that the system was either not tested after the repair job was completed or else, if tested, no leaks were detected.
