SAFETY INVESTIGATION REPORT

REPORT NO.: 05/2021

MV TITANIA

Serious injury to crew member while operating the on board lathe in position 35° 43.7' N 075° 10.5' W 04 February 2020

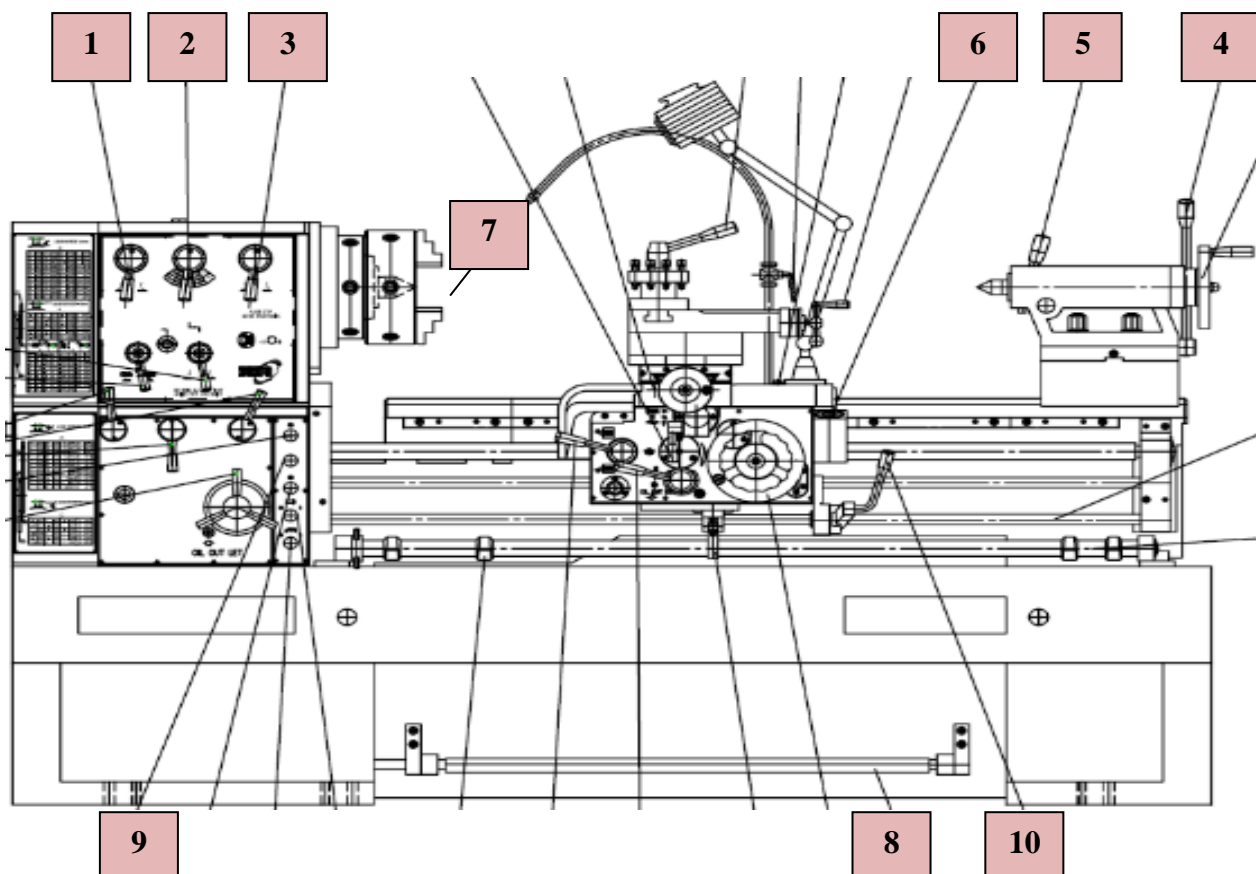
Figure 1: The lathe on *Titania*

The lathe was a DMTG CDL6251/1500 model. Figure 1 shows the various features and operating functions which were of interest to the safety investigation:

1. speed selecting lever;
2. spindle speed selecting lever;
3. high-low speed selecting lever;
4. tailstock sleeve moving handwheel;
5. tailstock clamp lever;
6. tailstock sleeve clamp lever;
7. three-jaw chuck (fitted at indicated location);
8. foot brake pedal;
9. emergency stop button; and
10. spindle control lever.

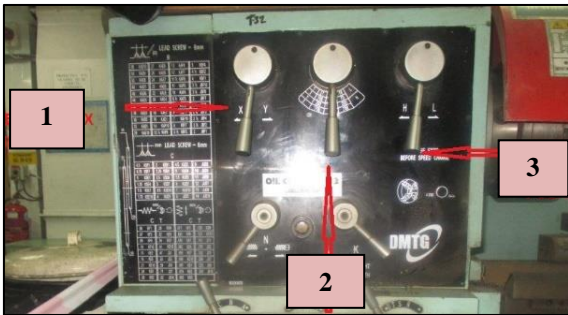
Figure 2: Settings of control levers.

- the speed selecting lever 1 set on 'X' (Figure 2);
- the spindle speed selecting lever 2 set to middle (Figure 2);
- high / low speed selecting lever 3 set on 'H' (Figure 2)
- the speed control levers were found in the positions depicted in Figure 2;
- the tailstock was secured tightly on the guideway of lathe;
- the length of the rod outside the chuck until the end that was supported by the tailstock was 734 mm;
- the distance from the chuck to the tailstock centre pin was 732 mm;
- while testing, the tailstock sleeve moving hand wheel was rotated clockwise but was noticed to turn anti-clockwise under its own weight, withdrawing the sleeve by about 2 mm;
- the tailstock sleeve clamp lever was noticed to have not been fully secured;
- the depth of the drilled point at the end of the rod that was supported on the tailstock was about 1.5 mm;

Following the accident, the Company suggested that the work should have started at a low speed setting so that the operator would have assessed the settings and positioning of the workpiece. However, it must be appreciated that the fitter may have perceived the task at hand as minor and which he may have executed many times.

This experience may have given him the confidence to start the lathe immediately at high speeds, rather than increasing it gradually.

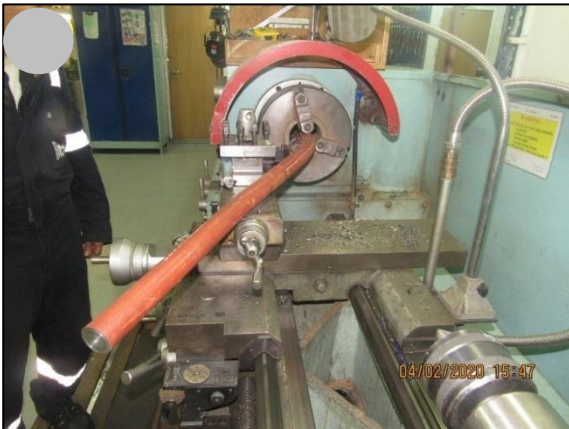
Figure 3: Condition of rod after accident

- no indentations were found on the rod, which could have indicated an axial shift of the rod in the three-jaw chuck.
- the rod was found bent (Figure 3).
- the tool post securing bolts were found broken (Figure 4).
- the chuck guard was found in a closed position (Figure 3).
- the spindle control lever was found in the lifted position (which would cause the spindle to rotate forward, *i.e.*, counter clockwise) (Figure 5).

The fitter was operating the lathe to machine a cast iron rod of 800 mm length and 35 mm in diameter. In the process, the rod slipped from the tailstock while the lathe was rotating at a very high speed. This caused the rod to bend and strike the fitter on his right shoulder region.

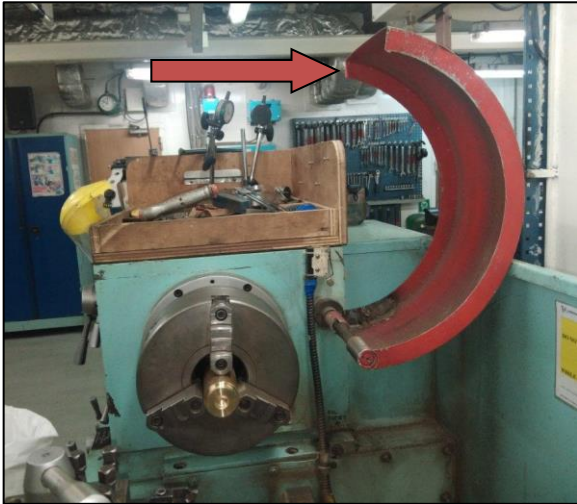
Figure 6: Chuck guard in open position

The fitter recalled being given a job order by the second engineer to fabricate a roller and shaft for the gangway. He also remembered centring the drilled hole on the rod in the lathe, sometime after 1310. He could also recall the open chuck guard (Figure 6), just

The chuck guard, installed on top of the three-jaw chuck, did not serve its purpose as a physical protective barrier. This was so because the deflection of the rod occurred at the other end, near the tailstock and away from the chuck guard. No other physical barriers were installed on the lathe. An analysis of the SMM indicated that a carriage guard (which would normally be installed on the main body of the lathe and moves with the tool post), was marked as an installed item. However, the safety investigation was unable to determine why the carriage guard was not installed on the lathe.

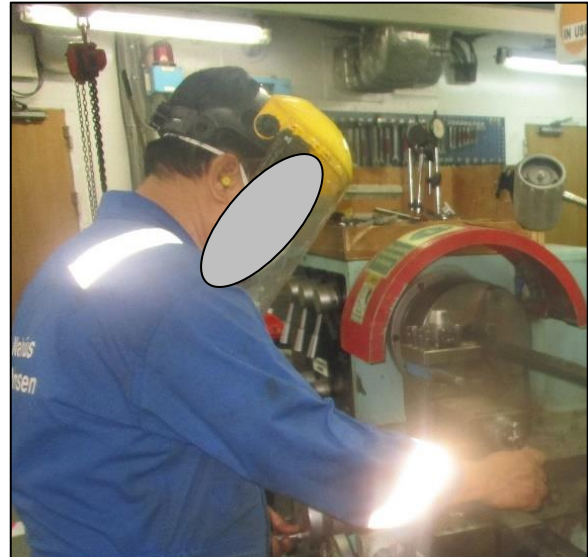
Figure 7: Simulation of fitter wearing face shield

At the time of occurrence, it was reported that the fitter was wearing overalls, safety shoes, ear plugs, a dust mask and a face shield. The PPE matrix required a safety helmet and safety goggles to be worn. However, considering that the fitter was wearing a face shield, this did not necessitate the donning of safety goggles. Additionally, the type of face shield worn by the fitter was not designed to be used in conjunction with a safety helmet (Figure 7).

The absence of a safety helmet may have contributed to the fitter's minor head injury.

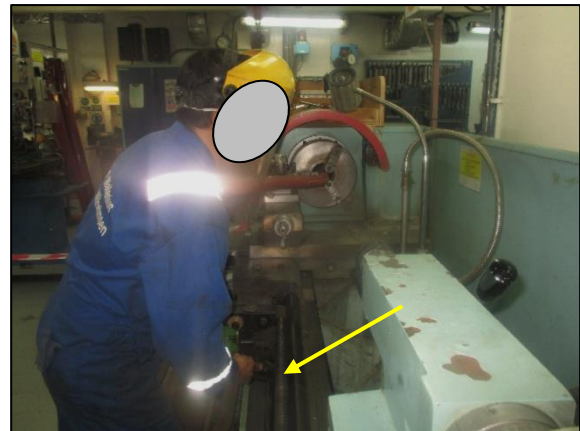
Figure 8: A photo simulation of fitter intending to operate the spindle control lever (yellow arrow) and being hit by the rod on his right shoulder

The possibility that the fitter may have tried to stop the rotational movement of the rod by operating the spindle control lever on the body of the lathe was also considered. While doing so, the fitter was struck by the rotating (and deflecting) rod on his right shoulder, knocking him on the floor, and hitting his head (Figure 8). This possibility was,

however, considered to be remote, given the short time that he would have had to react, unless he had noticed that something was not right with the rotating rod.

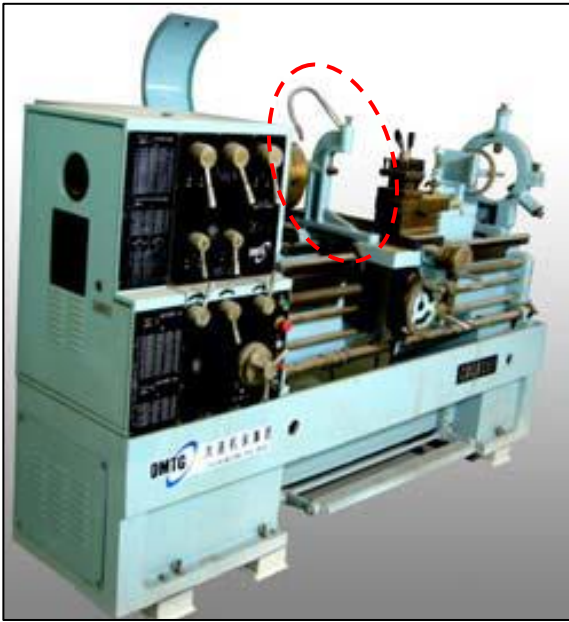
Figure 9: Follower rest installed on the lathe, as reproduced in the SMM

Taking into consideration the thickness of the solid rod (35 mm in diameter), it would have sufficed to use a follower rest for the task. Several long slender shafts that tend to whip and spring during machining, require the use of a follower rest. Follower rests (Figure 9)

are fitted on lathes to minimise excessive rotating deflections by holding long workpieces steady during machining. They are attached to the saddle (the lathe component that holds the tool post) and move along with or 'follow' the lathe.

The follower rest, which was compatible with *Titania's* lathe was designed for diameters of between 20 and 90 mm.

Whilst the SMM did not indicate the minimum lengths of workpieces for which a follower rest would have been required, it transpired that a follower rest was not available on board.

- The Company confirmed that steady⁷ and follower rests have been made available on board and were being used;
- A fleet wide experience exchange was carried out to ensure that the lessons learnt from this occurrence were promulgated and addressed.
