SAFETY INVESTIGATION REPORT

REPORT NO.: 20/2021

MV YSALINE **Serious injury to crew member** **Zeebrugge** **Belgium**

20 September 2020

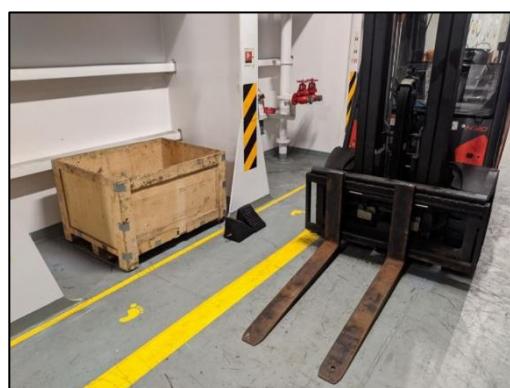
At 1250, the chief officer was on site to inspect the car deck. He saw one of the able seafarers standing inside a wooden box² on the forklift (Figure 2). The forklift was on deck no. 4. The able seafarer was collecting the railings, the bosun³ drove the forklift just below the aft section of deck no. 4A. With the able seafarer still in the box, he lifted the box about two metres to reach car deck no. 4A (Figure 3). It was at this time that after delivering the railings to another seafarer on deck no. 4A, the able seafarer turned around, and fell off the box. The wooden box also fell behind him.

Figure 2: Photo showing wooden box and forklift used for moving safety railings to deck no. 4A.

- issued a safety alert to all fleet vessels and prohibited crew riding on the forklift;
- reviewed risk assessment and procedures for lowering and preparing of hoistable car decks;
- conducted training of the crew to carryout tool-box meetings before starting a job.

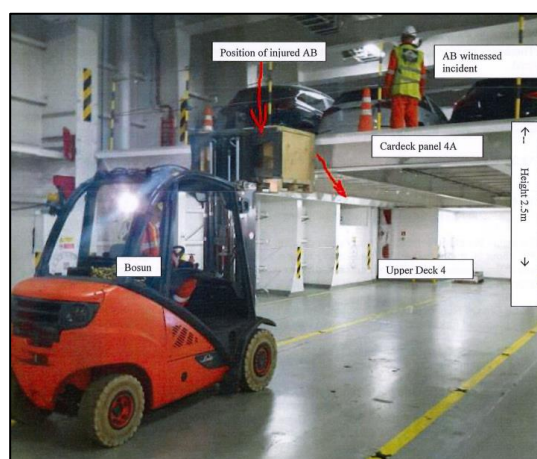
Figure 3: Simulated photo showing deck 4, hoistable car deck 4A, and position of crew members prior to the accident.

explanation as to the cause of the able seafarer's fall. Considering that there was no evidence of sudden or unexpected movement of the forklift and the vessel was found, the safety investigation thus did not exclude the possibility of loss of balance when the seafarer suddenly turned around (after the railings had been off-loaded), causing him and the box to topple over on the hard surface of the deck below.
