SAFETY INVESTIGATION REPORT

REPORT NO.: 01/2022

Pilot Boat *OHIO*

Allision with a tuna pen
in position 36° 00' N 014° 26.1' E
St. Pauls Bay, Malta

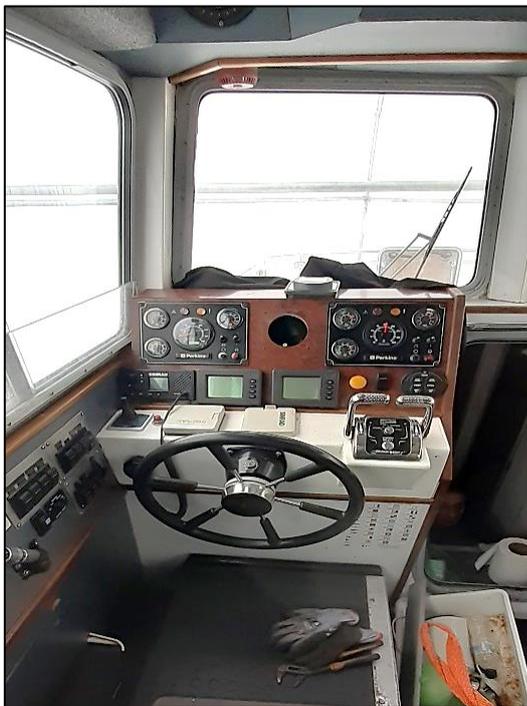
Figure 5: Conning station port side

Ohio left the Grand Harbour at around 2150, bound to motor vessel *CMA CGM Titus*, which was anchored at Bunkering Area 1. The GPH, who was being trained as coxswain (trainee-coxswain), had the con. He was seated at the conning station port side (Figure 5), while the boat's coxswain was seated on the starboard side.

The trainee coxswain recalled having difficulty seeing through the bridge-front window; the operation of window wiper² had made the visibility even worse. The trainee-coxswain executed the helm order using autopilot (push button) to turn the boat.

Ohio was fitted with two large, ‘reverse angled’ bridge-front windows, providing visibility ahead. Both windows were provided with wipers and window screen water-washers. However, the pump for the window washers had been dismantled for repairs ashore and was unavailable on the night of the accident.

After leaving Grand Harbour, the crew reported seeing lights of the anchored vessels as well as the fish farm’s yellow flashing light. As *Ohio* drew closer to the bunkering area, it was considered likely that fine sea spray or salt particles over the bridge-front windows compromised visibility from the conning position. The operation of the wiper (without water) in an attempt at improving visibility, smudged the glass. The glare and the reflected light exacerbated the crew members’ ability to see clearly through the bridge-front window.

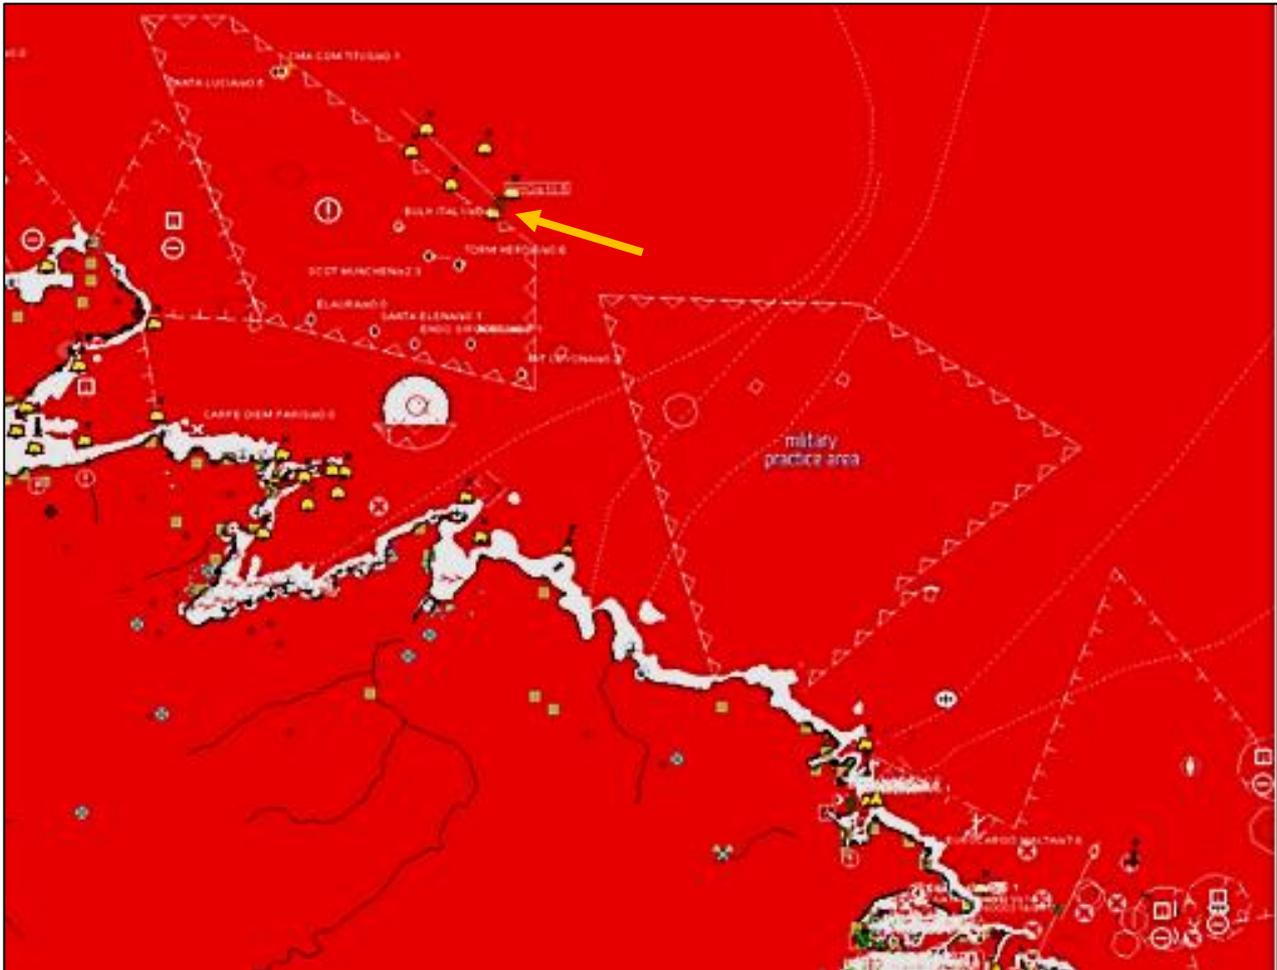
Figure 6: VTS screen shot showing *Ohio* stationary inside the tuna pen (yellow arrow)

About eight minutes later, the coxswain sighted a flashing light. He stood up and saw that the boat was very close to the tuna pen. Immediately, he pulled back the engine throttle, but *Ohio* breached into the perimeter fence, scurried over the HDPE pipes, and entered the enclosed section of the tuna pen. The allision occurred at 2233, in position 36° 00' N 014° 26.1' E (Figure 6).

In any event, the duty operator would have relied on the coxswain's judgement to call VTS for navigational assistance. However, the absence of a guard zone around the fish farm, which would alert the operator in the event of a breach, was considered by the safety investigation to be a missing safety barrier. Moreover, the VTS chart window had confusingly turned red (as the workstation software had not been reportedly upgraded), making detection even more challenging.

01/2022_R1 Upgrade VOC5060 and consider the functionality and activation of guard zones on the VTS operators' workstations.

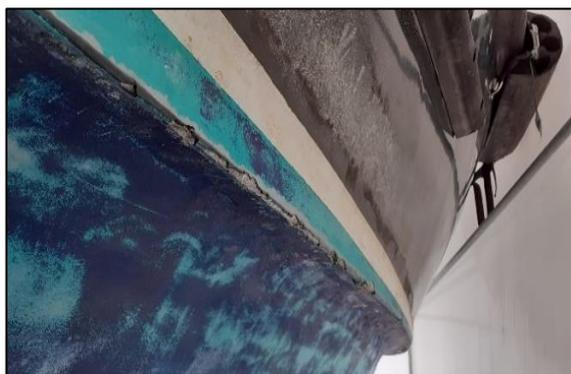
Figure 7: Photo showing hull damage

The following damages were sustained by *Ohio*:

- two propellers and propeller shafts;
- one missing rudder and one bent rudder;
- two rudder stocks;
- one Cutlas bearing;
- exhaust outlet; and
- minor hull damage on starboard side (Figure 7).

Following the initial course alteration to port³, the crew members were neither able to spot the farm’s yellow lights in good time, nor monitor *Ohio*’s position, relative to the fish farm. The minor hull damage that *Ohio* sustained to her starboard side indicated that the crew members had not recognised that the course alteration made earlier had not been enough to pass clear of the tuna pen.
